DOT HS 813 312

# **Special Crash Investigations: On-Site Driver Air Bag Inflator Rupture Crash Investigation; Vehicle: 2006 Ford Ranger; Location: Louisiana; Crash Date: March 2017**

**Special Crash Investigations  
On-Site Driver Air Bag Inflator Rupture Crash Investigation  
Office of Defects Investigation  
Case Number: CR18013  
Vehicle: 2006 Ford Ranger  
Location: Louisiana  
Crash Date: March 2017**

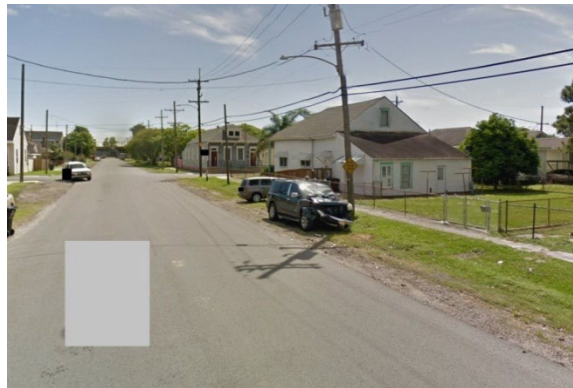
*Figure 2. Southbound view of the crash site and the final rest position of the Nissan (image obtained from an online mapping software)*

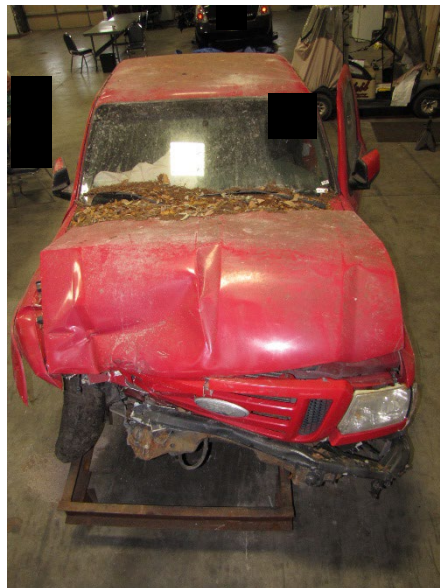
Figure 4. Overhead view of the Ford

The 2006 Ford Ranger (Figure 4) was manufactured in April 2006, identified by the Vehicle Identification Number 1FTYR14U76Pxxxxxx. The odometer reading at the time of the crash is unknown. The Ford was a super-cab pickup truck, configured with 2 doors and fixed B-pillars. It was built on a 319 cm (125.6 in) wheelbase and had a gross vehicle weight rating of 2,250 kg (4,960 lb). Front and rear axle ratings were 1,139 kg (2,510 lb) and 1,179 kg (2,600 lb), respectively. The Ford's curb weight was 1,502 kg (3,312 lb). Its powertrain consisted of a 3.0-liter, V-6, gasoline engine, linked to a 5-speed automatic transmission with a column-mounted shifter. The service brakes were power-assisted with front disc/rear drum with ABS. The vehicle manufacturer's recommended tire size and cold tire pressure were P235/75R15 front and rear, at 205 kPa (30 PSI) front and 240 kPa (35 PSI) rear. At the time of the SCI inspection, the Ford had a mismatch of tires with the left-front tire and wheel missing from the vehicle. The tires were mounted on OEM-style steel wheels. The tires at the time of the SCI inspection were as follows:

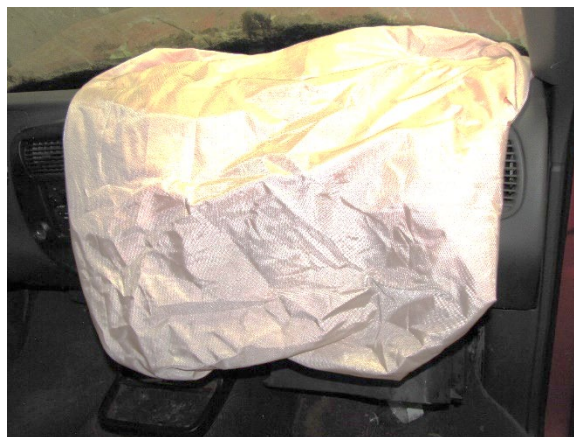
The passenger's frontal air bag (Figure 16) deployed from the module located in the mid-aspect of the right instrument panel through H-configuration cover flaps. The vehicle manufacturer determined through examination of a bar-code identification label located on the module assembly that the passenger's frontal air bag was original equipment to the Ford.

*Figure 16. Deployed passenger's frontal air bag in the 2006 Ford Ranger*

In its deflated state, the air bag measured approximately 65 cm (25.6 in) wide and 56 cm (22.0 in) tall. It deployed approximately 50 cm (20 in) rearward from the module. The air bag was vented on both sides by 6 cm (2.4 in) X-shaped vents. An additional 8 cm (3.1 in) diameter vent
