DOT HS 813 507

**Special Crash Investigations:
On-Site Electric Vehicle Fire
Investigation;
Vehicle: 2019 Chevrolet
Bolt EV;
Location: Florida;
Incident Date: October 2020**

**Special Crash Investigations
On-Site Electric Vehicle Fire Investigation
Office of Defects Investigation
Case Number: CR20035
Vehicle: 2019 Chevrolet Bolt EV
Location: Florida
Incident Date: October 2020**

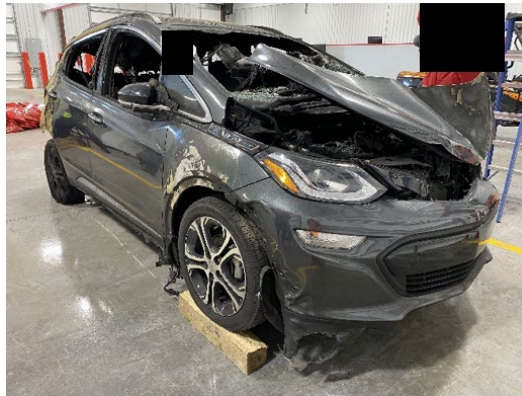
Figure 5. 2019 Chevrolet Bolt

The 2019 Chevrolet Bolt (Figure 5) was manufactured in October 2018 and identified by the Vehicle Identification Number (VIN) 1G1FZ6S06K4xxxxxx. The Chevrolet was a front-wheel drive platform, powered by a permanent magnetic drive motor. It had power-assisted, 4-wheel disc with antilock brakes. The curb weight was 1,625 kg (3,528 lb). At the time of the inspection the Chevrolet had Michelin Energy Saver tires for the left and right front tires. The left and right rear tires were damaged by the fire and not legible. All tires had at least 6 mm (7/32) of tread. Additionally, all tires were burned from the fire with the left front, left rear, and right rear tires deflated.

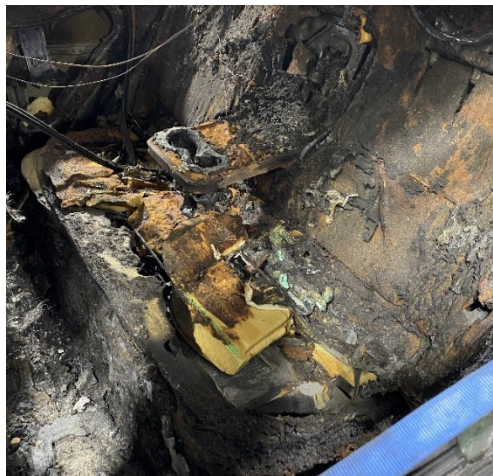
Figure 6. 2019 Chevrolet Bolt second row

The Chevrolet had seating for five occupants (2/3), with front-row bucket seats and a second-row bench seat (Figure 6) with split forward-folding seatbacks. The right front, left front, left rear, and right rear seating positions all had adjustable head restraints. Manual restraint systems consisted of 3-point lap and shoulder seat belts for all seat positions. Supplemental restraint systems included front seat belt retractors and 10 air bags consisting of the driver's and passenger's frontal, driver and passenger knee, front and rear outboard seat-mounted side impact, and inflatable curtain air bags.
