DOT HS 813 586

**Special Crash Investigations:
On-Site Air Bag Inflator Rupture
Investigation;
Vehicle: 2012 Mercedes-Benz C250;
Location: Florida;
Crash Date: November 2020**

On-Site Air Bag Inflator Rupture Crash Investigation
Office of Defects Investigation
SCI Case Number: CR20037
Vehicle: 2012 Mercedes-Benz C250
Location: Florida
Crash Date: November 2020

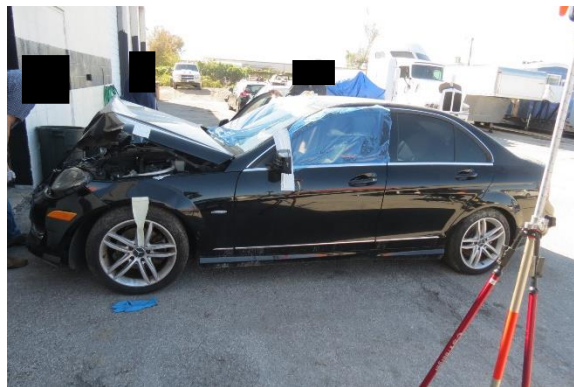
Figure 3. Left side view of the 2012 Mercedes-Benz

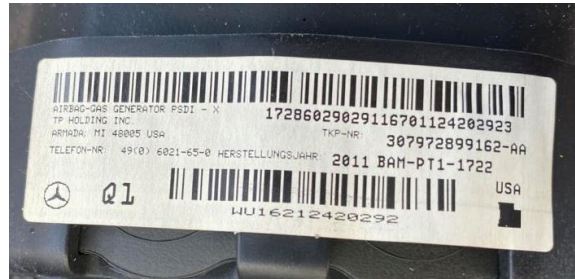
A bar-coded label affixed to the driver's frontal air bag module identified it as manufactured by TP Holding Inc. with a manufacture date of 2011 (Figure 9). This label indicated the driver's frontal air bag module was original to the Mercedes-Benz.

Figure 9. Driver's air bag module bar-coded label providing identification

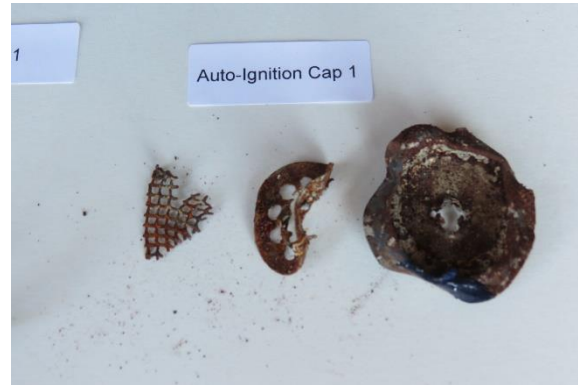
In a stepwise manner, passenger's frontal air bag components were located in the vehicle by consultants for the passenger's attorney and a description label of each component was placed where the component was found in the vehicle, the majority of them in the right front floor area. Each labeled component was then moved to a table where it could be analyzed and imaged. Figure 14 shows the labeling of air bag module components that were found in the passenger floorboard of the Mercedes-Benz. Figure 15 shows air bag module components that were removed from the Mercedes-Benz and placed on the documentation table with a label that matched the label placed in the Mercedes-Benz.

Figure 15. View of table where air bag module components were moved to after removal from the vehicle
