DOT HS 813 684

**Special Crash Investigations:
On-Site Rollover Crash
Investigation;
Vehicle: 2021 Porsche Macan;
Location: California;
Crash Date: June 2022**

Special Crash Investigations
On-Site Rollover Crash Investigation
Case No. DS22018
Vehicle: 2021 Porsche Macan
Location: California
Crash Date: June 2022

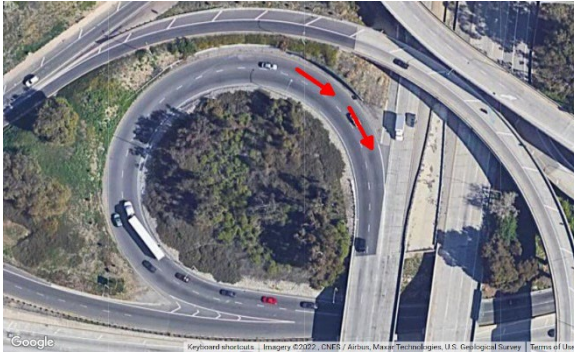
Figure 3. Overhead view of interchange (image source: Google Maps © 2022 Maxar Technologies)

The crash site was in a multi-level interchange of interstate highways in California (Figure 3). The crash occurred on a transition ramp from a westbound interstate roadway to a southbound interstate roadway. The ramp curved to the right and had two travel lanes separated by a dashed white painted line. It was bordered on the left by a solid yellow painted line, a solid white painted line, a narrow asphalt shoulder, and a concrete wall. It was bordered on the right by a solid white painted line and a metal guardrail. The radius of curvature for the ramp was 41 m (135 ft). The superelevation is unknown. There were no rumble strips present. The calculated critical speed¹ for a roadway with this radius is 55.8 km/h (34.7 mph). There was a 32 km/h (20 mph) speed warning sign at the beginning of the ramp. The posted speed limit was 105 km/h (65 mph). The southbound roadway had two travel lanes approaching the transition ramp and was bordered on the left by a solid white painted line, an asphalt shoulder and metal guardrail. The southbound roadway separated from the northbound roadway by a dirt/gravel median and a second guardrail.
