DOT HS 813 711

# **Special Crash Investigations: On-Site Rollover Crash Investigation; Vehicle: 2017 Nissan Altima; Location: California; Crash Date: August 2022**

**Special Crash Investigations**  
**On-Site Rollover Crash Investigation**  
**Case No. DS22019**  
**Vehicle: 2017 Nissan Altima**  
**Location: California**  
**Crash Date: August 2022**

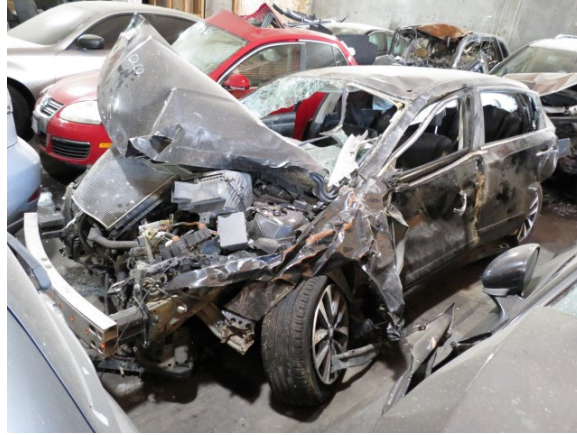
*Figure 1. 2017 Nissan Altima*

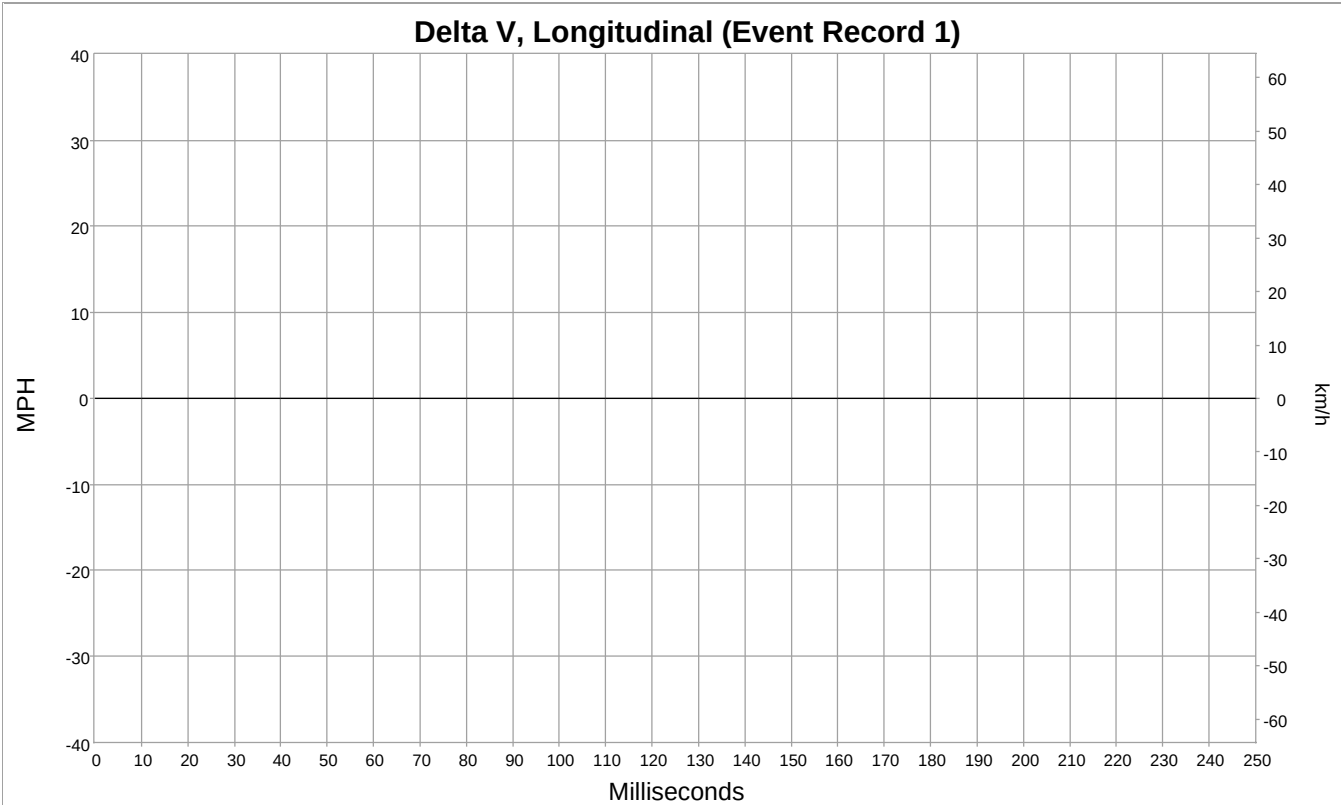
**Longitudinal Delta V (Event Record 1)**

Event 1 and Event 2 caused overlapping damage to the front plane. During the rollover, the vehicle's front bumper fascia and EAD were displaced from the vehicle, suggesting the front bumper may have had additional contact with the ground. The rollover event was out of scope for a full WinSMASH reconstruction, but the calculated barrier equivalent speed was 20 km/h (12 mph). The impacts involving the traffic signs were also out of scope. EDR Event Record 1 reported a maximum longitudinal delta V of 1 km/h (1 mph) and a maximum lateral delta V of -6 km/h (-4 mph).

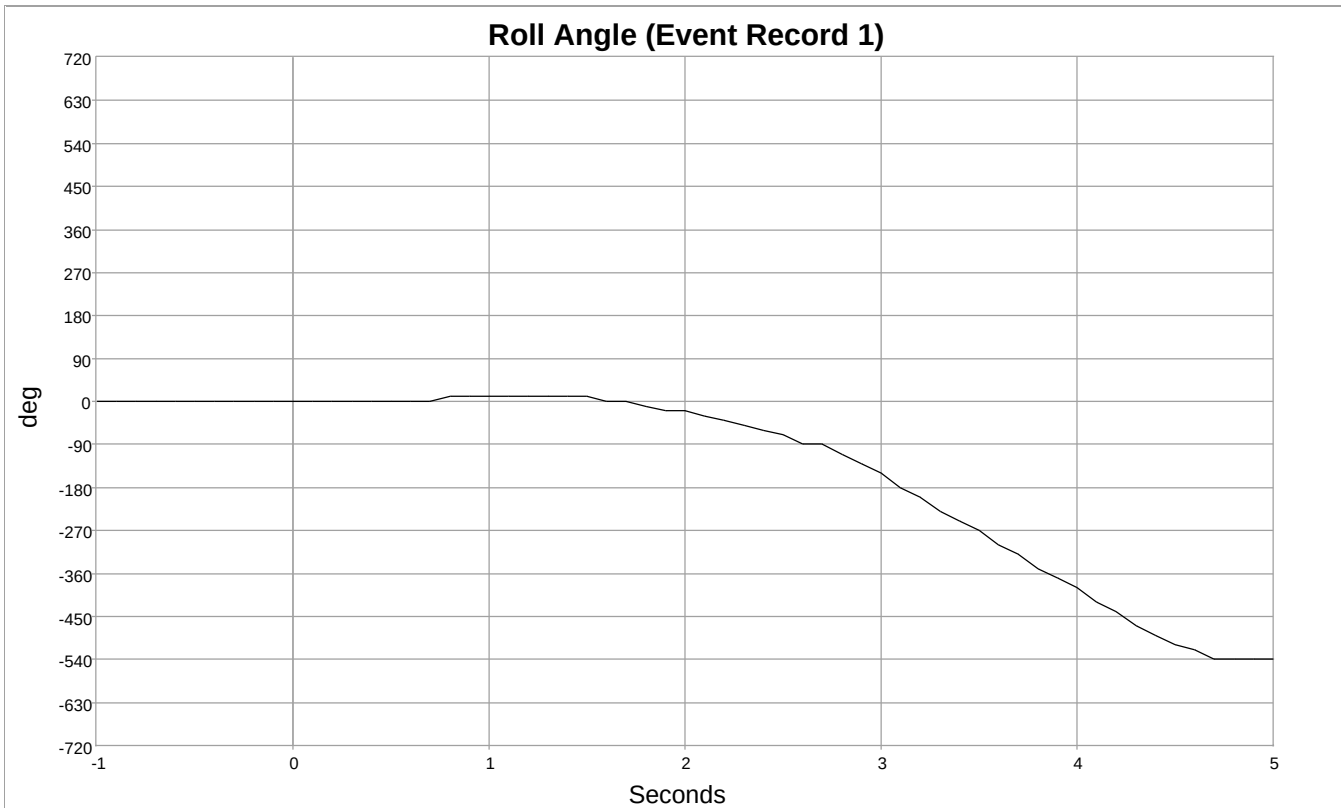
**Roll Angle (Event Record 1)**

trip rollover (Event 3 – EDR Event Record 2). The EDR roll angle data reported negative values (right to left rotation) beginning with  $-10^{\circ}$  at 0.2 seconds and ending with  $-560^{\circ}$  at 5.0 seconds. This event triggered the deployment of the driver's outboard seat-mounted side-impact air bag and the left IC air bag. Vehicle damage suggests the left, top, right, back planes, and possibly the front plane, contacted the ground during the rollover. The Nissan rolled an estimated seven quarter turns and came to rest on its right plane, facing south on the roadside (Figure 3). The estimated roll distance was 57 m (187 ft).
