DOT HS 812 534

**Special Crash Investigations  
Non-Traffic Surveillance  
Remote Hyperthermia Fatality  
Investigation  
Vehicle: 2003 Mitsubishi  
Galant  
Location: South Carolina  
Incident Date: July 2014**

**NON-TRAFFIC SURVEILLANCE  
SPECIAL CRASH INVESTIGATIONS  
CASE NO. CR16036  
REMOTE HYPERTHERMIA FATALITY INVESTIGATION  
VEHICLE: 2003 MITSUBISHI GALANT  
LOCATION: SOUTH CAROLINA  
INCIDENT DATE: JULY 2014**

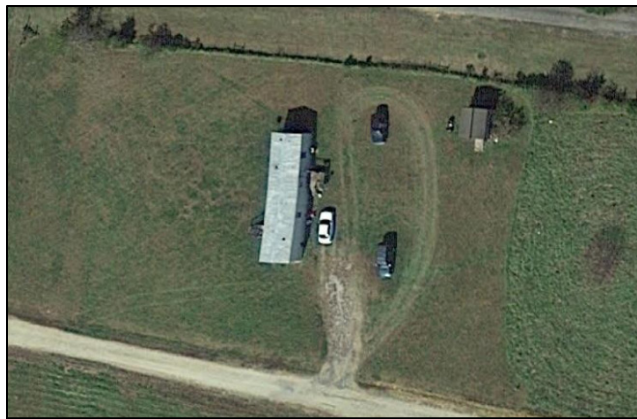
**Figure 2: Satellite image of the Incident Site. North lies at the top of the image.**

This hyperthermia incident occurred on the lawn area of a private residence in a rural area during midday hours. The family residence was a mobile home that was oriented in a north/south direction on a large lawn area (**Figure 2**). The family vehicle, consisting of the Mitsubishi that was registered to the child's grandmother was parked on the lawn, east of the mobile home facing in a southwesterly direction. On the day of the incident the National Weather Service reported a temperature of 30 °C (86.0 °F) at 1155 hours,

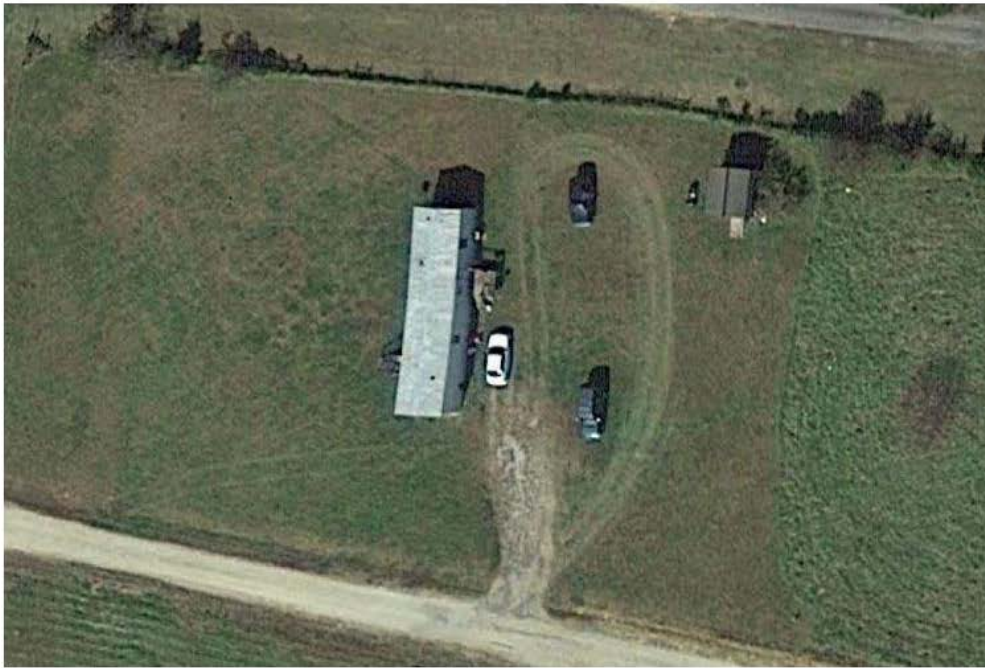
**INCIDENT SITE DIAGRAM**

**Incident Site:  
Private Property**

**V1: 2003 Mitsubishi Galant**
