DOT HS 812 544

Special Crash Investigations On-Site Crash Avoidance Technology Investigation Vehicle: 2016 Mercedes-Benz C450 Location: California Crash Date: April 2016

On-Site Crash Avoidance Technology Investigation SCI Case Number DS16012 Vehicle: 2016 Mercedes-Benz C450 Location: California Crash Date: April 2016

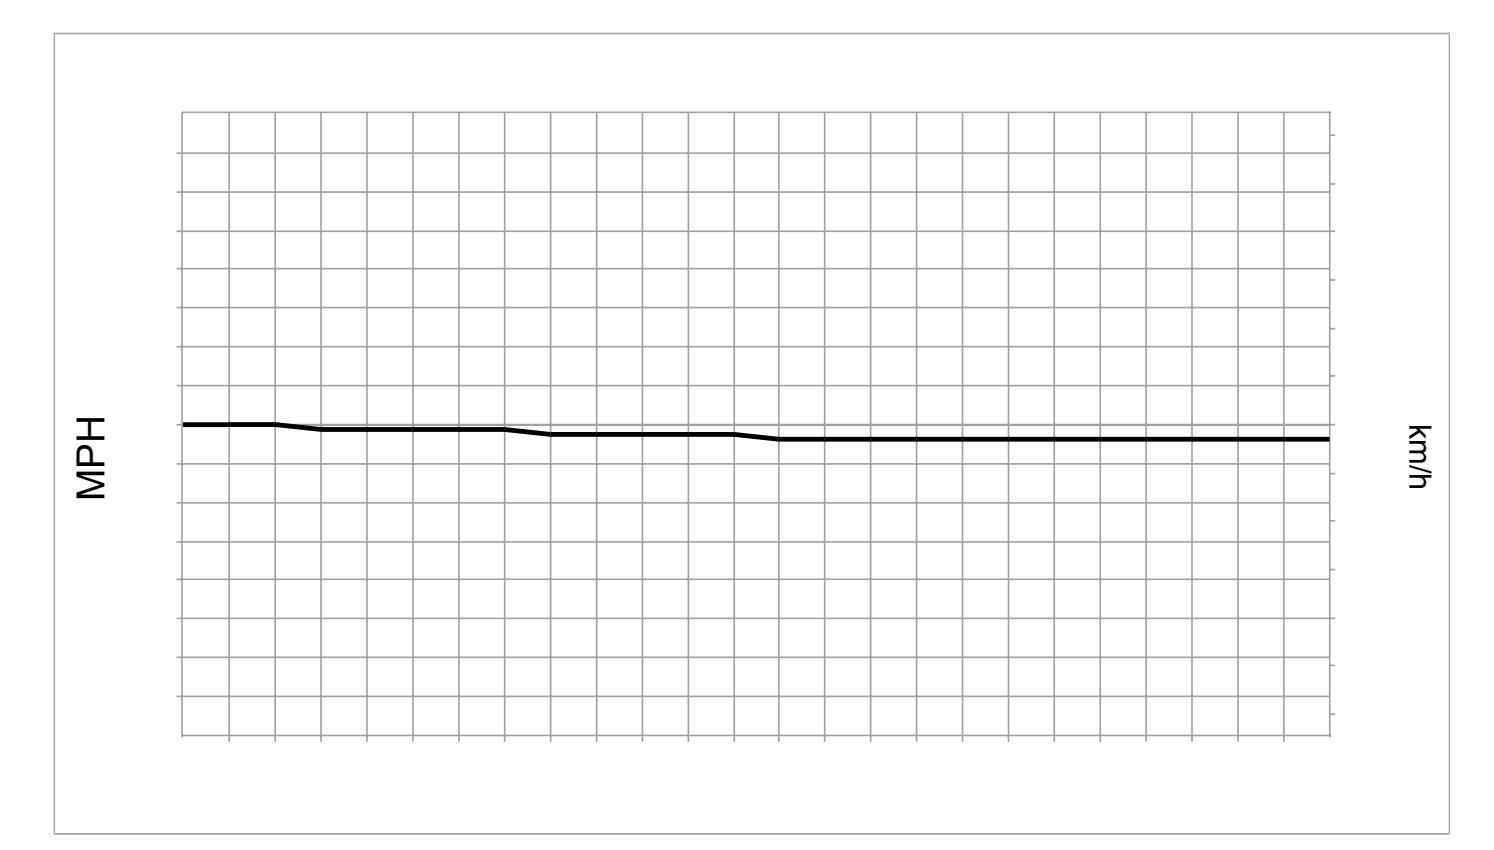
Longitudinal Crash Pulse (Record 1, Most Recent)

Time (msec)	Delta-V, Longitudinal (MPH [km/h])
0	[0] 0 0
10	0.0 [0]
20	0.0 [0]
30	-0.6 [-1]
40	-0.6 [-1]
50	-0.6 [-1]
60	-0.6 [-1]
70	-0.6 [-1]
80	-1.2 [-2]
90	-1.2 [-2]
100	-1.2 [-2]
110	-1.2 [-2]
120	-1.2 [-2]
130	-1.9 [-3]
140	-1.9 [-3]
150	-1.9 [-3]
160	-1.9 [-3]
170	-1.9 [-3]
180	-1.9 [-3]
190	-1.9 [-3]
200	-1.9 [-3]
210	-1.9 [-3]
220	-1.9 [-3]
230	-1.9 [-3]
240	-1.9 [-3]
250	-1.9 [-3]

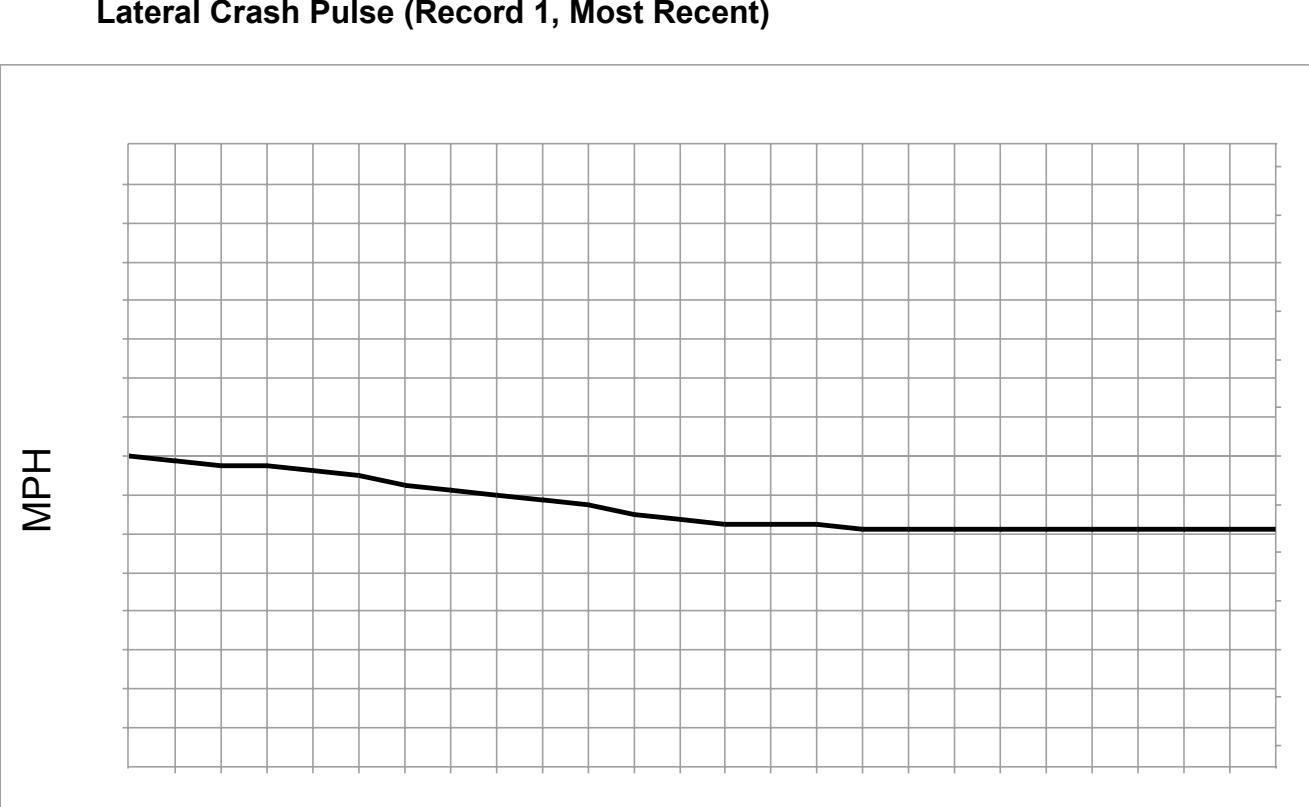
Lateral Crash Pulse (Record 1, Most Recent)

Time (msec)	Delta-V, Lateral (MPH [km/h])
0	0.0 [0]
10	-0.6 [-1]
20	-1.2 [-2]
30	-1.2 [-2]
40	-1.9 [-3]
50	-2.5 [-4]
60	-3.7 [-6]
70	-4.3 [-7]
80	-5.0 [-8]
90	-5.6 [-9]
100	-6.2 [-10]
110	-7.5 [-12]
120	-8.1 [-13]
130	-8.7 [-14]
140	-8.7 [-14]
150	-8.7 [-14]
160	-9.3 [-15]
170	-9.3 [-15]
180	-9.3 [-15]
190	-9.3 [-15]
200	-9.3 [-15]
210	-9.3 [-15]
220	-9.3 [-15]
230	-9.3 [-15]
240	-9.3 [-15]
250	-9.3 [-15]

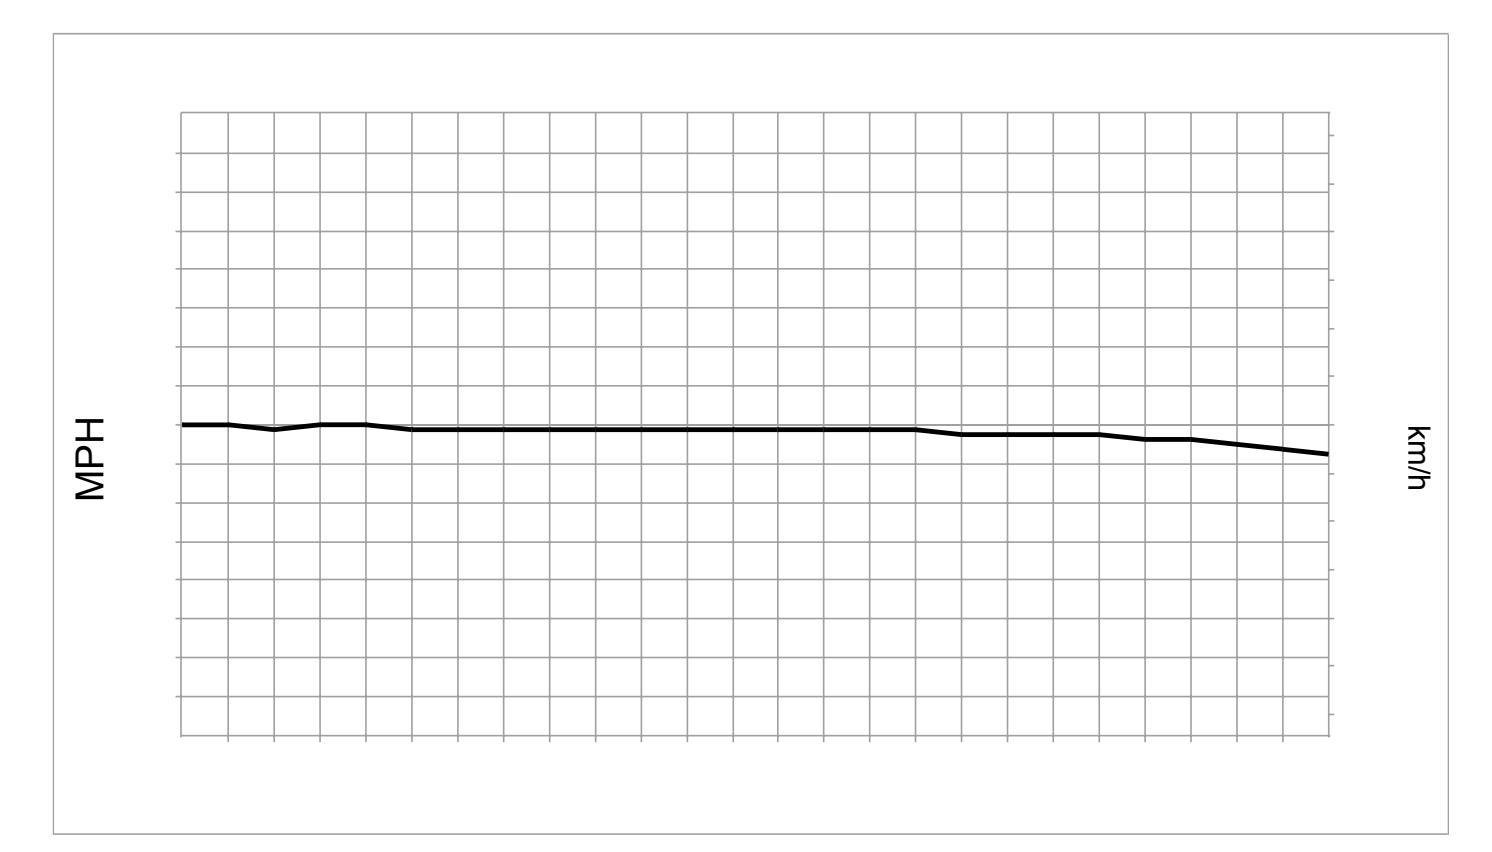
Longitudinal Crash Pulse (Record 2)

Delta-V, Longitudinal	
Time (msec)	(MPH [km/h])	
0	0.0 [0]	
10	0.0 [0]	
20	-0.6 [-1]	
30	0.0 [0]	
40	0.0 [0]	
50	-0.6 [-1]	
60	-0.6 [-1]	
70	-0.6 [-1]	
80	-0.6 [-1]	
90	-0.6 [-1]	
100	-0.6 [-1]	
110	-0.6 [-1]	
120	-0.6 [-1]	
130	-0.6 [-1]	
140	-0.6 [-1]	
150	-0.6 [-1]	
160	-0.6 [-1]	
170	-1.2 [-2]	
180	-1.2 [-2]	
190	-1.2 [-2]	
200	-1.2 [-2]	
210	-1.9 [-3]	
220	-1.9 [-3]	
230	-2.5 [-4]	
240	-3.1 [-5]	
250	-3.7 [-6]

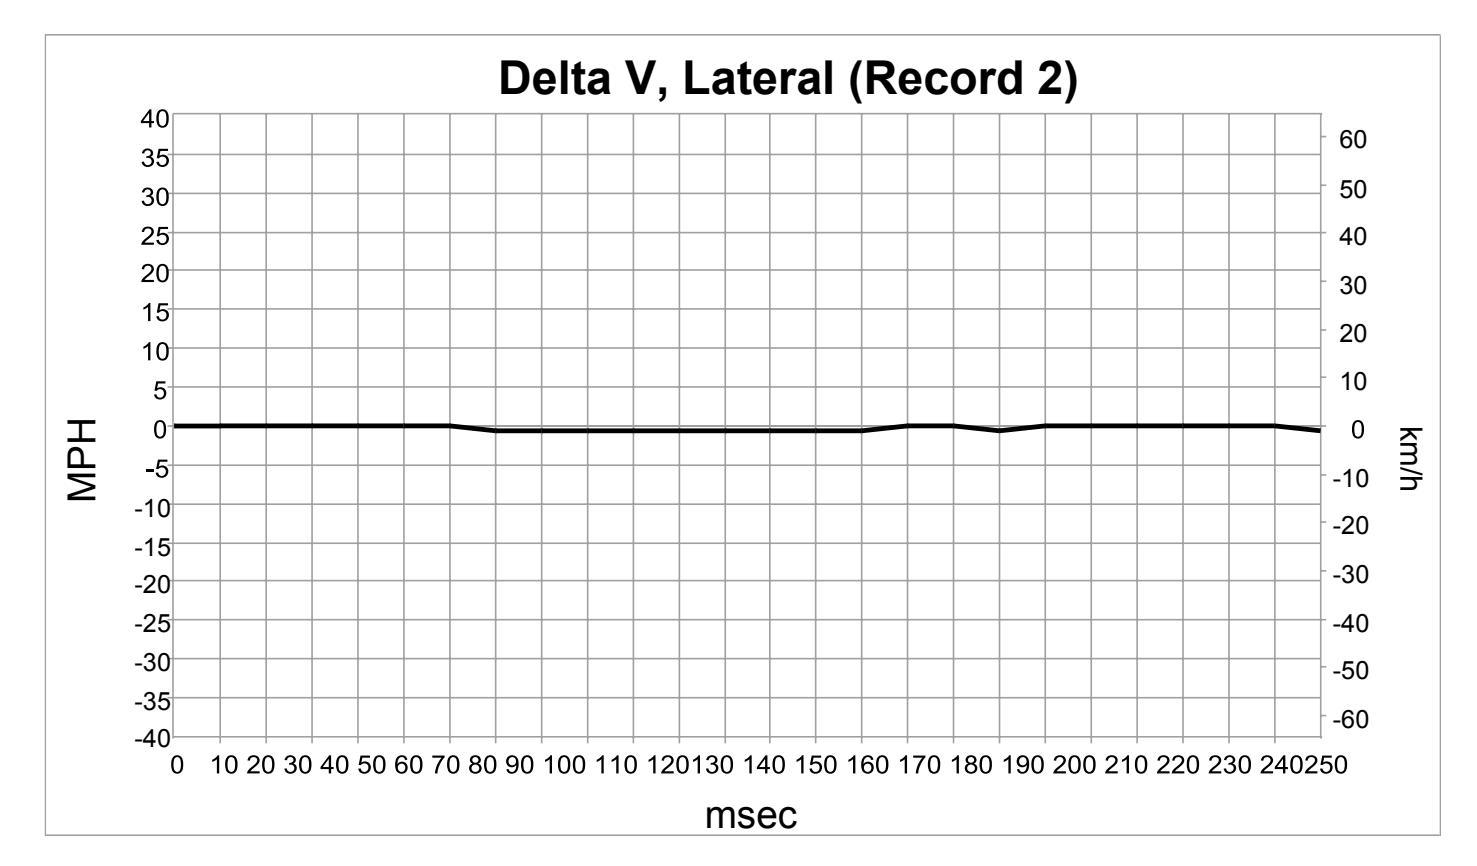
Lateral Crash Pulse (Record 2)

Time (msec)	Delta-V, Lateral (MPH [km/h])
0	0.0 [0]
10	0.0 [0]
20	0.0 [0]
30	0.0 [0]
40	0.0 [0]
50	0.0 [0]
60	0.0 [0]
70	-0.6 [-1]
80	-0.6 [-1]
90	-0.6 [-1]
100	-0.6 [-1]
110	-0.6 [-1]
120	-0.6 [-1]
130	-0.6 [-1]
140	-0.6 [-1]
150	-0.6 [-1]
160	0.0 [0]
170	0.0 [0]
180	-0.6 [-1]
190	0.0 [0]
200	0.0 [0]
210	0.0 [0]
220	0.0 [0]
230	0.0 [0]
240	0.0 [0]
250	-0.6 [-1]

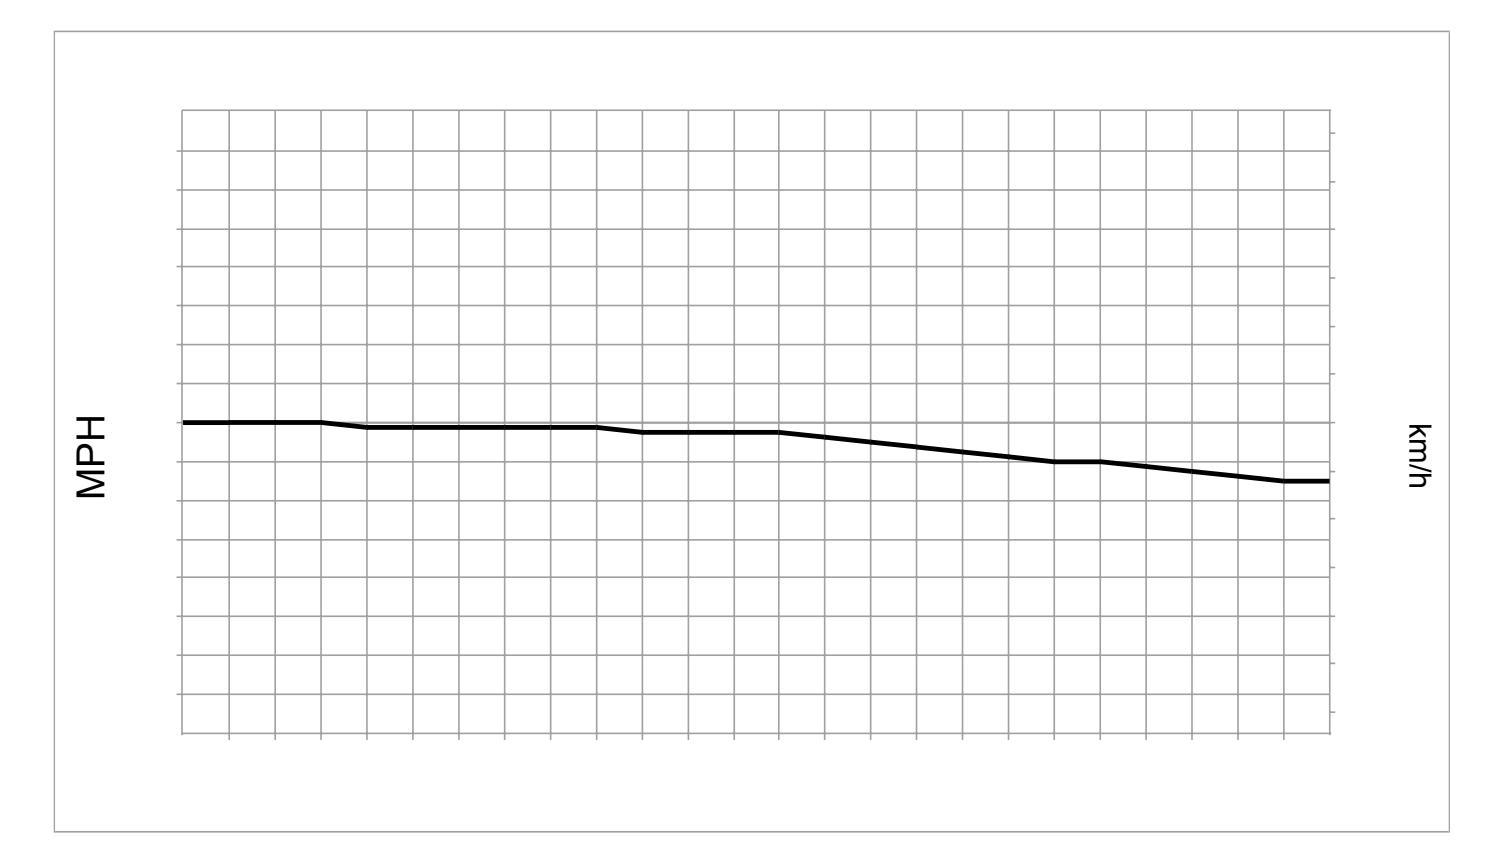
Longitudinal Crash Pulse (Record 3)

Time (msec)	Delta-V, Longitudinal (MPH [km/h])
0	0.0 [0]
10	0.0 [0]
20	0.0 [0]
30	0.0 [0]
40	-0.6 [-1]
50	-0.6 [-1]
60	-0.6 [-1]
70	-0.6 [-1]
80	-0.6 [-1]
90	-0.6 [-1]
100	-1.2 [-2]
110	-1.2 [-2]
120	-1.2 [-2]
130	-1.2 [-2]
140	-1.9 [-3]
150	-2.5 [-4]
160	-3.1 [-5]
170	-3.7 [-6]
180	-4.3 [-7]
190	-5.0 [-8]
200	-5.0 [-8]
210	-5.6 [-9]
220	-6.2 [-10]
230	-6.8 [-11]
240	-7.5 [-12]
250	-7.5 [-12]

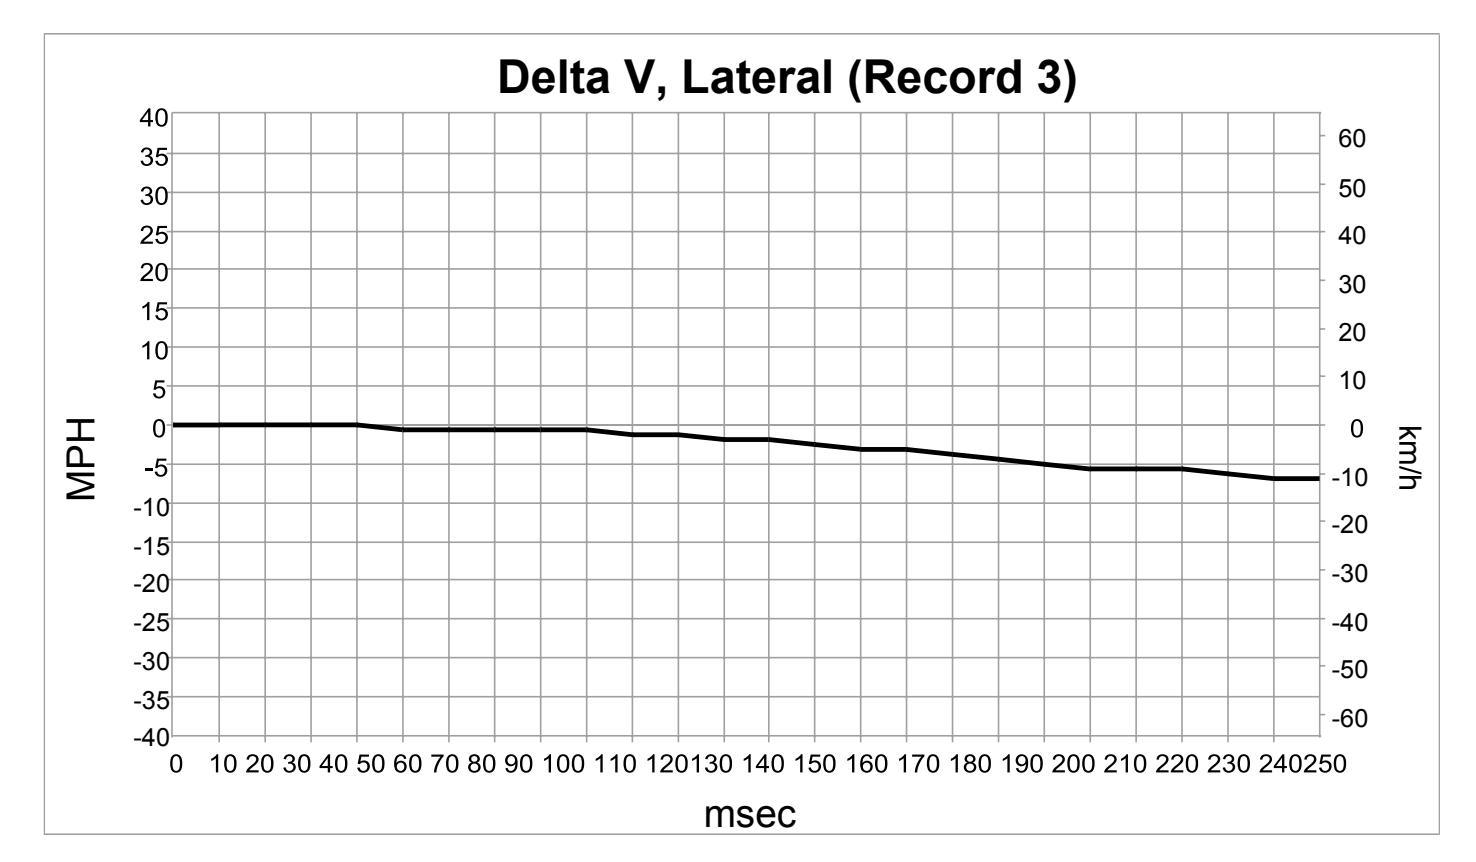
Lateral Crash Pulse (Record 3)

Delta-V, Lateral (MPH
Time (msec)	[km/h])
0	0.0 [0]
10	0.0 [0]
20	0.0 [0]
30	0.0 [0]
40	0.0 [0]
50	-0.6 [-1]
60	-0.6 [-1]
70	-0.6 [-1]
80	-0.6 [-1]
90	-0.6 [-1]
100	-1.2 [-2]
110	-1.2 [-2]
120	-1.9 [-3]
130	-1.9 [-3]
140	-2.5 [-4]
150	-3.1 [-5]
160	-3.1 [-5]
170	-3.7 [-6]
180	-4.3 [-7]
190	-5.0 [-8]
200	-5.6 [-9]
210	-5.6 [-9]
220	-5.6 [-9]
230	-6.2 [-10]
240	-6.8 [-11]
250	-6.8 [-11]
