DOT HS 812 562

# **Special Crash Investigations On-Site Side Impact Crash Investigation**

**Vehicle: 2016 Chevrolet  
Malibu**

**Crash Date: October 2016**

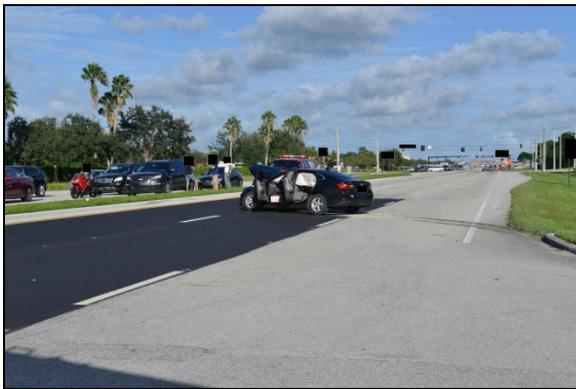
The Malibu and Tahoe maintained their respective rotations and continued on their deflected trajectories toward the east-southeast. The Malibu overrode the curb at the southeast intersection quadrant and continued on a left-arching trajectory into the grass roadside. It then re-entered the multilane roadway approximately 8 m (26 ft) east of the intersection and came to an uncontrolled final rest, facing north in the center of the eastbound portion of the roadway (**Figure 4**).

**Figure 4:** East-facing view of the multilane roadway and the Malibu at final rest (on-scene image obtained from the investigating law enforcement agency).

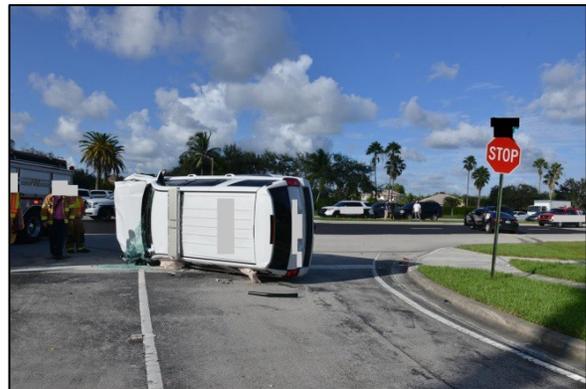
**Figure 5:** North-facing view of the Tahoe at final rest (on-scene image obtained from the investigating law enforcement agency).

Following the side-slap event, the Tahoe maintained its clockwise rotation. It achieved a left side-leading attitude, and an instability was created by the lateral drag force on the Tahoe's left side tires with respect to the vehicle's center of mass. Evidenced by a tire mark and gouge from the left rear wheel rim, the Tahoe tripped into a left side-leading rollover sequence. It rolled one quarter-turn onto its left plane (Event #3) and then slid to final rest while continuing its clockwise rotation. The Tahoe came to rest facing northwest, straddling the stop bar at the end of the intersecting local roadway's right turn-only lane (**Figure 5**).

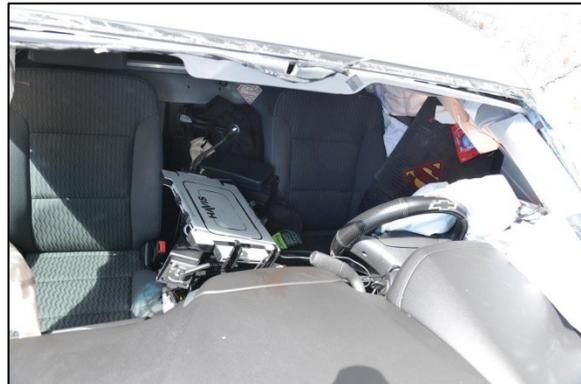
The Tahoe was operated by the 45-year-old male at the time of the crash. According to the PAR, he was restrained by the vehicle's available 3-point lap and shoulder seat belt. Post-crash images of the Tahoe revealed that multiple air bags deployed as a result of the crash, including the steering wheel hub-mounted CAC frontal air bag, driver's seat-mounted side impact air bag, and both the left and right IC air bags (**Figure 23**). Emergency response personnel cut and removed the Tahoe's windshield then assisted the driver from the vehicle. He was transported by ambulance to a local hospital for the treatment of police-reported non-incapacitating (B-level) injuries. Specific injuries sustained by the Tahoe's driver and his course of treatment remain unknown.

**Figure 23:** View of the interior of the overturned Tahoe (on-scene image obtained from the investigating law enforcement agency).

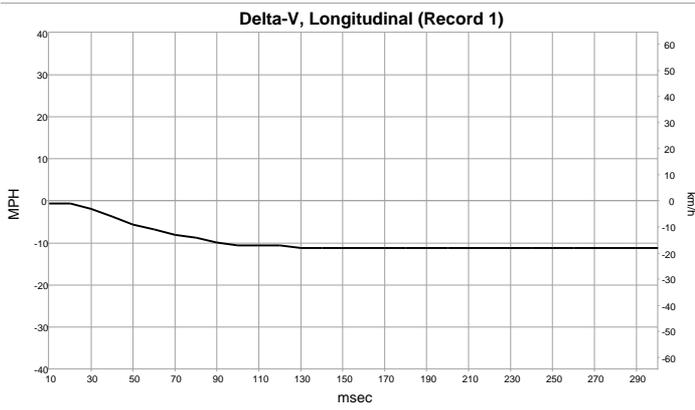
**Longitudinal Delta-V (Record 1)**

<b>Time (msec)</b>	<b>Delta-V, Longitudinal (SDM Recorded Vehicle Longitudinal Velocity Change for FSR Event) (MPH [km/h])</b>
10	-0.6 [-1]
20	-0.6 [-1]
30	-1.9 [-3]
40	-3.7 [-6]
50	-5.6 [-9]
60	-6.8 [-11]
70	-8.1 [-13]
80	-8.7 [-14]
90	-9.9 [-16]
100	-10.6 [-17]
110	-10.6 [-17]
120	-10.6 [-17]
130	-11.2 [-18]
140	-11.2 [-18]
150	-11.2 [-18]
160	-11.2 [-18]
170	-11.2 [-18]
180	-11.2 [-18]
190	-11.2 [-18]
200	-11.2 [-18]
210	-11.2 [-18]
220	-11.2 [-18]
230	-11.2 [-18]
240	-11.2 [-18]
250	-11.2 [-18]
260	-11.2 [-18]
270	-11.2 [-18]
280	-11.2 [-18]
290	-11.2 [-18]
300	-11.2 [-18]

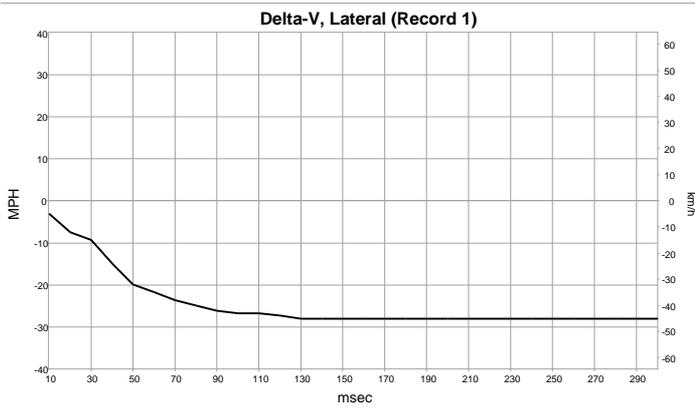
**Lateral Delta-V (Record 1)**

<b>Time (msec)</b>	<b>Delta-V, Lateral (SDM Recorded Vehicle Lateral Velocity Change for FSR Event) (MPH [km/h])</b>
10	-3.1 [-5]
20	-7.5 [-12]
30	-9.3 [-15]
40	-14.9 [-24]
50	-19.9 [-32]
60	-21.7 [-35]
70	-23.6 [-38]
80	-24.9 [-40]
90	-26.1 [-42]
100	-26.7 [-43]
110	-26.7 [-43]
120	-27.3 [-44]
130	-28.0 [-45]
140	-28.0 [-45]
150	-28.0 [-45]
160	-28.0 [-45]
170	-28.0 [-45]
180	-28.0 [-45]
190	-28.0 [-45]
200	-28.0 [-45]
210	-28.0 [-45]
220	-28.0 [-45]
230	-28.0 [-45]
240	-28.0 [-45]
250	-28.0 [-45]
260	-28.0 [-45]
270	-28.0 [-45]
280	-28.0 [-45]
290	-28.0 [-45]
300	-28.0 [-45]
