DOT HS 812 595

Special Crash Investigations On-Site Guardrail End Treatment Impact Investigation Vehicle: 2000 Volkswagen Jetta Location: Pennsylvania Crash Date: December 2016

SPECIAL CRASH INVESTIGATIONS
CASE NO.: CR16039
ON-SITE GUARDRAIL END TREATMENT IMPACT INVESTIGATION
VEHICLE: 2000 VOLKSWAGEN JETTA
LOCATION: PENNSYLVANIA
CRASH DATE: DECEMBER 2016

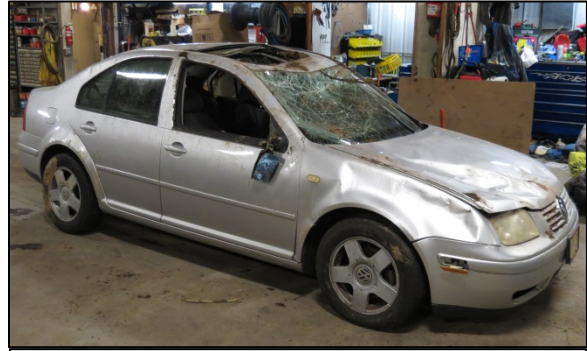
The 2000 Volkswagen Jetta (**Figure 9**) was a 5-passenger sedan identified by the VIN 3VWSC29M2YMxxxxxx. The electronic odometer was non-functional at the time of the SCI inspection. However, paperwork in the vehicle declared that its last known odometer reading was 361,938 km (224,898 mi) in mid-June 2016. The Jetta's body was configured on a 251 cm (98.8 in) wheelbase with front-wheel drive. It was powered by a 2.0 liter, inline, 4-cylinder gasoline engine linked to an automatic transmission with a center-console-mounted shifter. Deformation to the Volkswagen's left front door relative to impact with the end treatment had jammed the left front door shut. Therefore, the SCI investigator was unable to review the placard containing the vehicle's gross vehicle weight rating or the manufacturer's recommended tire sizes/pressures. At the time of the SCI vehicle inspection, the Volkswagen was equipped with Cooper CS9 Touring tires of size P195/65R15 and mounted on originally equipped aluminum wheels, at all four axle positions. The tires had matching Tire Identification Numbers of U9AE 1CA 4214. All four tires had ample tread, were not damaged or restricted, and remained inflated.

Figure 9: Front right oblique view of the Volkswagen.
