DOT HS 812 596

Special Crash Investigations On-Site ET-2000 Guardrail End Terminal Investigation Vehicle: 2007 Toyota Camry Location: Missouri Crash Date: November 2015

INDIANA UNIVERSITY
TRANSPORTATION RESEARCH CENTER
ON-SITE ET-2000 GUARDRAIL END TREATMENT INVESTIGATION
CASE NUMBER - IN15030
LOCATION - MISSOURI
VEHICLE - 2007 TOYOTA CAMRY
CRASH DATE - November 2015

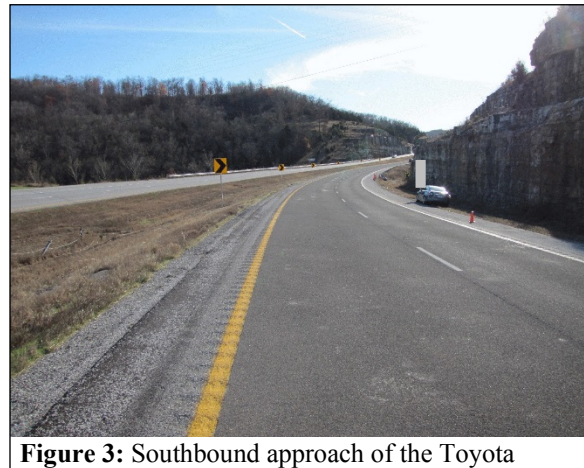
Figure 3: Southbound approach of the Toyota

Pre-Crash: The Toyota was traveling south in a right curve in the left lane (**Figure 3**). The driver was reported in her medical records as stating that she fell asleep. The vehicle’s left side tires departed the travel lane and encountered the rumble strip on the edge line and median shoulder. The driver initiated a right steering maneuver and the vehicle began to yaw clockwise. A yaw mark from the left front tire that began on the yellow median edge line and extended into and across the left lane was observed and documented at the SCI crash scene inspection. A speed-to-side slip calculation (Attachment A) based on the radius of curvature of this yaw mark was performed and yielded a vehicle speed of approximately 153 km/h (95 mph)¹ at the onset of the yaw mark. The left front yaw mark extended across the left lane for 48.1 m (157.8 ft) where a yaw mark from the left rear tire was observed in the left lane, near the centerline. The vehicle continued to yaw clockwise across the roadway an additional 26.9 m (88.2 ft) and departed the outside edge of the west shoulder approximately 3 m (10 ft) prior to the end of the guardrail (**Figure 4**).

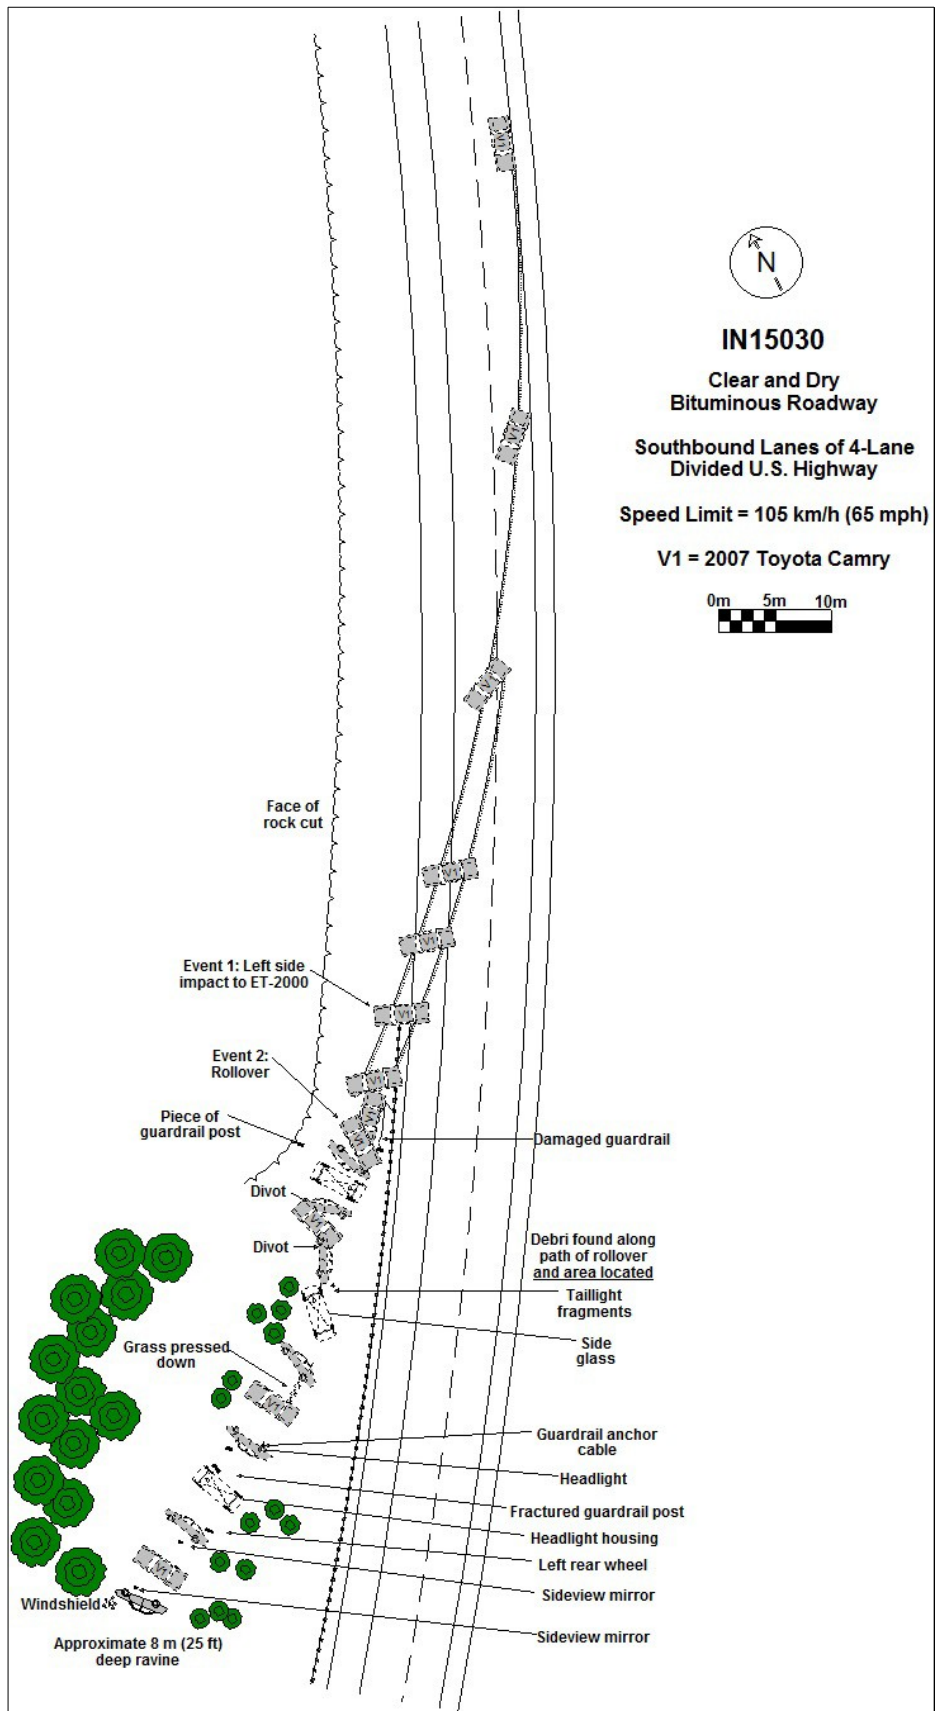
CRASH DIAGRAM

Crash Site: This crash occurred at dusk on the west roadside of a curved, four-lane, divided U.S. highway. The weather conditions were clear with 16.1 kilometers (10 miles) visibility, calm winds, a temperature of 12.8 °C (55 °F), and a dew point of -0.6 °C (31 °F), according to local weather reports. The highway had two bituminous southbound through lanes that were curved to the right and separated from the two northbound through lanes by a grass median. The design radius of curvature of the southbound lanes at the median edge line was 281.1 m (921.9 ft) based on data provided by MoDOT. The superelevation of the southbound lanes was 8 percent and the roadway grade in the area of the Toyota’s approach to the west roadside departure was negative 3 percent. The southbound travel lanes were each 3.6 m (11.8 ft) wide and were bordered by a 1.7 m (5.6 ft) wide bituminous median shoulder and a 2.9 m (9.5 ft) wide bituminous outside shoulder. A rumble strip was located on the edge line of each shoulder. A blocked out-W-beam guardrail equipped with an ET-2000 end terminal was located on the west side of the southbound lanes and adjacent to an approximately 8 m (25 ft) deep ravine. The speed limit was 105 km/h (65 mph). The Crash Diagram is included on pages 11 and 12 of this report.
