U.S. Department of Transportation

National Highway Traffic Safety Administration

DOT HS 812 612

Special Crash Investigations On-Site Child Restraint System Crash Investigation Vehicle: 2015 Honda Odyssey Location: New Jersey Crash Date: March 2016

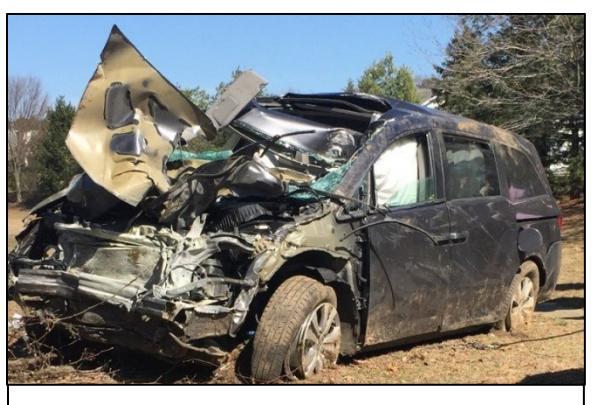
This report documents the on-site investigation of a child restraint system (CRS) used to restrain a 5month-old infant female in the second row of a 2015 Honda Odyssey. The Honda (**Figure 1**) was involved in a multiple- event crash when it departed the roadway, struck numerous trees, and initiated a rollover of three quarter-turns. During the crash sequence, supplemental restraint systems that included a driver's Certified Advanced 208-Compliant (CAC) frontal, front row rightseat-mounted, and both dual-sensing (side impact and rollover) inflatable curtain (IC) air bags were deployed. An unbelted 28-year-old female driver

Figure 1: On-scene view of the Honda during recovery (*image obtained from an online news source*).

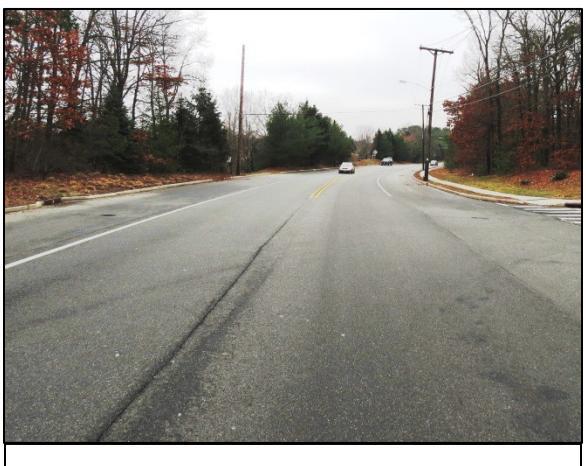
The crash occurred in the southbound direction on the local roadway in the area of a right curve. The curve, which had a measured curve radius of 466 m (1,529 ft), began in an area (**Figure 2**) where the local roadway was intersected from the west by a driveway into a residential subdivision. The roadway itself was essentially level. However, in the vicinity of the crash site, a landscaped berm extended parallel to the roadway beyond the east shoulder. Numerous species of shrubbery and mature coniferous and deciduous trees inhabited the length of the berm. On the downslope side of the berm was a chain link fence that protected an open-cut, depressed grass area that led up to another subdivision of residential homes. A

Figure 2: South-facing view of the local roadway for the Honda's pre-crash travel trajectory.

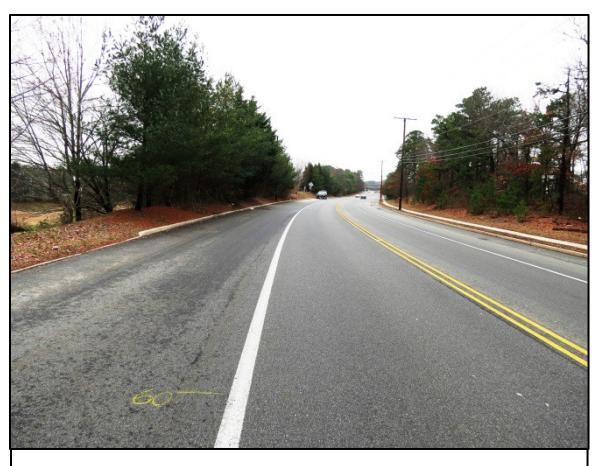
Figure 3: View of the southbound trajectory of the Honda on approach to its east roadside departure.

During the Honda's high-speed pre-crash travel, the driver maintained a southbound trajectory. She allowed the vehicle to travel left, from its travel lane, over the double-solid yellow centerline through the northbound travel lane, and onto the east shoulder of the roadway (**Figure 3**). There was no evidence of any avoidance action by the driver prior to the crash. Law enforcement investigation of the crash ultimately determined that the driver made suicidal statements prior to the crash, her family reported that she was suffering from ongoing emotional instability and psychological issues, and a handwritten suicide note was recovered during their investigation.

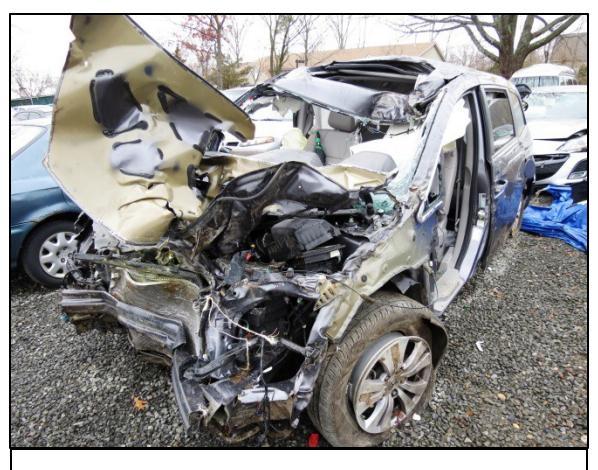
Figure 7: Left front oblique view of the Honda Odyssey at the time of the SCI vehicle inspection.

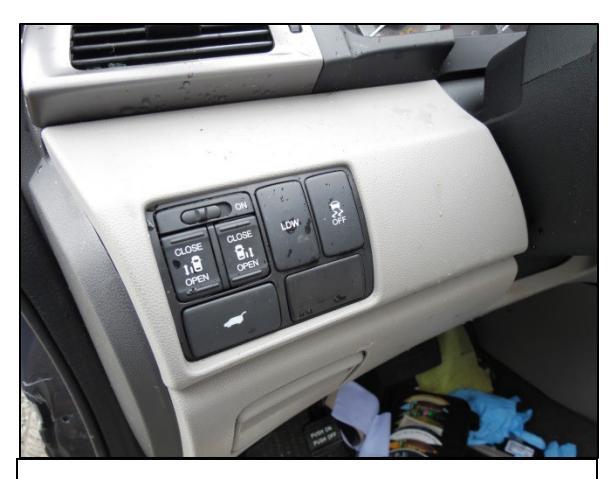
Figure 19: View of the Honda's LDW system button mounted in the instrument panel to the left of the steering column.

pressing the LDW button on the left aspect of the left instrument panel (Figure 19).
