DOT HS 812 651

Special Crash Investigations On-Site SKT Guardrail End Terminal Crash Investigation Vehicle: 2010 Hyundai Elantra Location: Pennsylvania Crash Date: May 2017

SPECIAL CRASH INVESTIGATIONS
CASE NO.: CR17014
ON-SITE SKT GUARDRAIL END TERMINAL CRASH INVESTIGATION
VEHICLE: 2010 HYUNDAI ELANTRA
LOCATION: PENNSYLVANIA
CRASH DATE: MAY 2017

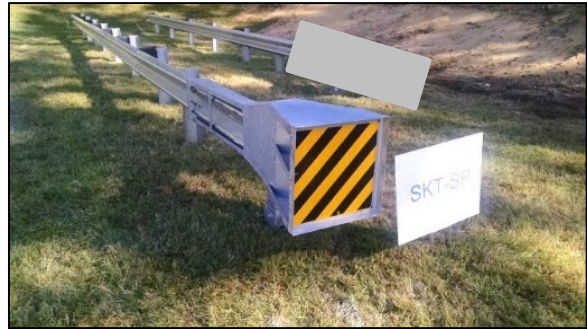
The SKT end terminal was an energy absorbing end treatment used to terminate W-beam guardrail systems (**Figure 5**). The SKT installation was 15 m (50 ft) in length and consisted of an SKT end terminal, two hinged posts at post locations 1 and 2, an anchor cable, and five standard steel posts at post locations 3 to 7 that supported the W-beam with a composite block-out and carriage bolt. Splices in the W-beam were located at Post 3, Post 5, and Post 7. The SKT installation was manufactured by Road Systems, Inc., and met the requirements for NCHRP 350 Test Level 3. The manufacturer's literature and installation manuals can be found at: <http://roadsystems.com/skt.html>.

Figure 5: Image depicting an exemplar SKT installation.

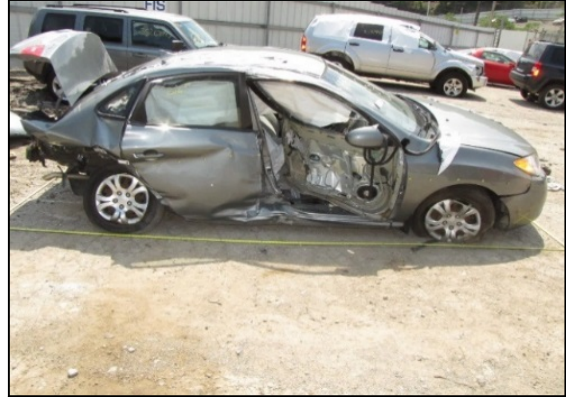
The Hyundai Elantra, 4-door sedan (**Figure 8**), was identified by Vehicle Identification Number: KMHDU4AD0AUxxxxxx and was manufactured in March 2010. The vehicle was designed with unibody construction on a 265 cm (104.3 in) wheelbase chassis and had a curb weight of 1,246 kg (2,247 lb). The powertrain consisted of a transverse-mounted, 2.0-liter gasoline engine linked to a 4-speed automatic transmission with front-wheel drive. Standard features included 4-wheel power-assisted disc brakes with ABS, power-assisted rack-and-pinion steering and traction

Figure 8: Right side view of the Hyundai.
