DOT HS 812 668

Special Crash Investigations On-Site Air Bag Inflator Rupture Crash Investigation Vehicle: 2001 Honda Civic Location: California Crash Date: September 2016

Case Number: DS16020
Office of Defects Investigation
On-Site Air Bag Inflator Rupture Crash Investigation
Vehicle: 2001 Honda Civic
Location: California
Crash Date: September 2016

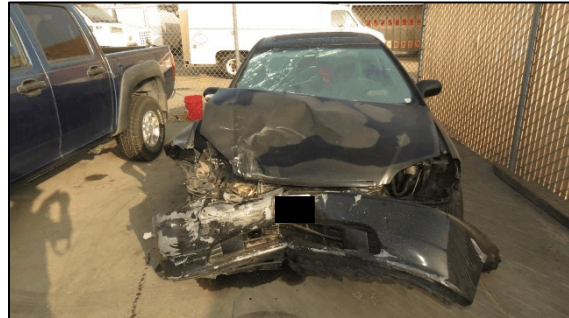
Figure 1. 2001 Honda Civic.

This report documents the on-site investigation of the inflator rupture of a frontal air bag module and the fatal injuries sustained by the driver of a 2001 Honda Civic (**Figure 1**) involved in an angled crash with a 2006 Chevrolet Colorado pickup. This case was initiated in response to a police notification to the National Highway Traffic Safety Administration. The case was forwarded to the Office of Defects Investigation (ODI); the Special Crash Investigations (SCI) group assigned the case to Dynamic Science, Inc., in October 2016.

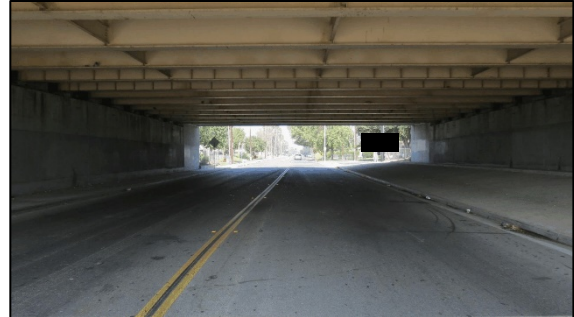
Figure 2. Westbound approach for the Honda.

The crash site was the three-leg intersection of two undivided urban roadways. The westbound leg consisted of one westbound lane and one eastbound lane (**Figure 2**). The asphalt roadway was straight and level. A roadway overpass measuring 47.2 m (154.8 ft) in width was located 16.3 m (53.4 ft) east of the intersection. The eastbound leg consisted of one eastbound and one westbound lane that were separated by painted double yellow lines that widened creating a painted divider in the westbound direction (**Figure 3**). The southbound lane leg consisted of one southbound and one northbound lane. Southbound traffic was controlled by a stop sign (**Figure 4**). The speed limit was 64 km/h (40 mph) for all roadways. The weather at the nearest reporting station was 32 °C (89 °F), 24 percent humidity, 16 km (10 miles) visibility, and the winds were variable at 5.6 km/h (3.5 mph). A crash diagram is attached at the end of this technical report.

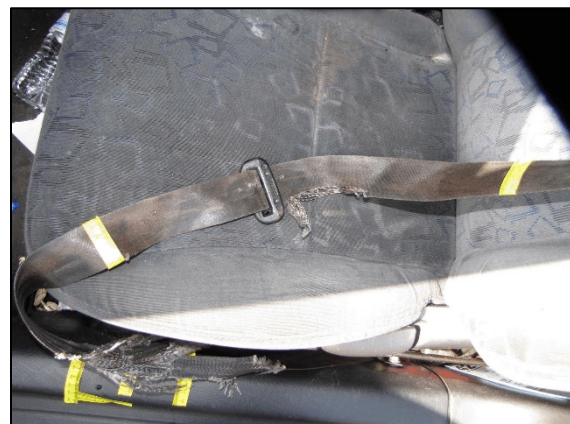
Figure 7. Driver's seat belt, 2001 Honda Civic.

The front row was equipped with driver and front right passenger lap and shoulder seat belts. The driver's belt was equipped with continuous loop belt webbing, a sliding latch plate, an emergency locking retractor (ELR), and non-adjustable upper anchor. There was a 46 cm (18.1 in) area of blood on the webbing located 52 cm (20.4 in) above the floor anchor (Figure 7). The belt was in poor condition with a 26 cm area (10.2 in) area of shredding (from use) located 24 cm (9.4 in) above the anchor and a 16 cm (6.3 in) area of shredding located 87 cm (34.2 in) above the anchor. This damage was not related to any crash. The front right passenger's seat belt was equipped the same as the driver, but had a switchable ELR/automatic

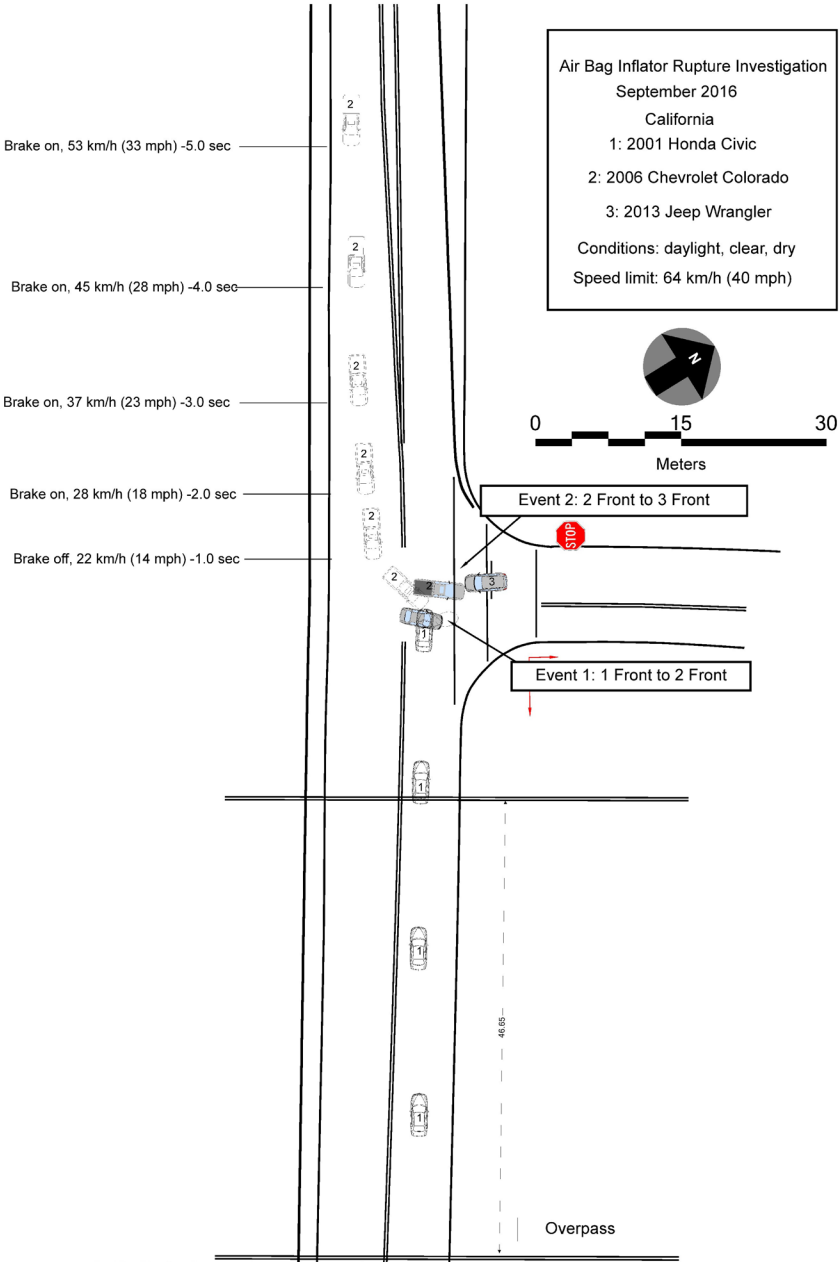
CRASH DIAGRAM

This three-vehicle crash occurred in a three-leg intersection in California. The Honda was being driven westbound under an overpass by a belted 50-year-old female. The Chevrolet was traveling eastbound. A 2013 Jeep Wrangler was stopped facing southwest at the intersection. At the intersection, the Chevrolet turned left and struck the front plane of the Honda with its front plane. At impact with the Chevrolet, the Honda's frontal air bag deployed and the Takata air bag inflator ruptured. The Honda was displaced clockwise and came to rest facing northeast. The Chevrolet was displaced counterclockwise and struck the front plane of the stopped Jeep.
