DOT HS 812 699

**Special Crash Investigations
On-Site Frontal Air Bag
Non-Deployment Investigation
Vehicle: 2008 Honda Accord
Location: Florida
Crash Date: March 2015**

SPECIAL CRASH INVESTIGATIONS
CASE NO.: CR15009
OFFICE OF DEFECTS INVESTIGATION
ON-SITE FRONTAL AIR BAG NON-DEPLOYMENT INVESTIGATION
VEHICLE: 2008 HONDA ACCORD
LOCATION: FLORIDA
CRASH DATE: MARCH 2015

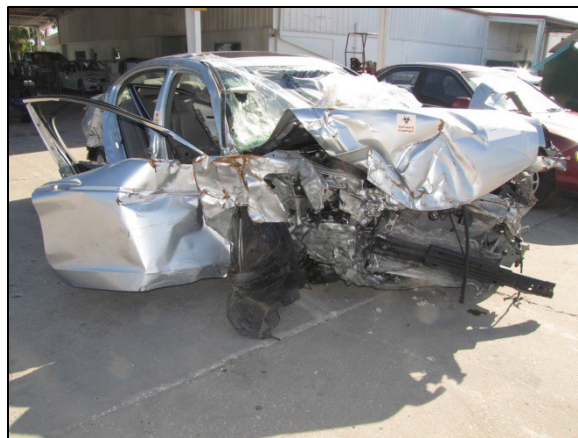
This report documents the on-site investigation of the non-deployment of the frontal air bags in a 2008 Honda Accord (**Figure 1**) that was involved in a single-vehicle, road departure/fixed object crash. The Honda was equipped with certified advanced 208-compliant (CAC) frontal air bags for the driver and the first row right occupant, front-seat-mounted side impact air bags and side impact-sensing inflatable curtain (IC) air bags. The crash occurred when the Honda, driven by a 19-year-old belted male, departed the road at a four-way intersection. The vehicle's front tires/wheels struck and overrode the curb and its front plane struck a landscape wall constructed of solid concrete blocks. None of the air bags deployed in the crash. The driver sustained police-reported A-level (incapacitating) injuries, was transported by ambulance, and admitted to a regional trauma center.

Figure 1: Front right oblique view of the 2008 Honda Accord.

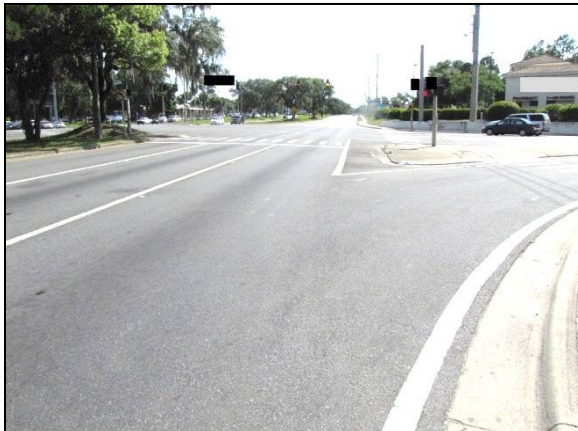
The crash occurred during nighttime of March 2015 at the angular four-way intersection of a three-lane divided roadway and a six-lane (undivided) roadway in a suburban commercial setting (**Figure 2**). The police-reported environmental conditions at the time of the crash were clear, dry, and dark with overhead lighting. The conditions reported by the National Weather Service were a temperature of 18.3 °C (65 °F), 59 percent relative humidity, west winds at 12.8 km/h (8.0 mph) and clear skies. The three-lane divided roadway was aligned northeast/southwest and intersected the six-lane north/south road at a 30-degree angle. The intersection was controlled by overhead traffic signals. The roadways were bordered by 15 cm (6 in) tall concrete curbs and sidewalks. A 1.5 m (5.0 ft) tall landscape wall, constructed of solid concrete blocks, was located in the southwest quadrant of the intersection and followed the curvature of the sidewalk (**Figure 3**). The concrete wall was backed up by soil filled above the level of the impact. A 20 cm (8 in) square concrete post supporting the pedestrian cross walk signal was positioned in sidewalk at the southwest quadrant. The posted speed limit was 72 km/h (45 mph).

Figure 2: Southwest trajectory view into the intersection where the crash occurred.

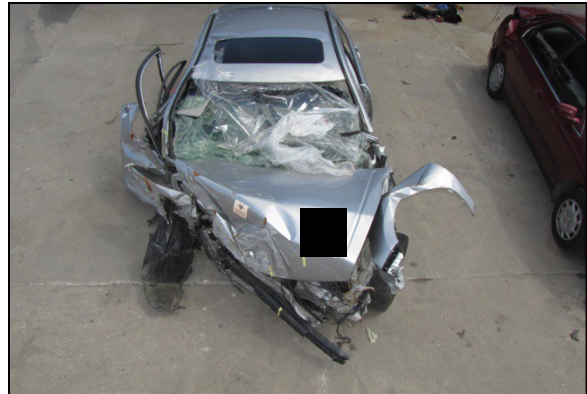
The 2008 Honda Accord (**Figure 6**) was identified by the Vehicle Identification Number JHMCP26828Cxxxxxx and it was equipped with the EXL trim package. The Honda was manufactured in May 2008. The odometer reading was unknown due to a damaged electrical system. The 4-door sedan was built on a 280 cm (110.2 in) wheelbase. The gross vehicle weight rating was 2,010 kg (4,431 lb) with a front axle and rear axle rating of 1,090 kg (2,403 lb) and 935 kg (2,061 lb), respectively. The vehicle's curb weight was 1,520 kg (3,351 lb). The powertrain consisted of a 2.4-liter, I-4 gasoline engine linked to a 5-speed automatic transmission with front-wheel drive. The brake system was a 4-wheel disc system with electronic brakeforce distribution, emergency brake assist and ABS. Additional features included stability control, traction control, and a tire pressure monitoring system (TPMS). The vehicle manufacturer's recommended tire size was P225/50R17 front and rear, with cold tire pressures of 221 kPa (32 PSI). The left front and right front tires were Bridgestone Turanza, the left rear tire was a Mile Star MS932 Sport and the right rear tire was a Michelin HXMXM4. All four tires were the recommended size. Specific tire data measured during the SCI inspection was as follows:

Figure 6: Overhead front view of the Honda.

Position	Measured Pressure	Measured Tread Depth	Restriction	Damage
LF	Tire Flat	2 mm (2/32 in)	No	Hole in sidewall, rim surface abraded
LR	269 kPa (39 PSI)	5 mm (6/32 in)	No	None
RR	Tire Flat	2 mm (3/32 in)	No	None
RF	Tire Flat	1 mm (1/32 in)	Yes	Hole in sidewall, rim fractured
