DOT HS 812 707

Special Crash Investigations On-Site Guardrail End Treatment Crash Investigation Vehicle: 2004 Pontiac Sunfire Location: Missouri Crash Date: May 2017

Special Crash Investigations
Case No.: CR17010
On-Site Guardrail End Treatment Crash Investigation
2004 Pontiac Sunfire
Location: Missouri
Crash Date: May 2017

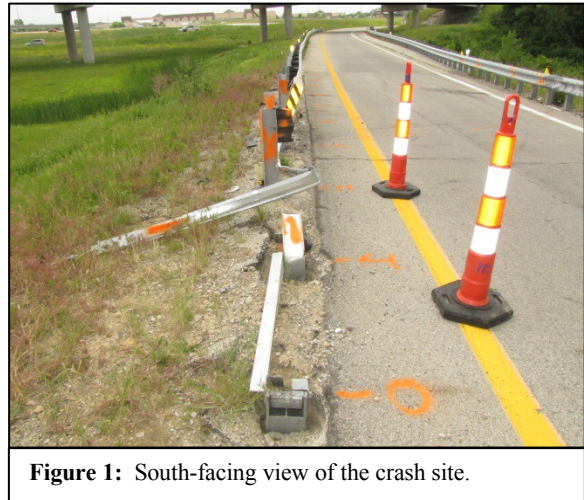
Figure 1: South-facing view of the crash site.

The Pontiac was reportedly traveling south on a limited-access roadway and exited onto a single-lane on-ramp that led to an intersecting limited-access roadway. While proceeding along the on-ramp, the Pontiac departed the left side of the roadway and struck the end terminal and guardrail (**Figure 1**). The Pontiac separated from this impact, crossed the travel lane, and then struck the guardrail on the opposite roadside. The driver of the vehicle sustained reported minor injuries in the crash and was transported by ambulance to a local hospital for treatment.

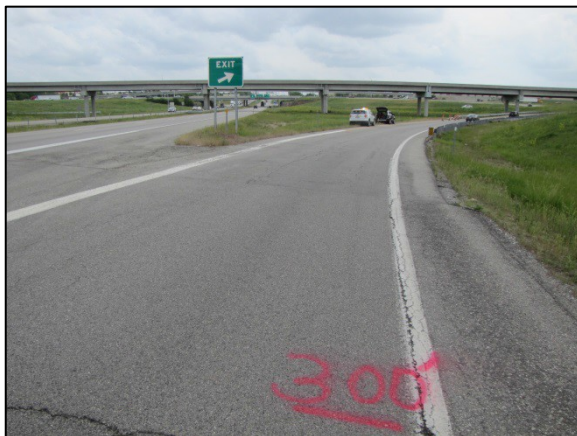
Figure 2: South-looking trajectory view of the Pontiac at the beginning of the ramp approximately 91 m (300 ft) from the guardrail impact.

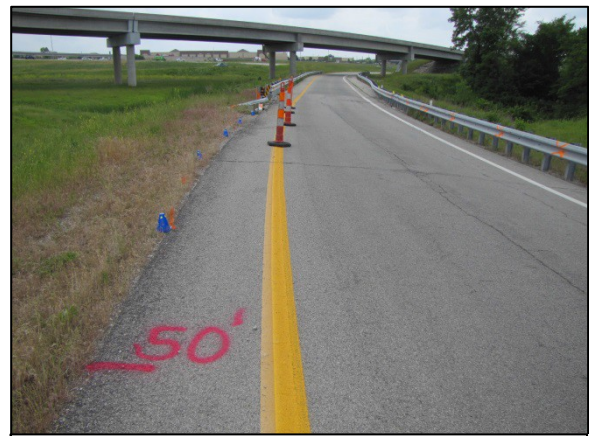
Figure 3: South-looking trajectory view of the Pontiac approximately 15 m (50 ft) from the guardrail impact.

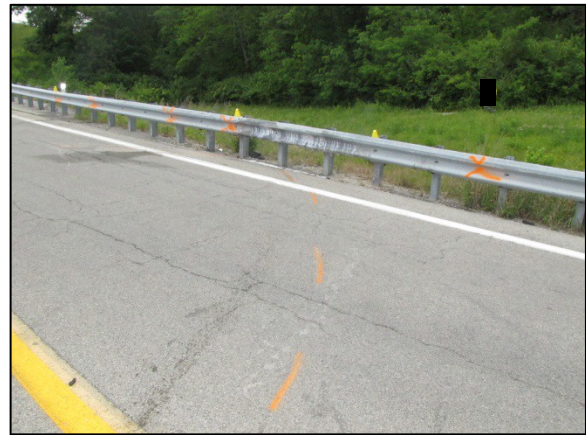
Figure 5: Southwest-looking trajectory view toward Event 2 impact with the face of the guardrail on the opposite roadside.

The Pontiac rotated approximately 45 degrees and separated from the end terminal along a westerly trajectory. The Pontiac continued to rotate clockwise as it traveled 8.4 m (27.6 ft) across the exit ramp (**Figure 5**). As the vehicle reached approximately 230 degrees of rotation relative to its original heading, the left plane/front corner area of the vehicle struck the face of the W-beam on the west side of the road. This impact deformed the guardrail approximately 15 cm (6 in) laterally over a 3.0 m (9.8 ft) distance (**Figure 6**). The force of the impact stopped the

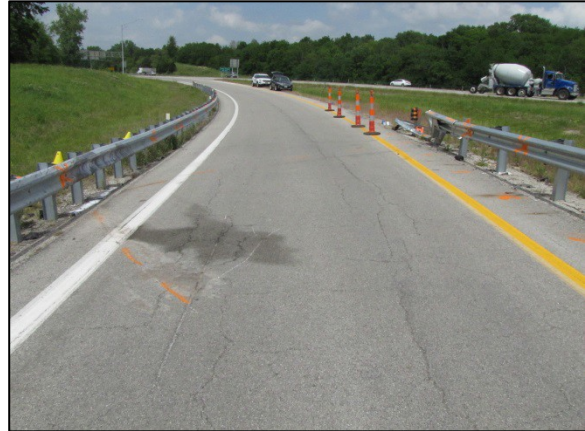
vehicle's rotation and the Pontiac rebounded along a south trajectory coming to final rest. At rest, the Pontiac was facing north denoted by a fluid spill 4.3 m (14.1 ft) from the west guardrail impact (Figure 7). This rest location was 17.1 m (56.1 ft) from the initial impact with the end terminal.

Figure 7: North facing view of the Pontiac's final rest position and a lookback of its approach to the crash.

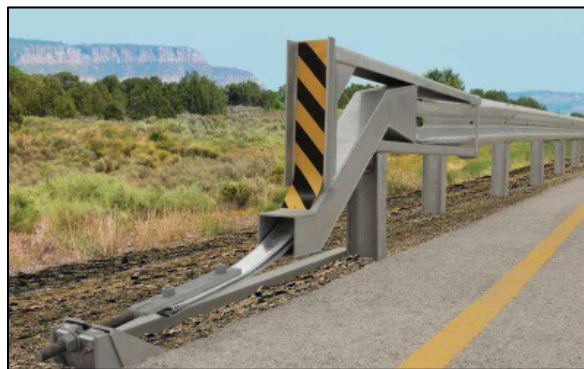
The SoftStop end terminal was an energy-absorbing end terminal used to terminate a 79 cm (31 in) high W-beam guardrail (Figure 8). The SoftStop installation consisted of a SoftStop rail flattening head, SoftStop anchor W-beam guardrail, anchor post (Post 0), two steel yielding terminal posts (SYTP) at post locations 1 and 2, and six standard posts at post locations 3 to 8 that supported the W-beam with a composite block-out and carriage bolt. The SoftStop was manufactured by Trinity Highway Products, and the end terminal was a MASH TL-3 system.

Figure 8: Image depicting an exemplar SoftStop end terminal and guardrail. Image obtained from the manufacturer's website.

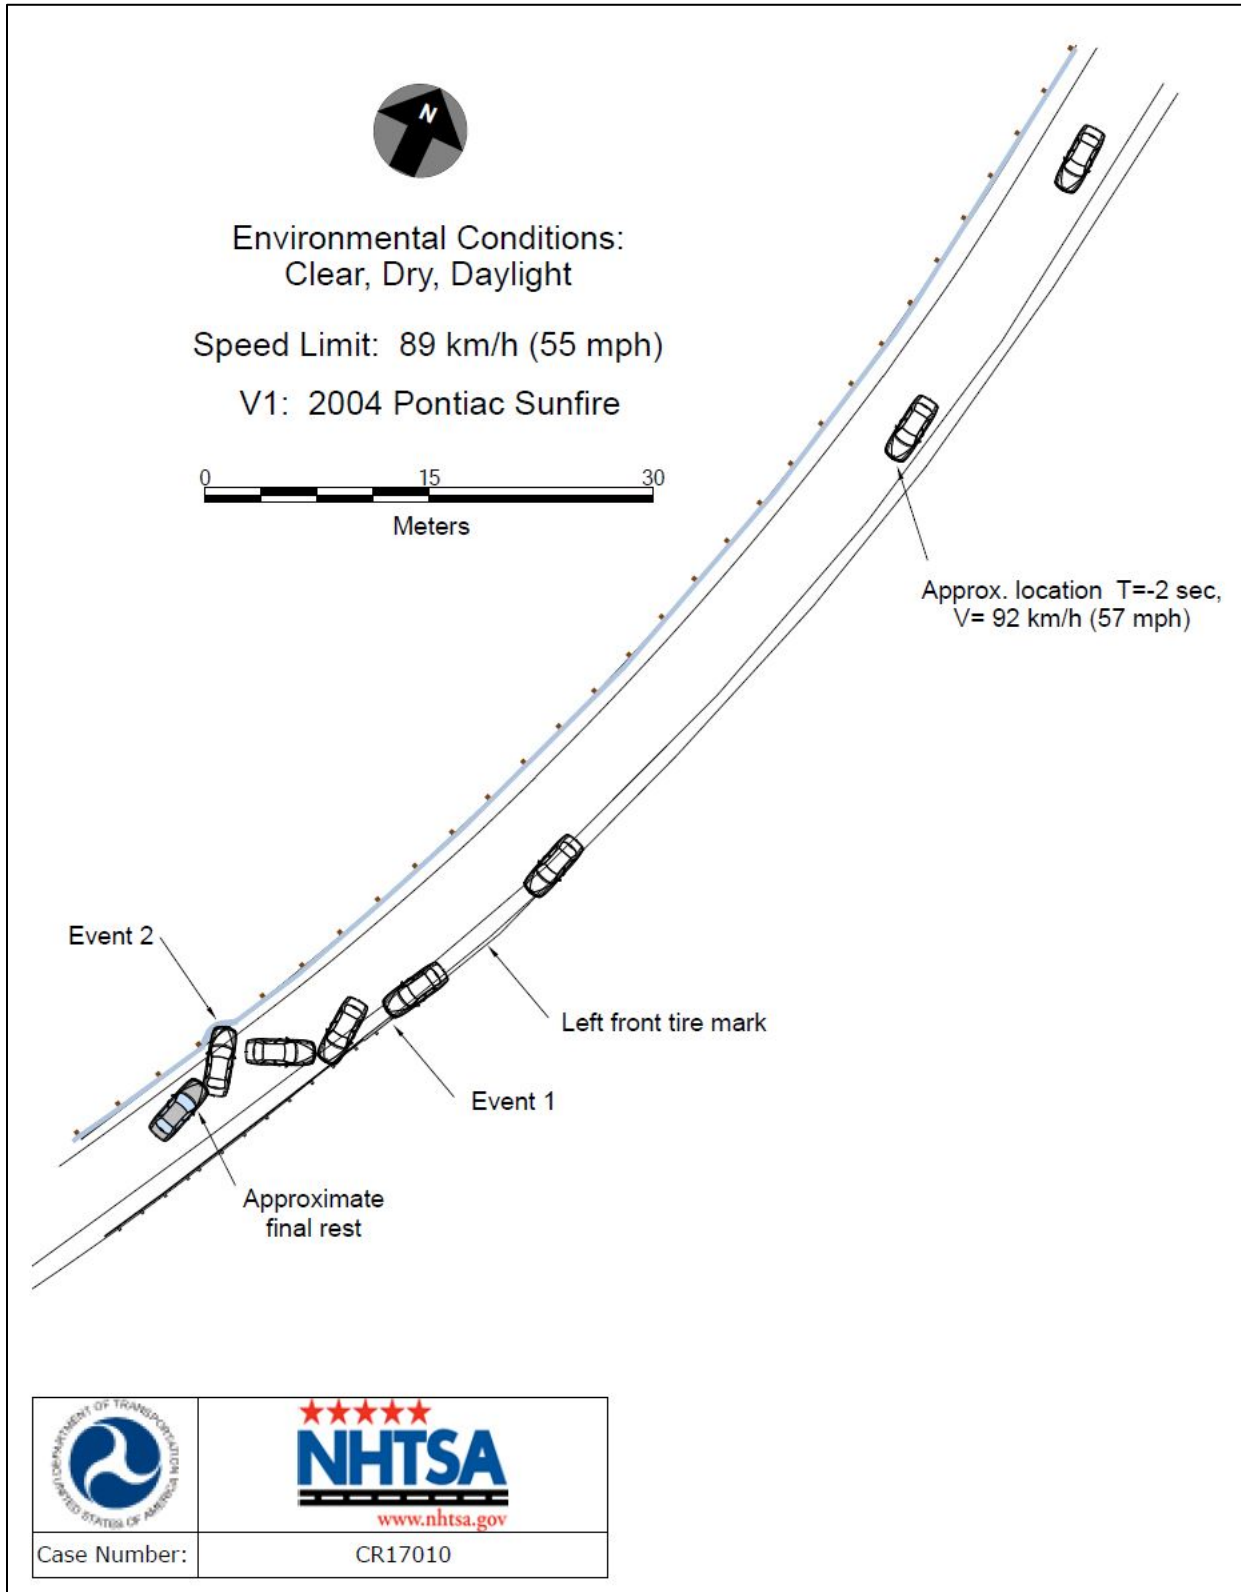
CRASH DIAGRAM

The guardrail bordering the right roadside was also contacted during the crash sequence. A 2.9 m (9.5 ft) section of the W beam was deformed from secondary contact with the Pontiac. This deformed section was located 9.2 m (30.2 ft) south of the initial point of impact (Post 0). A Crash Diagram is included at the end of this technical report on Page 12.
