DOT HS 812 716

# **Special Crash Investigations On-Site End Terminal Guardrail Investigation Vehicle: 2003 GMC Yukon Location: Missouri Crash Date: January 2017**

**Indiana University  
Transportation Research Center  
On-Site End Terminal Guardrail Investigation  
Case Number: IN17009  
Vehicle: 2003 GMC Yukon  
Location: Missouri  
Crash Date: January 2017**

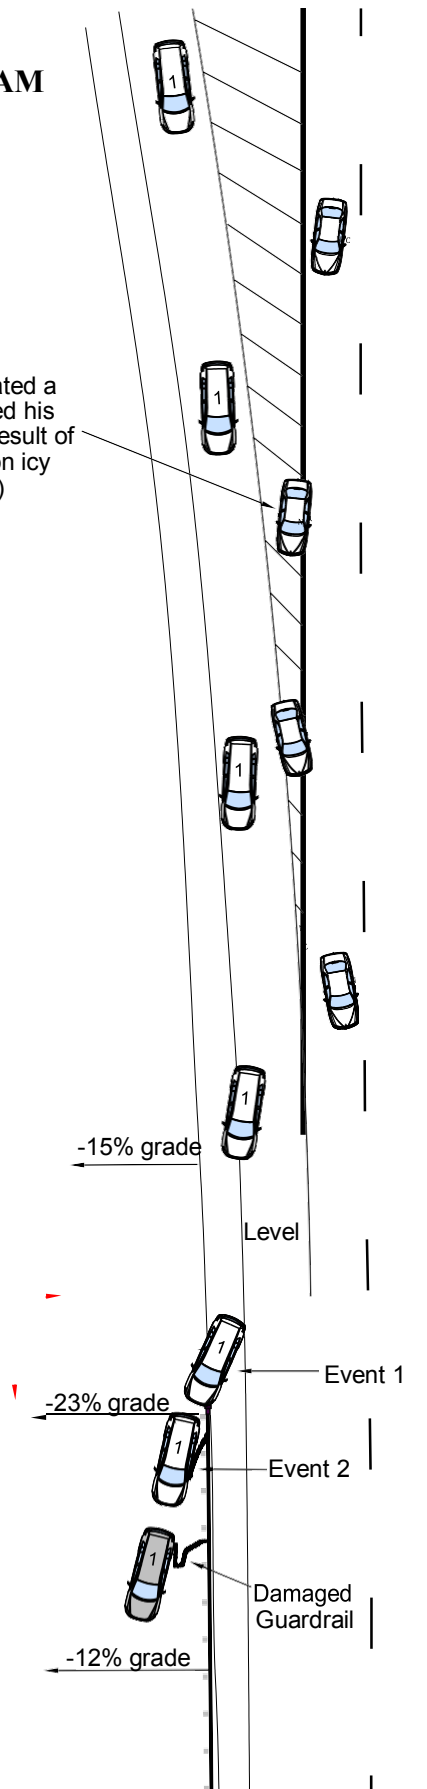
# CRASH DIAGRAM

Driver of 1 stated a vehicle entered his lane (possibly result of control loss on icy roadway)

Dark with Artificial Lighting

Light Freezing Rain
