Special Crash Investigations Remote Child Restraint System Investigation Vehicle: 2004 GMC Yukon Location: Montana Crash Date: July 2018

Special Crash Investigations
Remote Child Restraint System Investigation
Case Number: DS18019
Vehicle: 2004 GMC Yukon
Location: Montana
Crash Date: July 2018

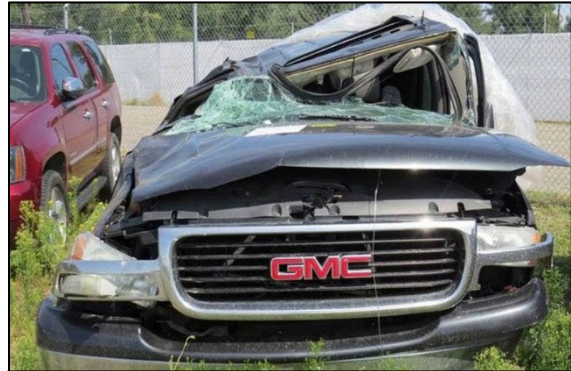
Figure 1. 2004 GMC Yukon

This report documents the remote investigation of a child restraint system (CRS) used by the juvenile occupant of a 2004 GMC Yukon involved in a rollover crash and the disparate injuries sustained by the occupants of the vehicle (**Figure 1**). A 16-month-old male occupant restrained in a CRS and an unbelted 6-year-old male occupant were transported to a trauma center 230 miles away. The driver of the GMC was fatally injured. The investigation looked at what role manual restraint usage played in the occupants' kinematics and injury mitigation, with a focus on the CRS-
