DOT HS 812 797

# **Special Crash Investigations On-Site Rollaway/Backover Investigation Vehicle: 2002 Dodge Ram Location: Illinois Crash Date: May 2017**

**Special Crash Investigations**  
**Case No: CR17013**  
**Office of Defects Investigation**  
**On-Site Non-Traffic Surveillance Rollaway/Backover Investigation**  
**Vehicle: 2002 Dodge Ram 2500 Quad Cab**  
**Location: Illinois**  
**Crash Date: May 2017**

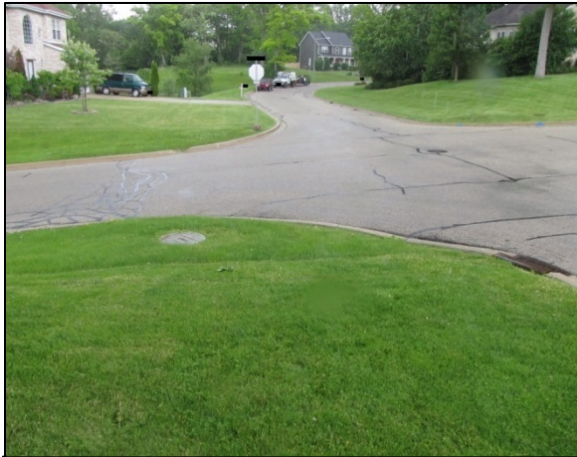
The east/west leg of the intersection was 7.7 m (25.3 ft) in width and had an average grade of 2.1 percent, negative to the east. This street was straight in the area of the intersection (**Figure 4**), however, the east leg transitioned to a gradual right curve 65 m (213 ft) east of the intersection. A retention pond was located north of the east

**Figure 4:** Eastward view of the intersection with the retention pond located in the upper left quadrant of the image.

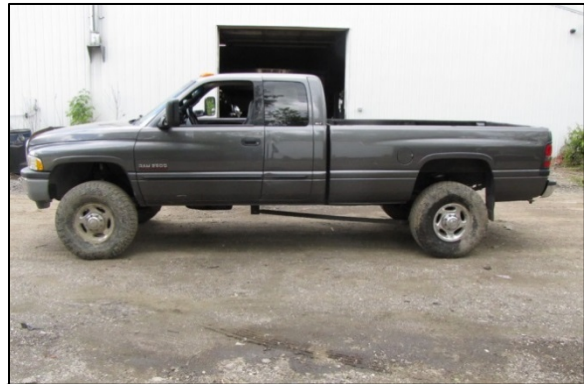
The involved vehicle in this rollaway/backover crash investigation was a 2002 Dodge Ram 2500 series long-bed pickup truck (**Figure 6**). The Dodge was manufactured in February 2002 and was identified by the Vehicle Identification Number 3B7KF23602Mxxxxxx. Manufactured as a quad cab with C-pillar hinged rear doors, the Dodge did not have a fixed B-pillar as the doors opened to provide full-access to the vehicle's cab. The powertrain was a 6-cylinder Cummins turbo diesel engine with a displacement of 5.9 liters linked to a 4-speed automatic transmission with a column-mounted transmission and 4-wheel drive. A separate transfer case shift lever was floor-mounted to the left side of the center tunnel. The gross vehicle weight rating was 3,992 kg (8,800 lb) with gross axle weight ratings of 2,359 kg (5,900 lb) front and 2,760 kg (6,084 lb) rear. The Dodge was equipped with power-assisted disc brakes with ABS and electronic brakeforce distribution. Steering was power-assisted and speed sensitive. The vehicle manufacturer recommended tires sized at LT245/75R16 with cold tire pressures of 448 kPa (65 PSI) for the front axle and 551 kPa (80 PSI) for the rear axle. At the time of this incident, the Dodge was equipped with oversize Nitto Terra Grappler tires of size LT315/75R16. In addition to the oversize tires, the Dodge was equipped with a supplemental air-ride rear suspension with the air bags mounted forward of the rear axle. The height of the door sills of the Dodge were 56 cm (22 in) above the pavement. Although not directly involved in the pedestrian backover, the ground clearance of the rear differential was 23 cm (9.1 in).

**Figure 6:** Left plane view of the 2002 Dodge 2500 Quad Cab pickup truck.

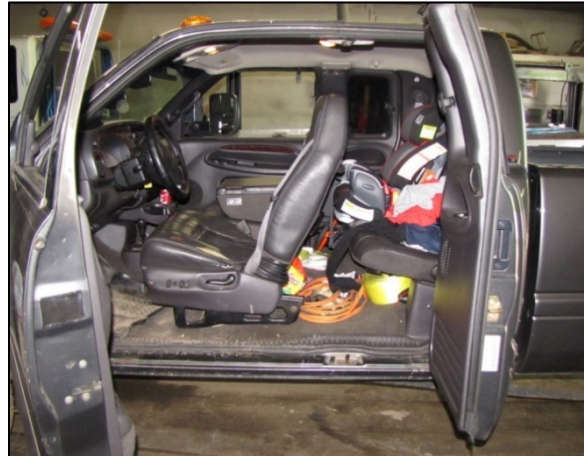
The interior of the Dodge Quad Cab pickup truck was configured with front bucket seats and a flip and fold center console. At the time of this incident, the backrest was folded forward and used as a center console/armrest. The second row seat was a forward-facing bench with a forward-folding seat back. The forward-facing Graco CRS was installed in the second row center position. All seating surfaces were leather.

**Figure 8:** Interior view of the Dodge with the left doors in the open positions.
