DOT HS 812 812

Special Crash Investigations On-Site Rollaway Crash Investigation Vehicle: 2014 RAM 1500 Location: Texas Crash Date: August 2018

**Special Crash Investigations (SCI)
On-Site Office of Defects Investigation
Rollaway Crash Investigation
Case Number: DS18024
Vehicle: 2014 Ram 1500
Location: Texas
Crash Date: August 2018**

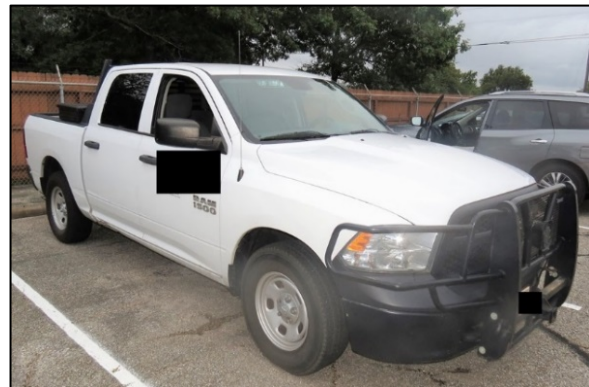
This report documents the on-site investigation of a rollaway crash involving a 2014 Ram 1500 (**Figure 1**). The vehicle was unoccupied and there were no injuries. This investigation was initiated by the Office of Defects Investigation (ODI) after being notified by the General Services Administration (GSA). The Special Crash Investigations (SCI) group of the National Highway Traffic Safety Administration assigned the case to Dynamic Science, Inc., in September 2018. The vehicle and scene inspections were completed in September 2018. A representative of Fiat Chrysler Automobiles N. V. (FCA) was present during the vehicle inspection. The Ram was supported by the Bosch Crash Data Retrieval (CDR) system and the vehicle's event data recorder (EDR) was imaged during the inspection.

Figure 1. 2014 Ram 1500 ST.

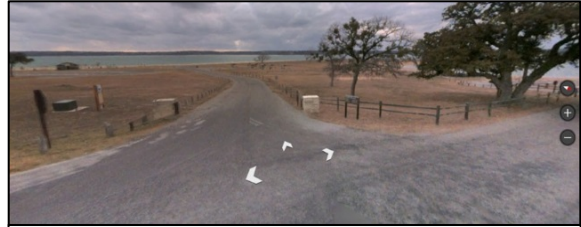
This vehicle was involved in a similar incident 11 days earlier. That incident occurred at nighttime. The crash scene was the entrance to a parking area in a State park (**Figure 12**). The through road was configured north/south and the entrance was configured east/west. The entrance was secured by two gates. There were series of 15 x 15 cm (5.9 x 5.9 in) wooden posts located along the east side of the roadway and along the south side of the entrance. It has been reported that there was a negative 8 percent grade in this general location. A crash diagram is located on the following page.

Figure 12. Area of incident, looking west (on-line image).
