DOT HS 812 834

November 2019

**Special Crash Investigations
On-Site Alleged Air Bag Inflator
Rupture Crash Investigation
Vehicle: 2007 Honda CR-V
Location: Texas
Crash Date: October 2017**

**SPECIAL CRASH INVESTIGATIONS
ON-SITE ALLEGED AIR BAG INFLATOR RUPTURE
CRASH INVESTIGATION
CASE NUMBER: CR17031
VEHICLE: 2007 HONDA CR-V
LOCATION: TEXAS
CRASH DATE: OCTOBER 2017**

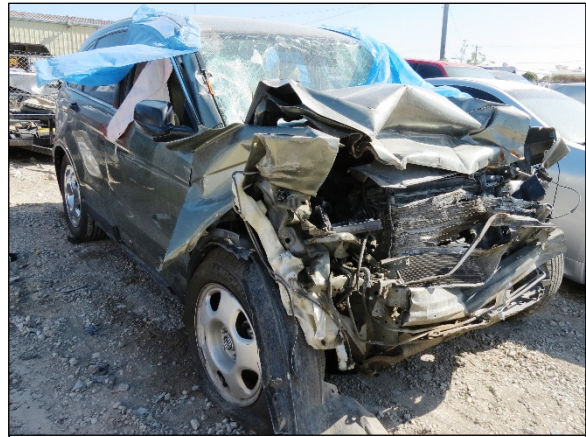
This report documents the on-site investigation of the alleged rupture of the driver's air bag inflator in a 2007 Honda CR-V sport utility vehicle (SUV) (**Figure 1**). The Honda was involved in a distributed front plane impact with the rear plane of a 1994 Mack single-unit straight truck on a limited-access roadway. During the crash, the Honda's driver's frontal and right inflatable curtain (IC) air bags deployed. The crash resulted in fatal injuries to the Honda's 41-year-old male driver. Law enforcement documentation of the crash indicated that the driver was not restrained by the available 3-point lap and shoulder seat belt system. The investigating law enforcement agency observed that the fabric of the driver's air bag was torn, and alleged that the driver's air bag inflator may have ruptured. Through the course of this SCI investigation, it was determined that the unbelted driver produced significant distributed loading to the deployed driver's air bag which increased the pressure in the inflated bag beyond the fabric's tolerance. This caused the fabric of the air bag to burst along the right circumference of the steering wheel rim. The air bag's inflator operated as designed, without rupture or evidence of malfunction.

Figure 1. Right front oblique view of the Honda at the time of the SCI vehicle inspection.

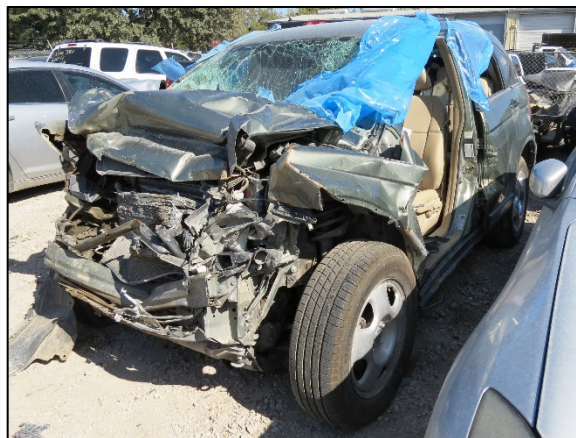
Figure 4. Front left oblique view of the 2007 Honda CR-V at the time of the SCI vehicle inspection.

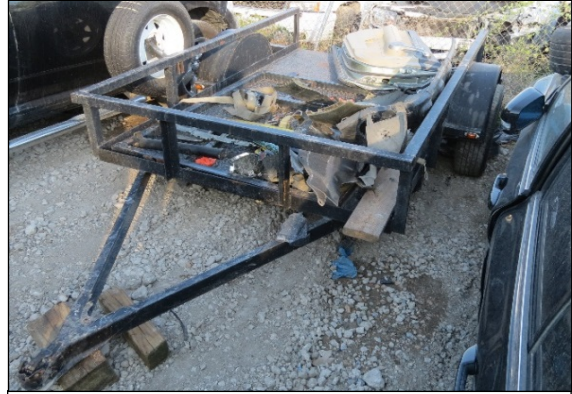
The utility trailer was manufactured in 2000 by Stoughton Trailers, Inc., and identified by the VIN 1DW1C5323YExxxxxx. It was a single-axle trailer with a 1.5 x 2.4 m (5.0 x 8.0 ft) flatbed deck. The trailer was of steel construction. During the crash, the trailer pitched forward and was involved in intra-unit contact with the back plane of the Honda. This fractured the jack from the trailer's tongue. **Figure 13** depicts the small utility trailer at the time of the SCI inspection.

Figure 13. Front left oblique view of the 2000 Stoughton Trailers utility trailer.

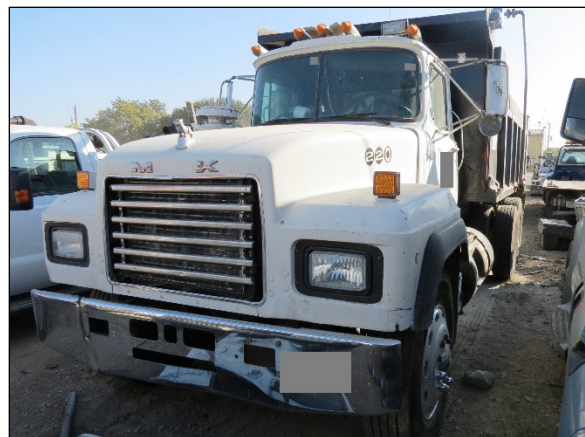
Figure 14. Front left oblique view of the 1994 Mack RB600 at the time of the SCI vehicle inspection.
