DOT HS 812 839

**Special Crash Investigations
On-Site Air Bag Non-Deployment
Crash Investigation
Vehicle: 2006 Mazda 6
Location: Maryland
Crash Date: March 2018**

Special Crash Investigations
On-Site Air Bag Non-Deployment Crash Investigation
Office of Defects Investigation
Case No: CR18017
Vehicle: 2006 Mazda 6
Location: Maryland
Crash Date: March 2018

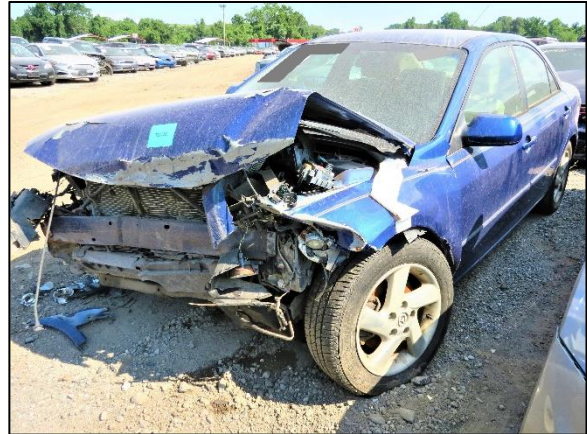
This report documents the on-site investigation of a crash involving a 2006 Mazda 6 sedan (**Figure 1**), in which none of the air bag systems deployed. According to a person who reported the crash to the National Highway Traffic Safety Administration, the crash occurred when the Mazda swerved to avoid a non-contact vehicle and struck a concrete barrier on a limited-access roadway. The claimant reported that there were no warning indicators illuminated prior to the crash and the air bags did not deploy. The 22-year-old belted female driver sustained police-reported possible (C-level) injuries and was transported by ambulance to a local hospital. The Mazda was equipped with a Certified Advanced 208-Compliant (CAC) frontal air bag system for the driver and front right passenger positions, as well as front seat-mounted and inflatable curtain (IC) side impact air bags.

Figure 1: Front left oblique view of the 2006 Mazda 6.

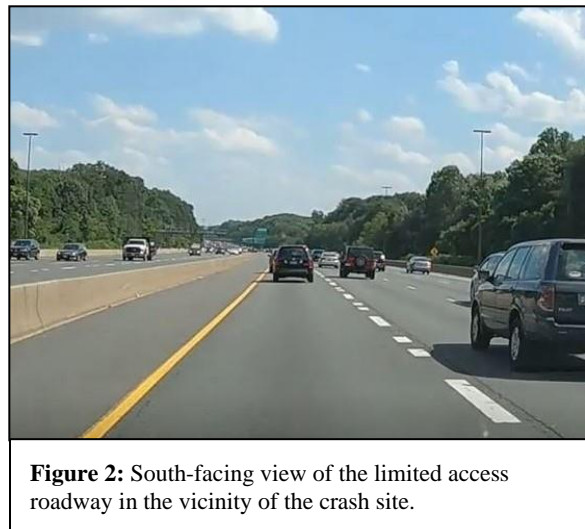
The southbound portion of the roadway consisted of four travel lanes, which each measured approximately 3.7 m (12.1 ft) wide. They were delineated by a single solid white right fog line, broken white center lane lines, and a single solid yellow median line. They were supported by an approximate 3.6 m (11.8 ft) wide west shoulder and an approximate 3.4 m (11.2 ft) wide east shoulder. Concrete barriers bordered both roadway edges (**Figure 2**). Speed of traffic on the roadway was regulated by a posted limit of 89 km/h (55 mph). A crash diagram is included at the end of this report.

Figure 2: South-facing view of the limited access roadway in the vicinity of the crash site.

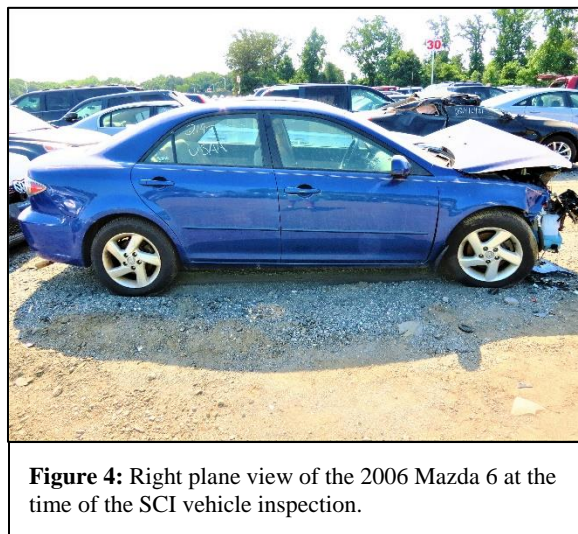
The Mazda (**Figure 4**) was manufactured during August 2005 and was identified by the VIN 1YVHP80C465xxxxx. It was a 4-door sedan built on a 268 cm (105.5 in) wheelbase with a 2.3 liter, inline, 4-cylinder gasoline engine. The Mazda's electronic odometer reading could not be read during the SCI inspection due to electrical system inoperability. However, salvage facility auction information indicated that the vehicle's odometer reading when it arrived at the facility was 202,890 km (126,070 mi). The Mazda had a gross vehicle weight rating of 1,941 kg (4,279 lb). Front and rear axle ratings were

Figure 4: Right plane view of the 2006 Mazda 6 at the time of the SCI vehicle inspection.

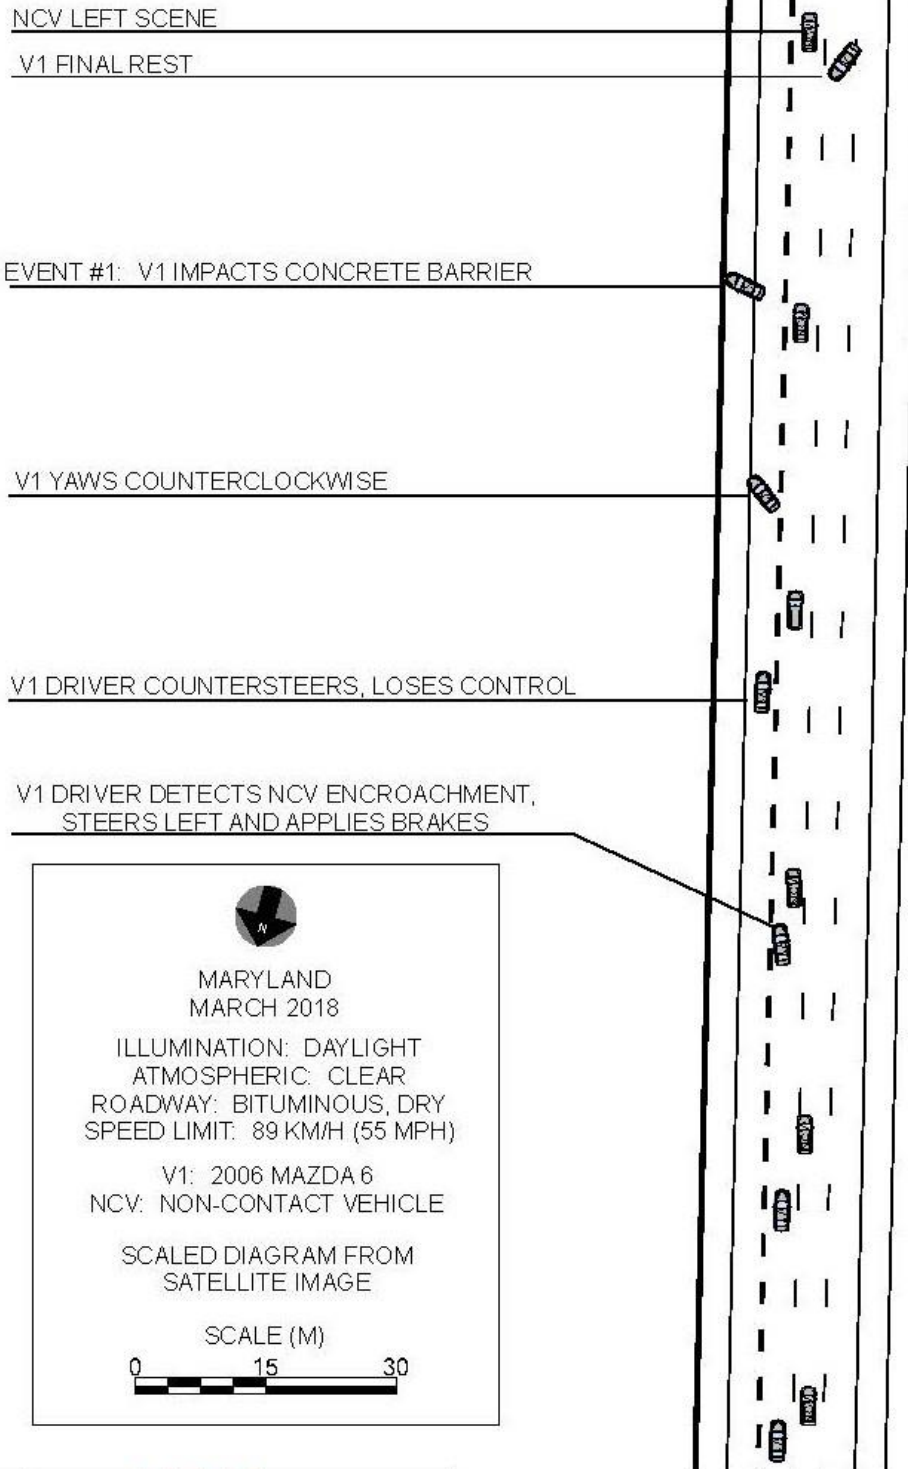
CRASH DIAGRAM

The crash (Event 1) occurred as the front plane/left aspect of the Mazda struck the face of the concrete barrier. Impact forces accentuated the vehicle's counterclockwise rotation, and the entire width of the front plane engaged the barrier. The Mazda was redirected by the barrier and rebounded toward the southwest (back toward the travel lanes). It ultimately slid to final rest straddling the travel lane second from the right, facing north. **Figure 3** depicts the concrete barrier with impact damage in the area of the crash site. However, due to the numerous impacts to the barrier, the SCI investigator was unable to determine which specific area of contact was related to the Mazda's impact.
