**National Highway
Traffic Safety
Administration**

DOT HS 812 843

**Special Crash Investigations
On-Site Air Bag
Non-Deployment Crash
Investigation
Vehicle: 2016 Nissan Versa
Location: Virginia
Crash Date: June 2017**

**SPECIAL CRASH INVESTIGATIONS
ON-SITE AIR BAG NON-DEPLOYMENT CRASH INVESTIGATION
CASE NO.: CR17023
OFFICE OF DEFECTS INVESTIGATION
VEHICLE: 2016 NISSAN VERSA
LOCATION: VIRGINIA
CRASH DATE: JUNE 2017**

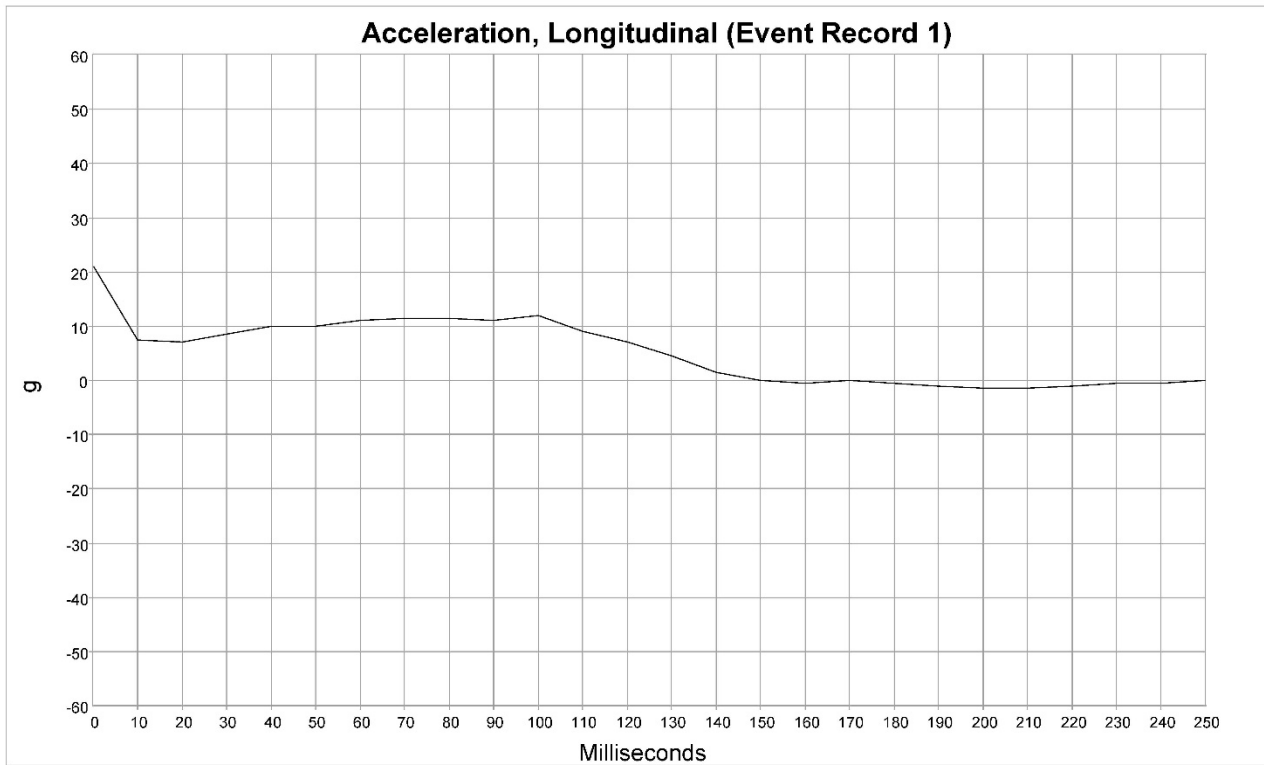
Longitudinal Acceleration (Event Record 1)

Time (msec)	g
0	21
10	7.5
20	7
30	8.5
40	10
50	10
60	11
70	11.5
80	11.5
90	11
100	12
110	9
120	7
130	4.5
140	1.5
150	0
160	-0.5
170	0
180	-0.5
190	-1
200	-1.5
210	-1.5
220	-1
230	-0.5
240	-0.5
250	0

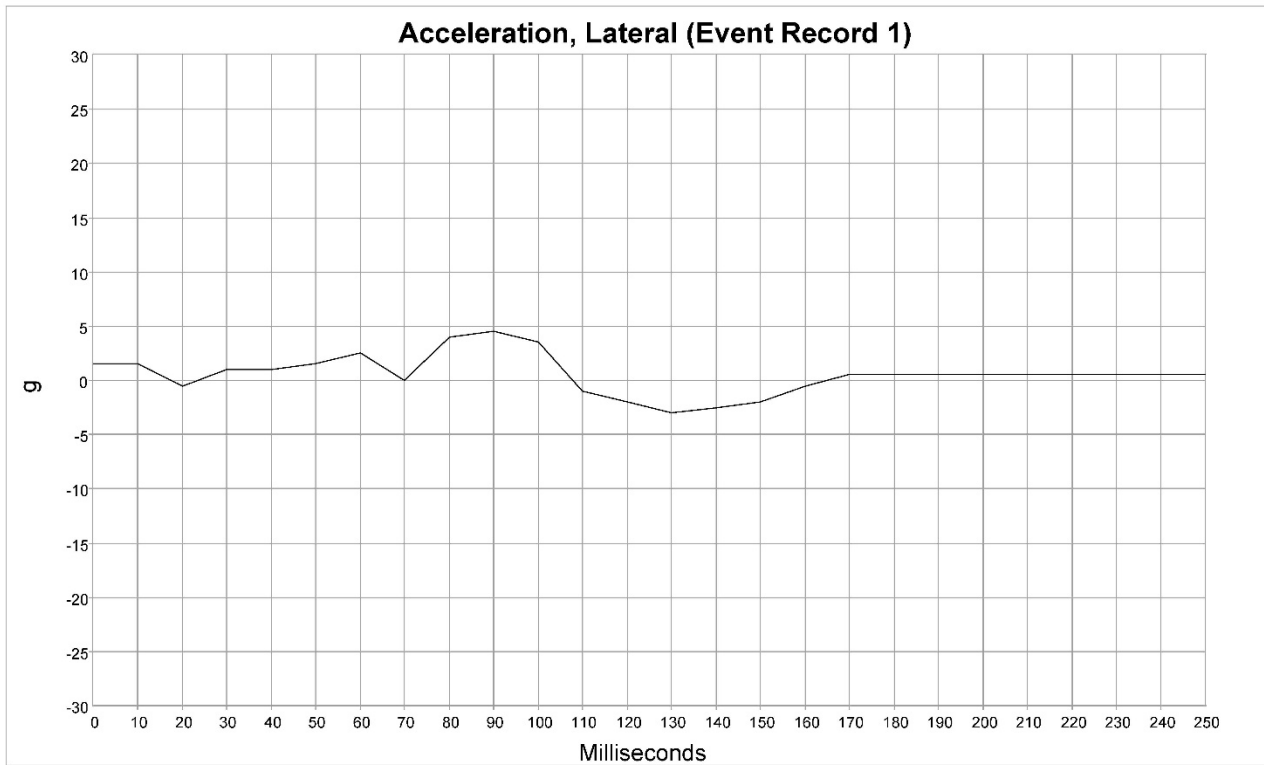
Lateral Acceleration (Event Record 1)

Time (msec)	g
0	1.5
10	1.5
20	-0.5
30	1
40	1
50	1.5
60	2.5
70	0
80	4
90	4.5
100	3.5
110	-1
120	-2
130	-3
140	-2.5
150	-2
160	-0.5
170	.5
180	.5
190	.5
200	.5
210	.5
220	.5
230	.5
240	.5
250	.5
