DOT HS 812 848

# **Special Crash Investigations On-Site Ambulance Crash Investigation**

**Vehicle: 2016 Ford F-450 Type I  
Ambulance**

**Crash Date: February 2018**

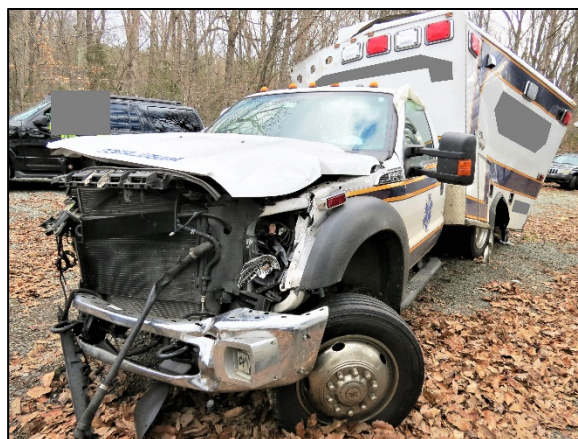
**Figure 6:** Left front oblique view of the 2016 Ford F-450 Super Duty at the time of the SCI inspection.

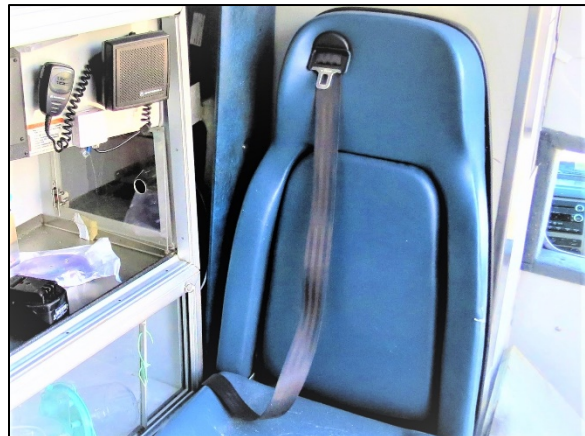
The patient compartment was configured with manual seat belt systems for each position. For the occupied rear-facing captain's chair, an integrated 3-point lap and shoulder seat belt system was available. It had a retractor mounted in the seat back, with continuous loop webbing and a sliding latch plate. The system was located on the right aspect of the seat, with respect to its orientation. The latch plate was slid upward with excess webbing hanging loosely at the time of the SCI inspection (**Figure 17**). Although there was little evidence of historical wear, there appeared to be slight waffling of the webbing below the latch plate that may have correlated to occupant loading in the crash. It was the opinion of the SCI investigator that the system was in use by the male EMT at the time of the crash.

**Figure 17:** Three-point lap and shoulder safety belt system for the captain's chair position at the time of the SCI inspection.

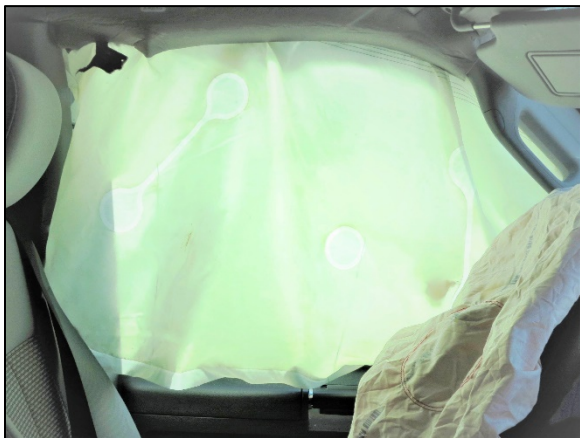
The left and right IC air bags deployed from the roof side rails of the Ford's cab without damage. They provided vertical coverage from the roof to below the beltline, extending down below the base of the side glazing. The left IC air bag appeared to be clean, with no evidence of driver contact (**Figure 20**). However, the right IC air bag had several longitudinal scuffs along its lower half (**Figure 21**), suggestive of make-up transfer and occupant contact by the front row right occupant during the Event 1 impact engagement.

**Figure 20:** Deployed left IC air bag in the Ford ambulance.

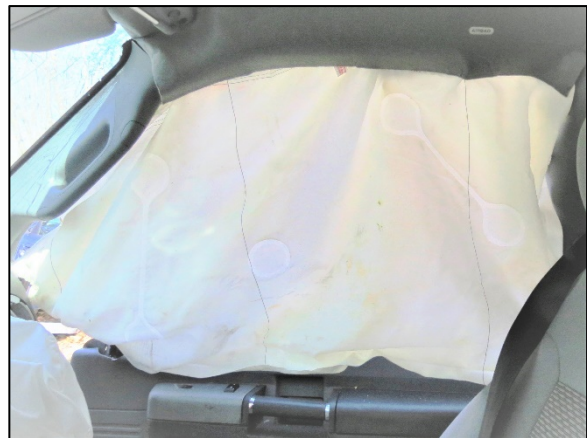
**Figure 21:** View of the deployed right IC air bag at the time of the SCI inspection.

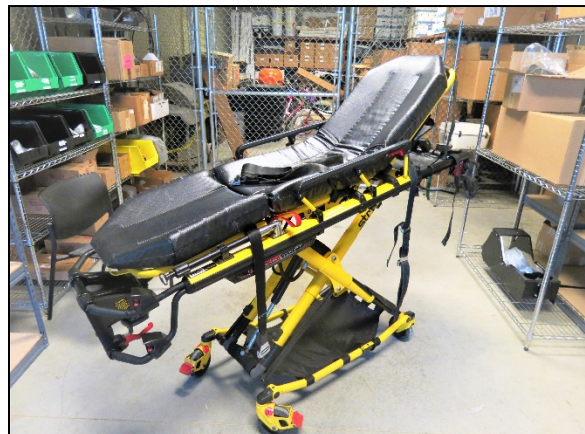
The wheeled ambulance cot installed in the Ford ambulance was a Power Pro XT Model 6500, manufactured by Stryker. Its serial number was S/N 12064xxxx, indicative that it was manufactured in June 2012. The Stryker cot (**Figure 22**) was constructed of a tubular aluminum frame with circumferential weld joints and steel hardware fasteners. The X-frame supporting the mattress platform featured power lift capabilities with infinite height positions between a minimum of 36 cm (14 in) and a maximum of 105 cm (41.5 in). The mattress platform featured 0-73 degrees of positive backrest angular adjustment via a manually controlled gas-pressure cylinder. In a similar fashion, the leg portion featured 15 degrees of positive angular adjustment.

**Figure 22:** View of the Stryker Power Pro wheeled ambulance cot at the time of the SCI inspection.

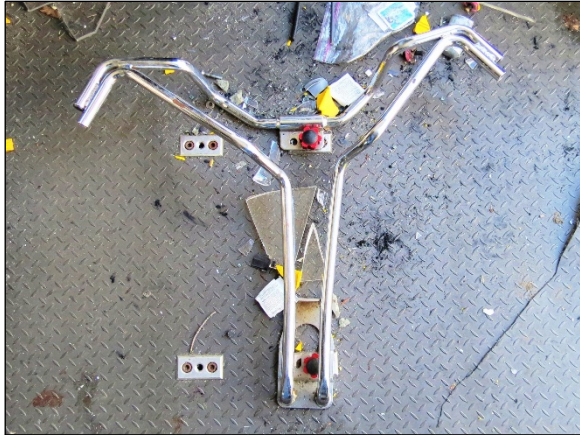
The antler bracket was secured to the floor of the patient compartment by two hand-tightened bolts that were in-line at the forward and aft aspect of the steel tube bracket. Four bolts held the rectangular base of the clamp to a vertical support. Combined, these two components were intended to restrict the lateral and longitudinal movement of the cot in the ambulance during transport. **Figures 26 and 27** depict the antler bracket and locking clamp mechanism as observed by the SCI investigator during the vehicle inspection.

**Figure 26:** Antler bracket of the cot fastening system mounted in the Ford ambulance.

The SCI investigator observed that the bolts of the antler bracket remained intact and the bracket was in place. However, it was crooked with respect to the alignment of the securement points, and the right aspect was deformed diagonally to the front and right (toward the direction of the primary impact forces). The rail clamp mounting bracket, bolts, and clamp mechanism also remained intact, with the clamp in the unlocked position. The SCI investigator concluded that the clamp had released during the crash. The occupant responded toward the frontal crash force and the back of her torso compressed against the mattress platform and inclined back support. This translated a loading force into the cot's frame. The moment of this force created a load at the locking clamp mechanism that forced the rail clamp open.

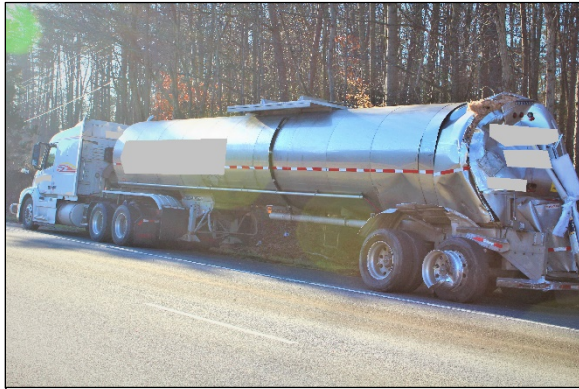
However, significant damage was sustained by the rear aspect of the tanker semi-trailer. The truck and semi-trailer were retained by their respective owners after the crash, and had returned to their out-of-State origin prior to SCI case assignment. Consequently, neither was available for SCI inspection. **Figure 28** depicts the combined unit at the crash site, while **Figure 29** depicts the damage pattern to the back of the tanker semi-trailer.

**Figure 28:** Left rear oblique view of the truck tractor and semi-trailer (*on-scene law enforcement image*).
