DOT HS 812 896

**Special Crash Investigations
On-Site Guardrail End
Terminal Investigation;
Vehicle: 2011
Chevrolet Impala;
Location: Missouri;
Crash Date: January 2018**

SPECIAL CRASH INVESTIGATIONS
ON-SITE GUARDRAIL END TREATMENT INVESTIGATION
CASE NUMBER - IN18001
VEHICLE - 2011 CHEVROLET IMPALA
LOCATION - MISSOURI
CRASH DATE - JANUARY 2018

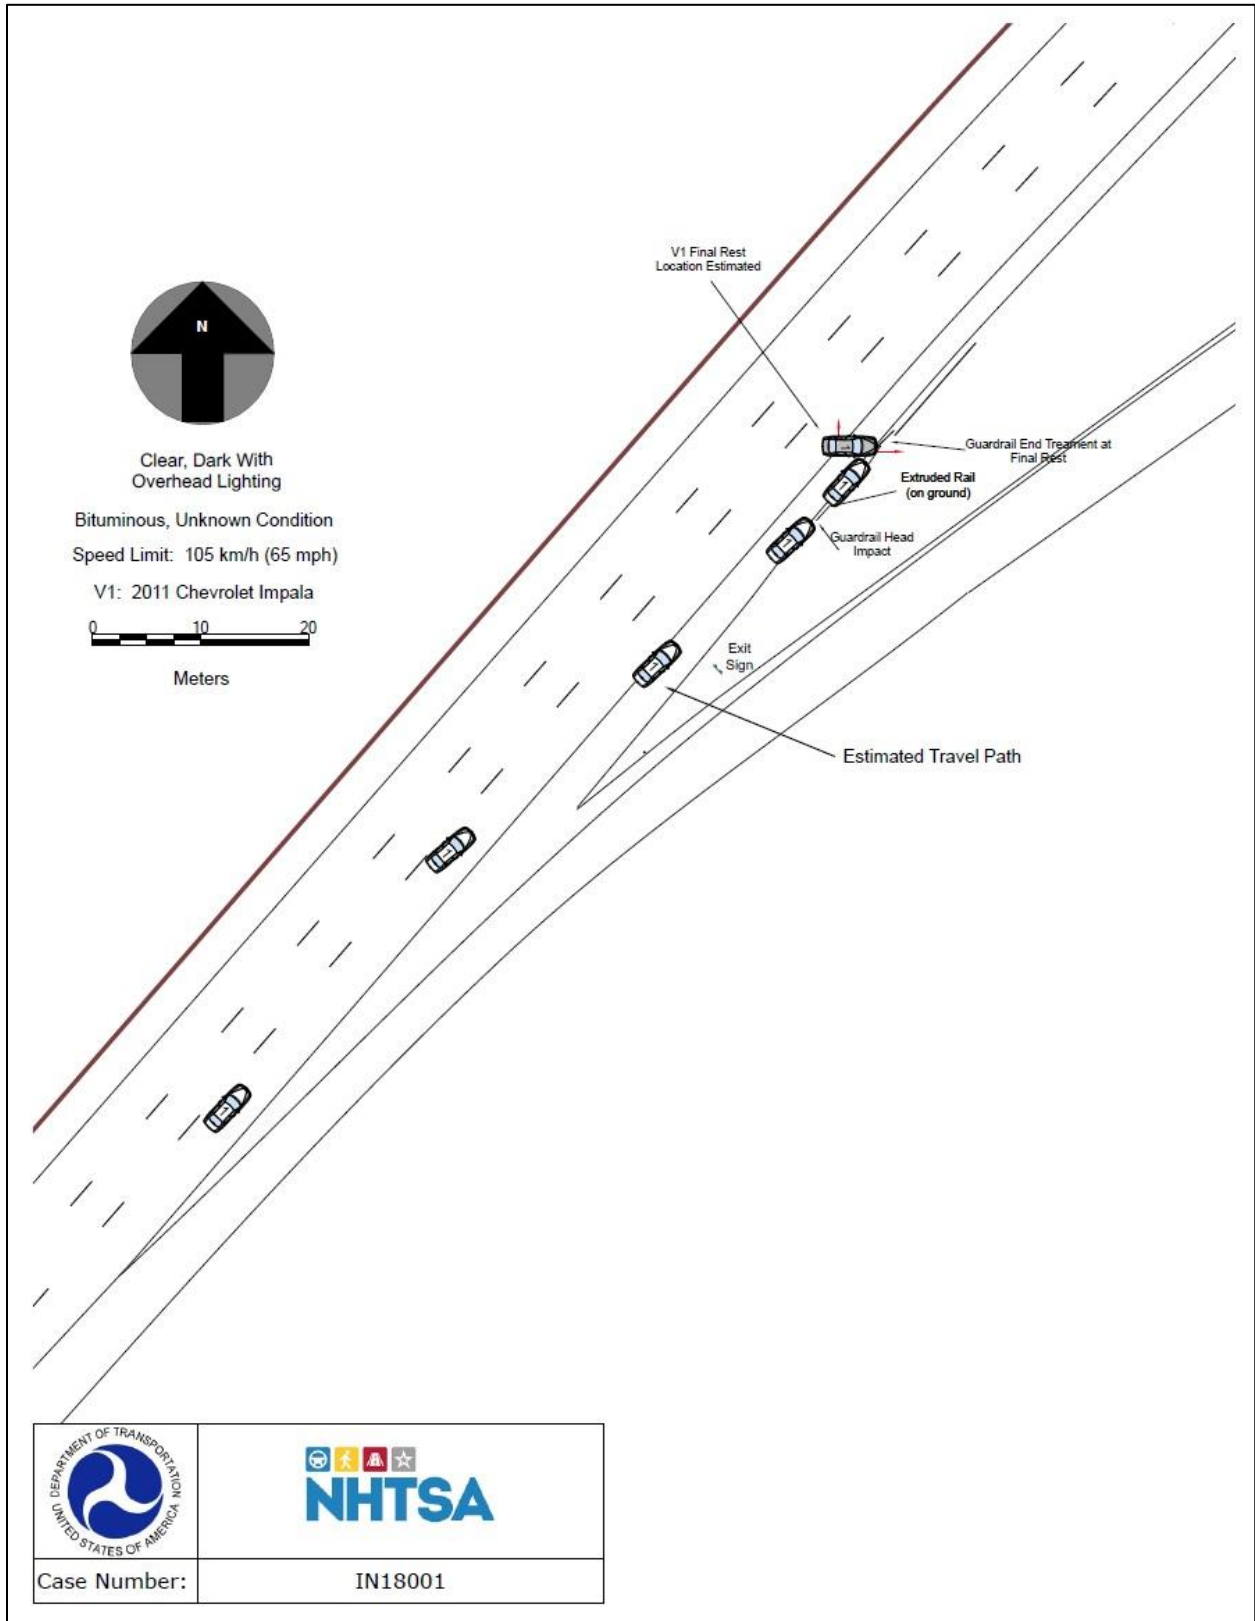
CRASH DIAGRAM

The driver was not restrained by the lap and shoulder seat belt and the seat track was adjusted between the middle and rearmost positions. The front plane impact with the end terminal displaced the driver forward. She loaded the frontal air bag and was redirected to the left as the vehicle rotated clockwise. Her injuries from the guardrail crash are unknown.

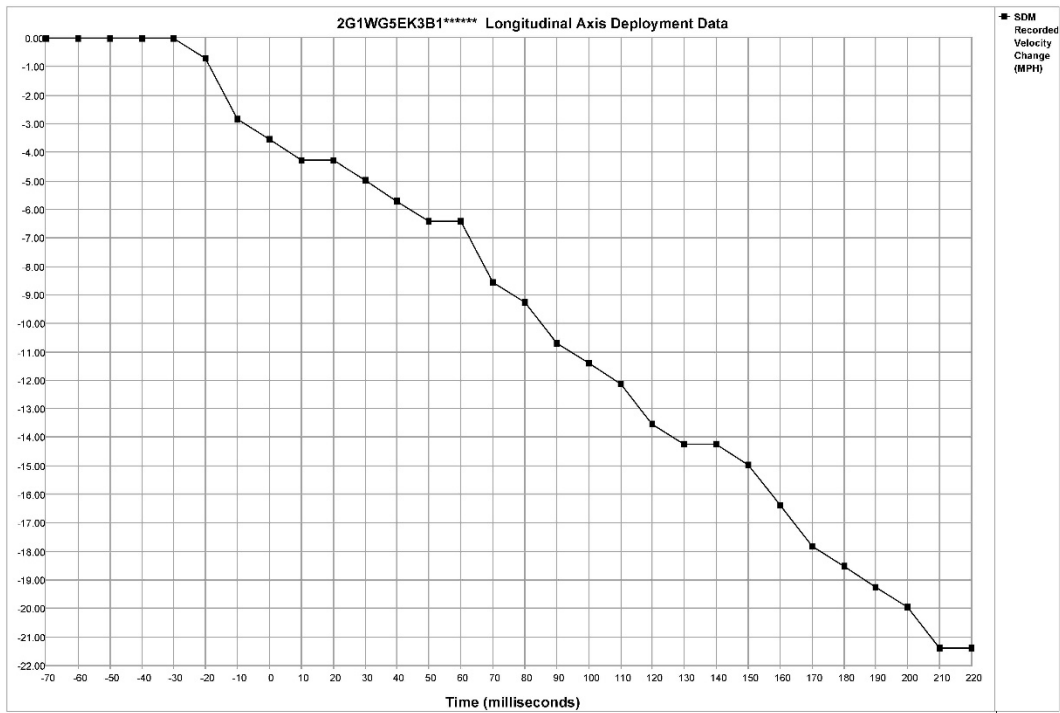
Time (milliseconds)	-70	-60	-50	-40	-30	-20	-10	0	10	20	30	40	50	60	70
SDM Longitudinal Axis Recorded Velocity Change (MPH)	0.00	0.00	0.00	0.00	0.00	-0.71	-2.85	-3.56	-4.28	-4.28	-4.99	-5.70	-6.41	-6.41	-8.55
Time (milliseconds)	80	90	100	110	120	130	140	150	160	170	180	190	200	210	220
SDM Longitudinal Axis Recorded Velocity Change (MPH)	-9.27	-10.69	-11.40	-12.12	-13.54	-14.25	-14.25	-14.97	-16.39	-17.82	-18.53	-19.24	-19.96	-21.38	-21.38

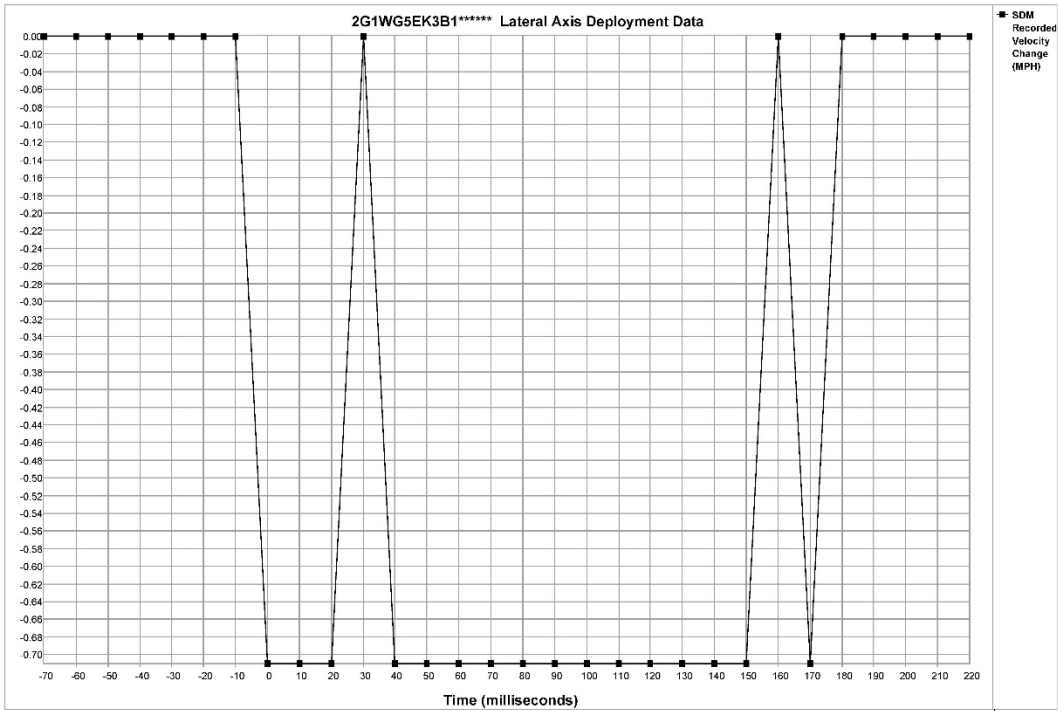
Time (milliseconds)	-70	-60	-50	-40	-30	-20	-10	0	10	20	30	40	50	60	70
SDM Lateral Axis Recorded Velocity Change (MPH)	0.00	0.00	0.00	0.00	0.00	0.00	0.00	-0.71	-0.71	-0.71	0.00	-0.71	-0.71	-0.71	-0.71
Time (milliseconds)	80	90	100	110	120	130	140	150	160	170	180	190	200	210	220
SDM Lateral Axis Recorded Velocity Change (MPH)	-0.71	-0.71	-0.71	-0.71	-0.71	-0.71	-0.71	-0.71	0.00	-0.71	0.00	0.00	0.00	0.00	0.00

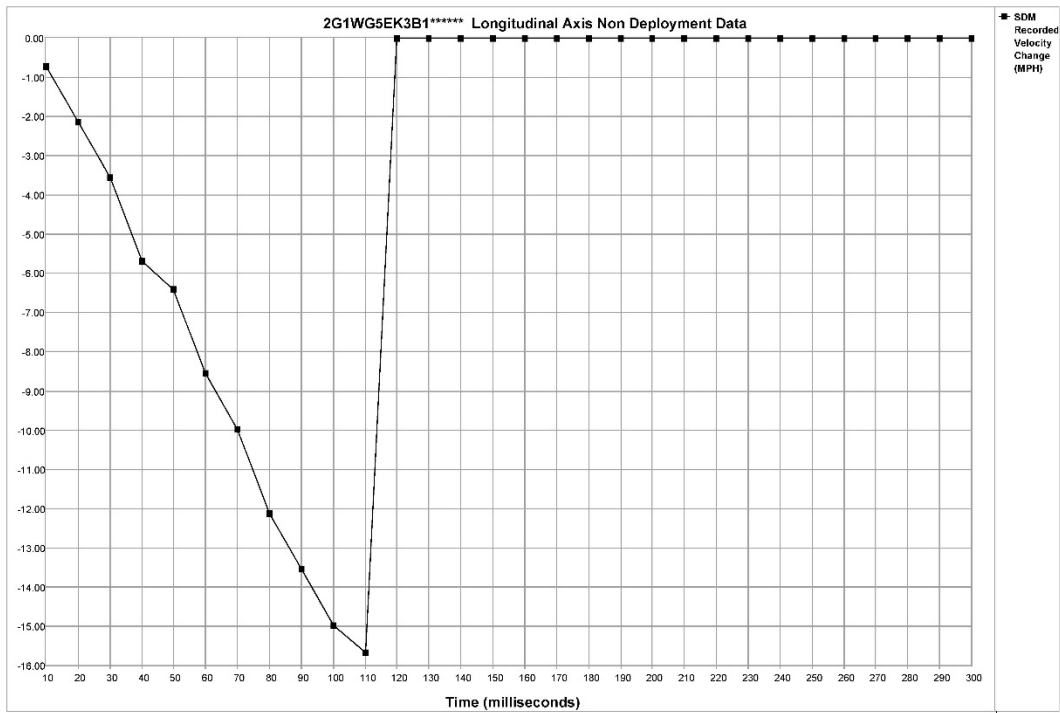
Time (milliseconds)	10	20	30	40	50	60	70	80	90	100	110	120	130	140	150
SDM Longitudinal Axis Recorded Velocity Change (MPH)	-0.71	-2.14	-3.56	-5.70	-6.41	-8.55	-9.98	-12.12	-13.54	-14.97	-15.68	0.00	0.00	0.00	0.00
Time (milliseconds)	160	170	180	190	200	210	220	230	240	250	260	270	280	290	300
SDM Longitudinal Axis Recorded Velocity Change (MPH)	0.00	0.00	0.00	0.00	0.00	0.00	0.00	0.00	0.00	0.00	0.00	0.00	0.00	0.00	0.00

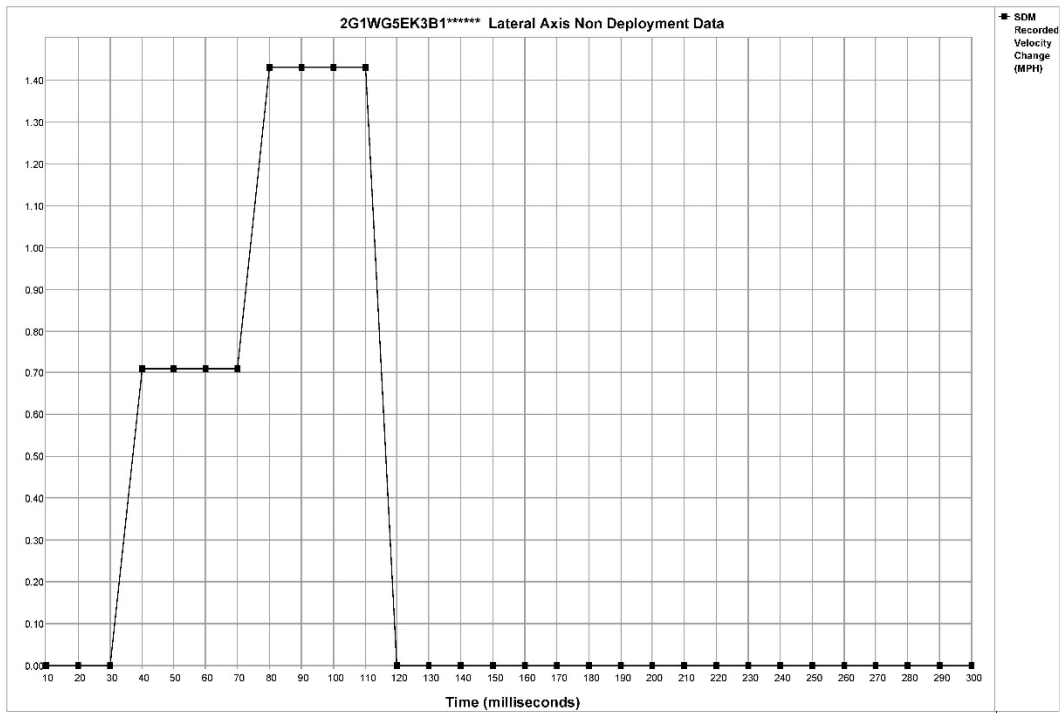
Time (milliseconds)	10	20	30	40	50	60	70	80	90	100	110	120	130	140	150
SDM Lateral Axis Recorded Velocity Change (MPH)	0.00	0.00	0.00	0.71	0.71	0.71	0.71	1.43	1.43	1.43	1.43	0.00	0.00	0.00	0.00
Time (milliseconds)	160	170	180	190	200	210	220	230	240	250	260	270	280	290	300
SDM Lateral Axis Recorded Velocity Change (MPH)	0.00	0.00	0.00	0.00	0.00	0.00	0.00	0.00	0.00	0.00	0.00	0.00	0.00	0.00	0.00
