DOT HS 812 911

**Special Crash Investigations
On-Site Guardrail End Terminal
Investigation
Vehicle: 2005 Chevrolet Uplander
Location: Missouri
Crash Date: December 2017**

Special Crash Investigations
On-Site Guardrail End Terminal Investigation
Case Number: IN17036
Vehicle: 2005 Chevrolet Uplander
Location: Missouri
Crash Date: December 2017

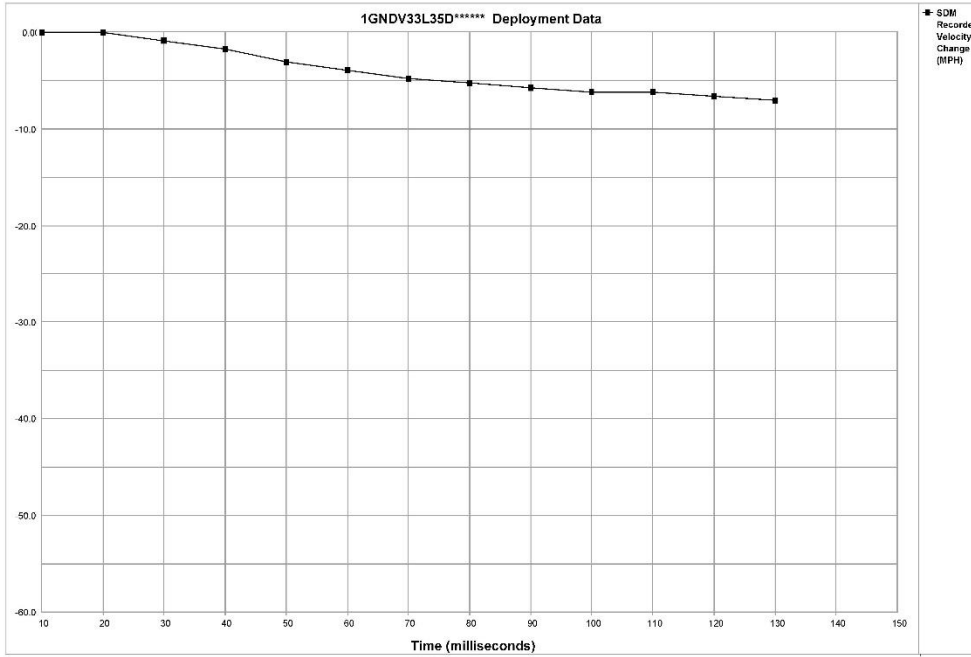
Time (milliseconds)	10	20	30	40	50	60	70	80	90	100	110	120	130	140	150
SDM Recorded Velocity Change	0.00	0.00	-0.88	-1.76	-3.07	-3.95	-4.83	-5.27	-5.70	-6.14	-6.14	-6.58	-7.02	N/A	N/A

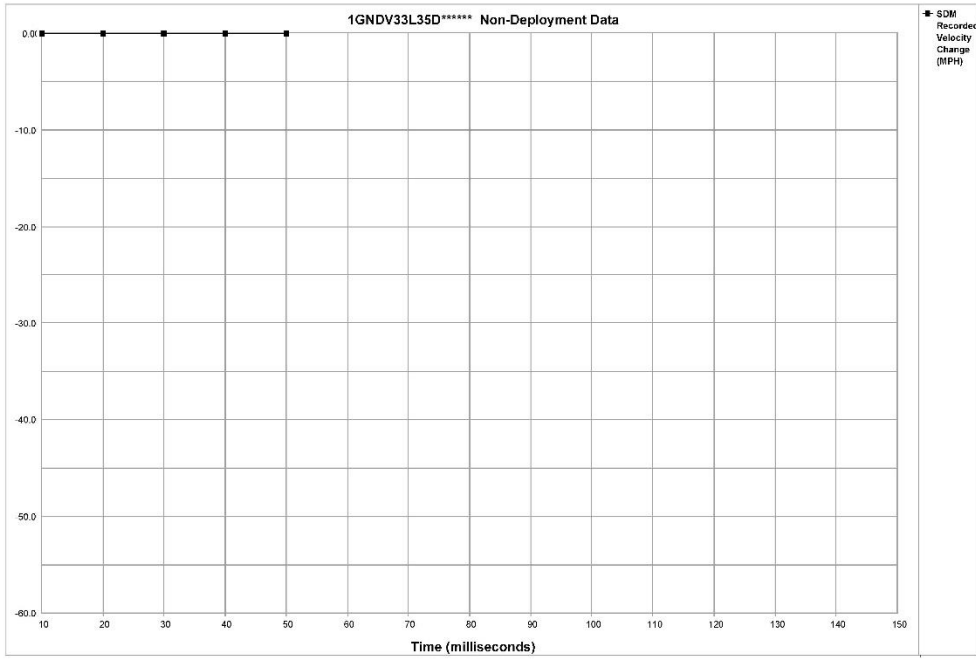
Time (milliseconds)	10	20	30	40	50	60	70	80	90	100	110	120	130	140	150
SDM Recorded Velocity Change	0.00	0.00	0.00	0.00	0.00	N/A	N/A	N/A	N/A	N/A	N/A	N/A	N/A	N/A	N/A
