DOT HS 812 915

**Special Crash Investigations
On-Site Rear Impact Crash and
Fire Investigation
Vehicle: 2007 Jeep Liberty
Location: Ohio
Date: August 2017**

**Special Crash Investigations
On-Site Rear Impact Crash and Fire Investigation
Office of Defects Investigation
Case Number: CR17025
Vehicle: 2007 Jeep Liberty
Location: Ohio
Crash Date: August 2017**

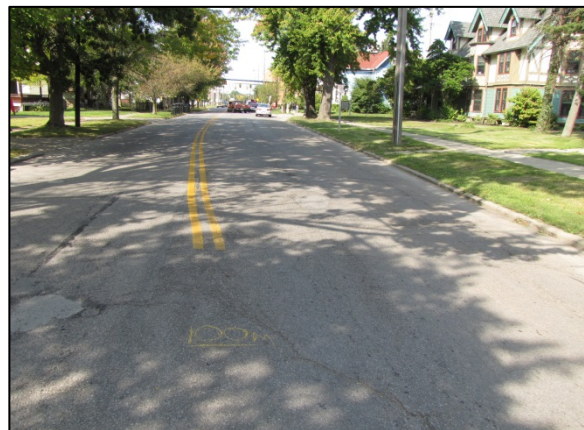
Figure 2. North-facing trajectory view 100 m (328 ft) south of the POI.

poles were located at each quadrant of the intersection. The non-breakaway traffic light support pole at the northwest quadrant was struck by the Jeep in a secondary impact as the vehicle came to final rest. The posted speed limit was 56 km/h (35 mph). **Figure 2** is a north-facing view along pre-crash trajectory of the vehicles. **Figure 3** is a north-facing view at the point of impact.

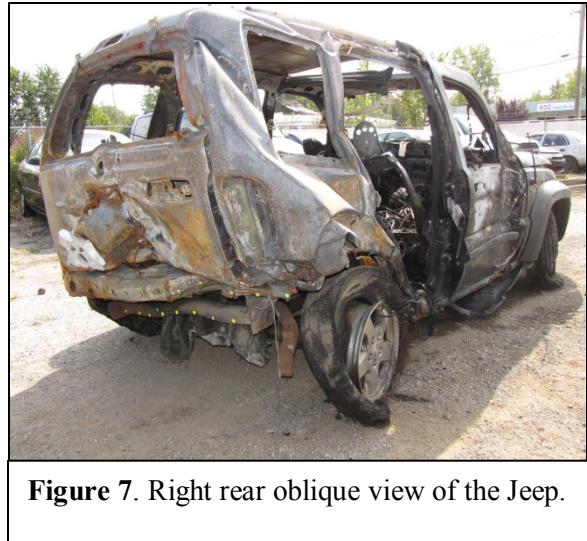
Figure 7. Right rear oblique view of the Jeep.

The 2007 Jeep Liberty Trail Rated 4x4 (**Figure 7**) was identified by the Vehicle Identification Number (VIN) 1J4GL48K37Wxxxxxx, which was determined by the police through registration records. The date of manufacturer is unknown as the crash-induced fire consumed all labeling. The sport utility vehicle (SUV) was built on a 265 cm (104.4 in) wheelbase and had a gross vehicle weight rating (GVWR) of 2,540 kg (6,150 lb). The front axle and rear axle ratings were 1,179 kg (2,599 lb) and 1,429 kg (3,150 lb), respectively. The curb weight was 1,819 kg (4,002 lb). The Jeep was powered by a conventionally mounted 3.7-liter, V-6, gasoline engine linked to a 4-speed automatic transmission with a console-mounted shift lever. Power was transmitted to the front and rear axles via drive shafts from the transfer case that was mounted to the aft aspect of the automatic transmission. Specifications for this vehicle listed the following as standard equipment: traction control, electronic stability control, power-assisted four-wheel disc brakes with ABS, electronic brakeforce distribution, emergency braking assist, and power-assisted rack-and-pinion steering. The vehicle manufacturer recommended tire size was P225/75R16. At the time of the crash, the Jeep was equipped with matching Firestone Destination tires of the recommended size. All tires were mounted on OEM 5-spoke alloy wheels. The rear tires sustained fire damage; however, they were not completely consumed. The specific tire data at the time of the SCI inspection is listed in the following table. It should be noted that the fire fighters removed the valve stems from the wheels to stabilize the vehicle during the extrication efforts; therefore, all tires were flat.

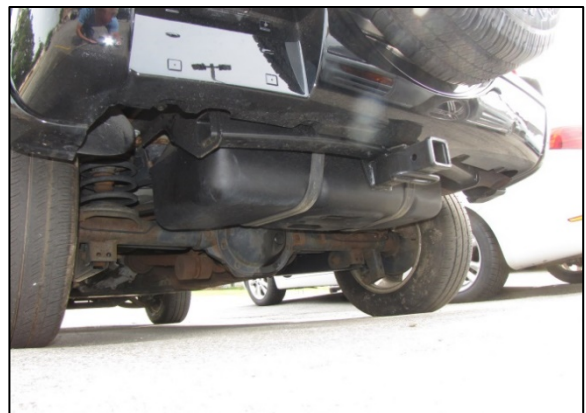
Figure 15. Rear view of the fuel tank and its location on an exemplar Jeep Liberty.

The Jeep was configured with a 77.6-liter (20.5 gal) high density polyethylene (HDPE) fuel tank mounted to the undercarriage aft of the rear axle. Based on an inspection of an exemplar vehicle (**Figure 15**), the overall dimensions of the fuel tank were 86 cm (34 in) in width, 33 cm (13 in) in height, and 38 cm (15 in) in depth (longitudinal). The rectangular tank was secured

with two steel straps 4 cm (1.5 in) wide and 3 mm (0.125 in) thick. Both straps were bolted to sheet metal undercarriage cross members. The fuel filler tube extended from the left side of the fuel tank and was located at the upper aspect of the left rear quarter panel, aft of the axle location. A ratcheting plastic fuel cap closed the tube. A composite hinged fuel door closed the filler cap port. The steel filler tube was 30 cm (11.75 in) in overall length and was connected to the tank by a neoprene hose. A steel overflow tube extended from the head of the filler tube and was formed to the contour of the tube. The steel filler tube and the overflow tube remained intact while all connecting neoprene tubing was consumed by the fire. The filler tube was found in the passenger compartment of the Jeep as it had separated from its plastic mounting support. The amount of gasoline in the fuel tank at the time of the crash is unknown.

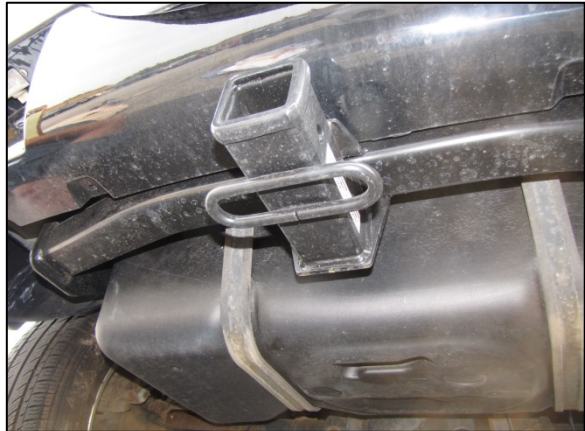
Figure 18: Back undercarriage view of the trailer hitch mounted on an exemplar Jeep Liberty.

The 5 cm (2.0 in) receiver sleeve was welded to bottom of the square tube of the hitch. The receiver protruded 13 cm (5.0 in) rearward of the tubing. A plate was welded to the back side of the receiver to cover the edges of the receiver sleeve. There was no ball mount installed in the receiver at the time of the crash. **Figure 17** is an undercarriage view of the Jeep's deformed trailer hitch. **Figure 18** is an undercarriage view of a trailer hitch mounted on an exemplar Jeep Liberty.

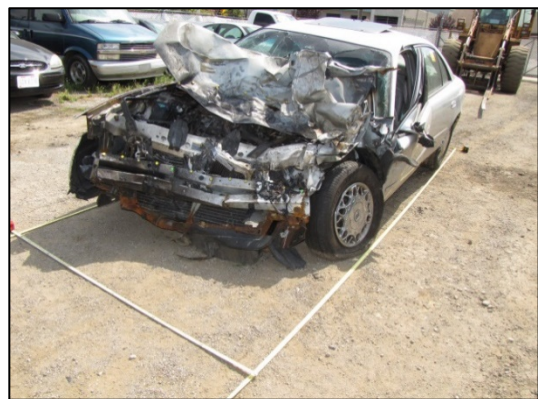
Figure 19. Left front oblique view of the Buick.

The 2003 Buick Century (**Figure 19**) was identified by VIN 2G4WS52J531xxxxx. The vehicle's date of manufacture is unknown as the placard was concealed by the jammed left front door. The Buick was powered by a 3.1-liter, V-6 gasoline engine linked to a 4-speed automatic transmission with a steering column-mounted shift lever. The front wheel-drive platform was configured on a 277 cm (109.1 in) wheelbase. Standard features included power-assisted, 4-wheel disc brakes with ABS and
