DOT HS 812 935

# **Special Crash Investigations: On-Site Air Bag Non-Deployment Crash Investigation; Vehicle: 2014 Audi Q5; Location: New York; Crash Date: April 2018**

**Special Crash Investigations  
On-Site Air Bag Non-Deployment Crash Investigation  
Case Number: CR18015  
Office of Defects Investigation  
Vehicle: 2014 Audi Q5  
Location: New York  
Crash Date: April 2018**

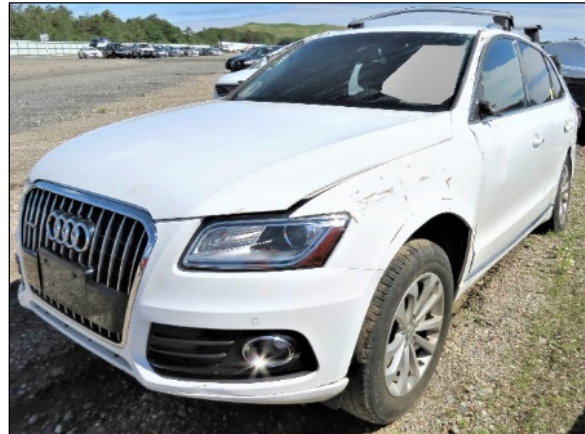
**Figure 1.** Left front oblique view of the 2014 Audi Q5 at the time of the SCI inspection.

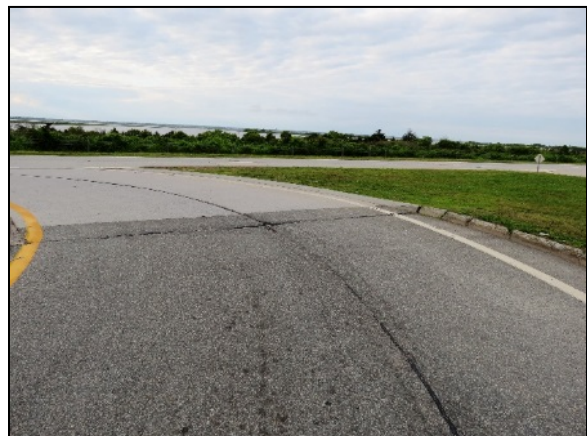
**Figure 2.** North-facing view in the U-turn crossover, for the Audi's pre-crash travel trajectory.

(11.8 ft) wide acceleration lane that progressed along the westbound lanes for approximately 100 m (328 ft). **Figure 2** shows the U-turn crossover, while **Figure 3** shows the merge lane and westbound travel lanes. Speed of traffic on the roadway was regulated by a posted limit of 56 km/h (35 mph). A crash diagram is included at the end of this technical report.

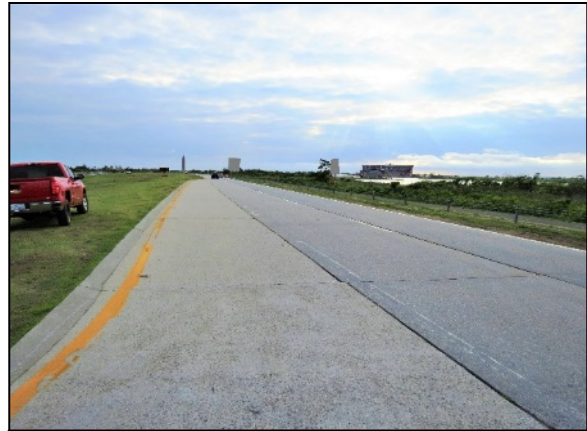
**Figure 3.** West-facing view of the merge lane and westbound travel lanes.

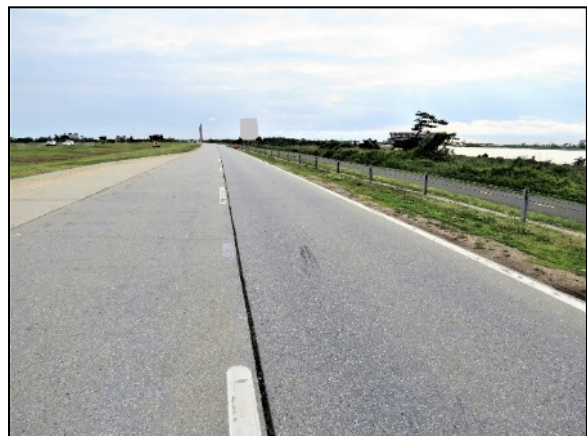
**Figure 4.** West-facing view of the area of impact in the left aspect of the right travel lane.

force were in the 12 o'clock sector for the Acura and the 6 o'clock sector for the Audi. Crash forces displaced the Audi forward and induced a counterclockwise rotation to the vehicle, redirecting it southwest. **Figure 4** shows the area of impact in the left aspect of the right travel lane, while **Figure 5** shows diverging tire marks from the Audi as it rotated counterclockwise away from the area of impact.

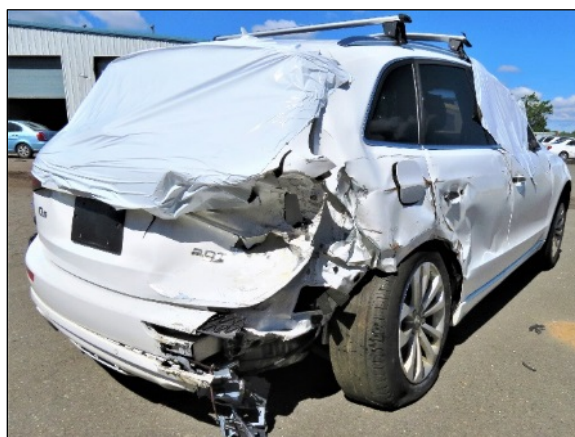
The Audi (**Figure 6**) was manufactured in September 2013 and was identified by the VIN WA1LFAP3EAXxxxxx. It was a 4-door sport utility vehicle (SUV) built on a 281 cm (110.6 in) wheelbase with a 2.0 liter, inline 4-cylinder gasoline engine. The Audi's electronic odometer reading at the time of the SCI inspection could not be determined due to electrical system inoperability. The Audi had a gross vehicle weight rating of 2,435 kg (5,368 lb). Front and rear axle ratings were 1,180 kg (2,601 lb) and 1,350 kg (2,976 lb), respectively. The curb weight was 1,850 kg (4,079 lb).

**Figure 6.** Right-plane view of the 2014 Audi Q5 at the time of the SCI vehicle inspection.

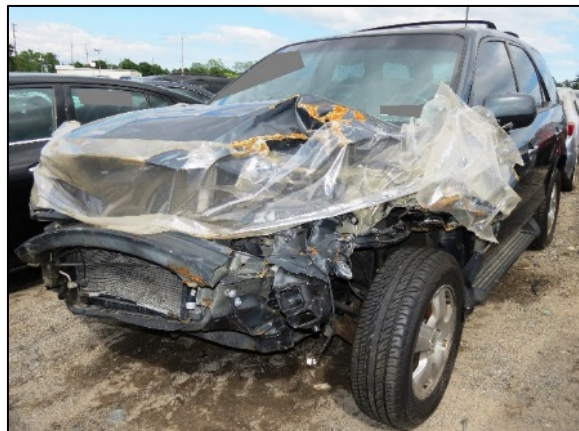
The Acura (**Figure 17**) was manufactured in April 2006 and was identified by the VIN 2HNYD18256Hxxxxxx. It was a 4-door SUV built on a 270 cm (106.3 in) wheelbase with a 3.5-liter, V-6 gasoline engine. The Acura's electronic odometer reading at the time of the SCI inspection could not be determined due to electrical system inoperability. The vehicle had a gross vehicle weight rating of 2,600 kg (5,730 lb). Front and rear axle ratings were 1,310 kg (2,890 lb) and 1,335 kg (2,945 lb), respectively. The curb weight was 1,992 kg (4,392 lb). Placarding on the frame of the left front door

**Figure 17.** Left front oblique view of the 2006 Acura MDX at the time of the SCI vehicle inspection.
