DOT HS 812 940

**Special Crash Investigations:
On-Site Guardrail End Terminal
Investigation;
Vehicle: 1999 Chevrolet Blazer;
Location: Missouri;
Crash Date: May 2017**

Special Crash Investigations
On-Site Guardrail End Terminal Investigation
Vehicle: 1999 Chevrolet Blazer
Case Number: IN17021
Location: Missouri
Crash Date: May 2017

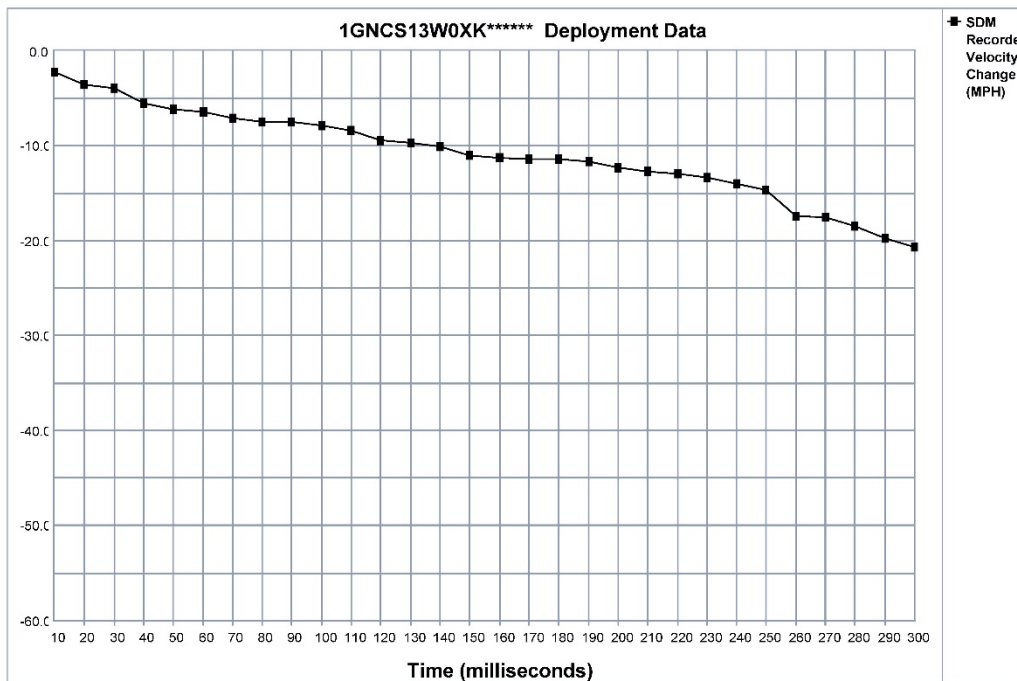
System Status At Deployment

Time (milliseconds)	10	20	30	40	50	60	70	80	90	100	110	120	130	140	150
Recorded Velocity Change (MPH)	-2.19	-3.51	-3.95	-5.49	-6.14	-6.36	-7.02	-7.46	-7.46	-7.90	-8.34	-9.43	-9.65	-10.09	-10.97
Time (milliseconds)	160	170	180	190	200	210	220	230	240	250	260	270	280	290	300
Recorded Velocity Change (MPH)	-11.19	-11.41	-11.41	-11.63	-12.29	-12.73	-12.94	-13.38	-14.04	-14.70	-17.33	-17.55	-18.43	-19.75	-20.62

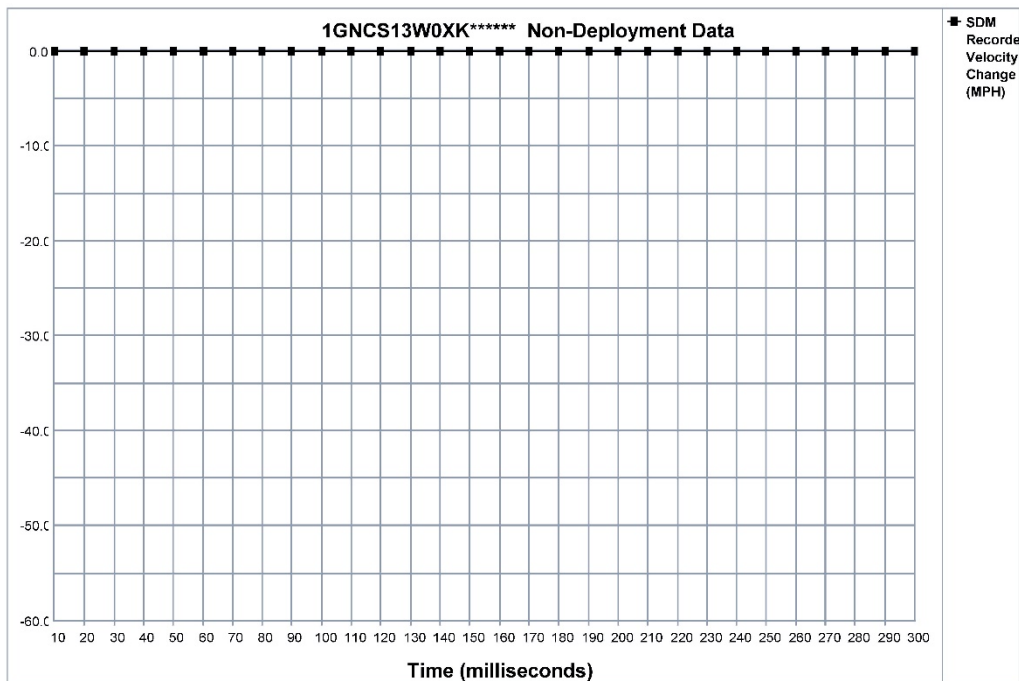
System Status At Non-Deployment

Time (milliseconds)	10	20	30	40	50	60	70	80	90	100	110	120	130	140	150
Recorded Velocity Change (MPH)	0.00	0.00	0.00	0.00	0.00	0.00	0.00	0.00	0.00	0.00	0.00	0.00	0.00	0.00	0.00
Time (milliseconds)	160	170	180	190	200	210	220	230	240	250	260	270	280	290	300
Recorded Velocity Change (MPH)	0.00	0.00	0.00	0.00	0.00	0.00	0.00	0.00	0.00	0.00	0.00	0.00	0.00	0.00	0.00
