DOT HS 812 950

Special Crash Investigations: On-Site Guardrail End Terminal Crash Investigation; Vehicle: 2002 Kia Optima; Location: Missouri; Crash Date: March 2017

Special Crash Investigations
On-Site Guardrail End Terminal Crash Investigation
Case Number: IN17013
Vehicle: 2002 Kia Optima
Location: Missouri
Crash Date: March 2017

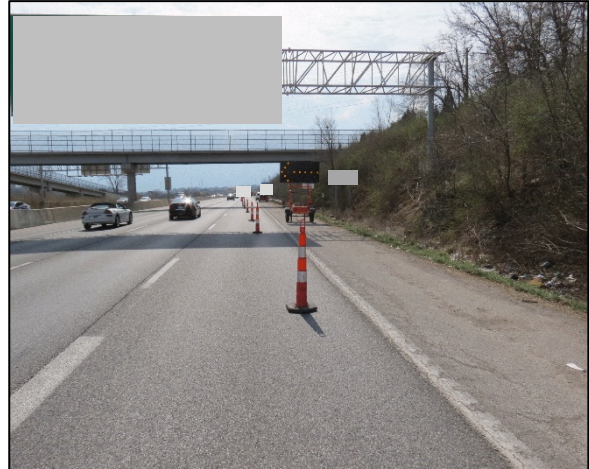
The Kia was traveling south (**Figure 3**) at an unknown speed and in an unknown travel lane when the vehicle departed the right (west) side of the roadway. The police crash report stated that the female passenger thought the driver fell asleep.

Figure 3. Southbound approach of the Kia in an unknown lane.
