DOT HS 812 956

**Special Crash Investigations:
On-Site Child Restraint System
Investigation;
Vehicle: 2015 Hyundai Sonata;
Location: Ohio;
Crash Date: December 2016**

**Special Crash Investigations
On-Site Child Restraint System Investigation
Office of Defects Investigation
Case Number: IN17016
Vehicle: 2015 Hyundai Sonata
Location: Ohio
Crash Date: December 2016**

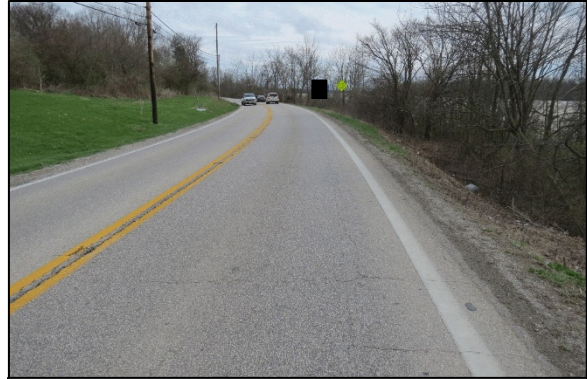
Figure 2. Southeast-bound approach of the Hyundai.

The Hyundai was traveling southeast in its lane (**Figure 2**), negotiating a left curve at a speed recorded by the event data recorder (EDR) of 89 km/h (55 mph) at -5.0 sec prior to algorithm enable (AE). The EDR reported the vehicle gradually decelerated with the service brake off to a speed of 87 km/h (54 mph) at -0.5 sec. The Honda was traveling northwest in its lane, negotiating a right curve (**Figure 3**) when it traveled into the Hyundai's lane. The EDR reported the Hyundai's speed at 0.0 sec as 83 km/h (52 mph).

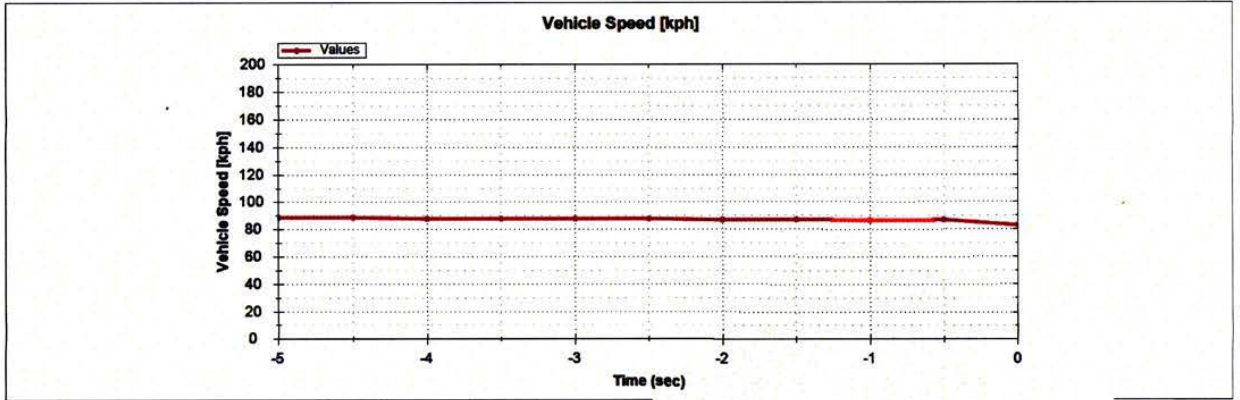
< Event 1 >
 Vehicle Speed

Num	Time (sec)	Vehicle Speed [kph]
1	-5.0	89
2	-4.5	89
3	-4.0	88
4	-3.5	88
5	-3.0	88
6	-2.5	88
7	-2.0	87
8	-1.5	87
9	-1.0	87
10	-0.5	87
11	0.0	83

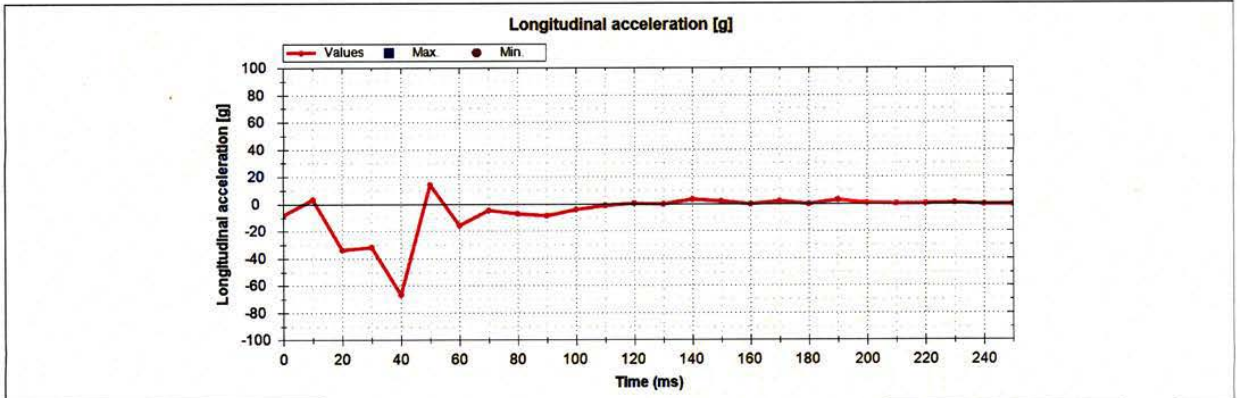
Longitudinal crash pulse_acceleration (g, 0 ~ 250msec)

Num	Time (ms)	Longitudinal acceleration [g]
1	0.0	-8.0
2	10.0	3.5
3	20.0	-33.5
4	30.0	-31.5
5	40.0	-66.5
6	50.0	14.5
7	60.0	-15.5
8	70.0	-4.5
9	80.0	-7.0
10	90.0	-8.5
11	100.0	-4.0
12	110.0	-1.0
13	120.0	0.5
14	130.0	0.0
15	140.0	3.5
16	150.0	2.0
17	160.0	0.0
18	170.0	2.0
19	180.0	0.0
20	190.0	3.0
21	200.0	1.0
22	210.0	0.5
23	220.0	0.5
24	230.0	1.0
25	240.0	0.0
26	250.0	0.0

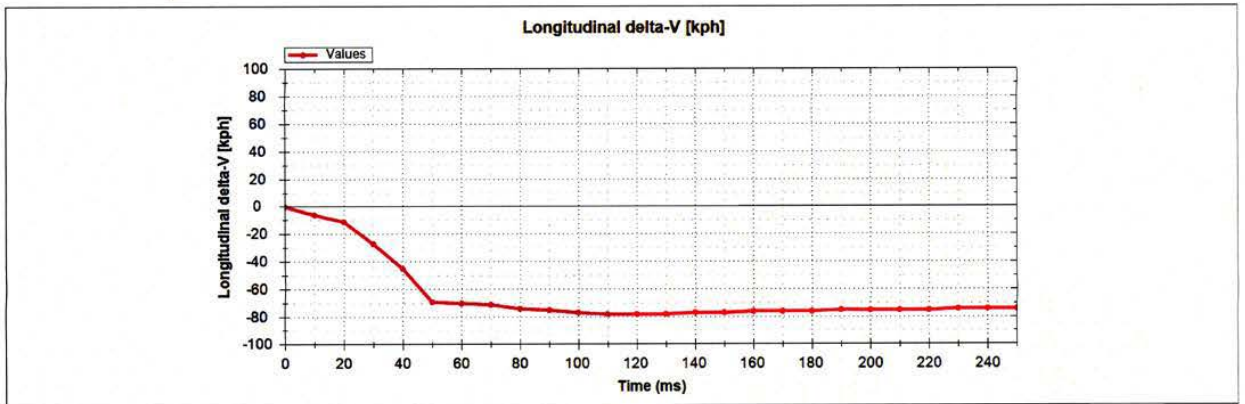
Longitudinal crash pulse_delta-v (kph, 0 ~ 250msec)

Max. delta-V [kph]	-78
Time, Max. delta-V [msec]	107.5

Num	Time (ms)	Longitudinal delta-V [kph]
1	0.0	0
2	10.0	-6
3	20.0	-11
4	30.0	-27
5	40.0	-45
6	50.0	-69
7	60.0	-70
8	70.0	-71
9	80.0	-74
10	90.0	-75
11	100.0	-77
12	110.0	-78
13	120.0	-78
14	130.0	-78
15	140.0	-77
16	150.0	-77
17	160.0	-76
18	170.0	-76
19	180.0	-76
20	190.0	-75
21	200.0	-75
22	210.0	-75
23	220.0	-75
24	230.0	-74
25	240.0	-74
26	250.0	-74

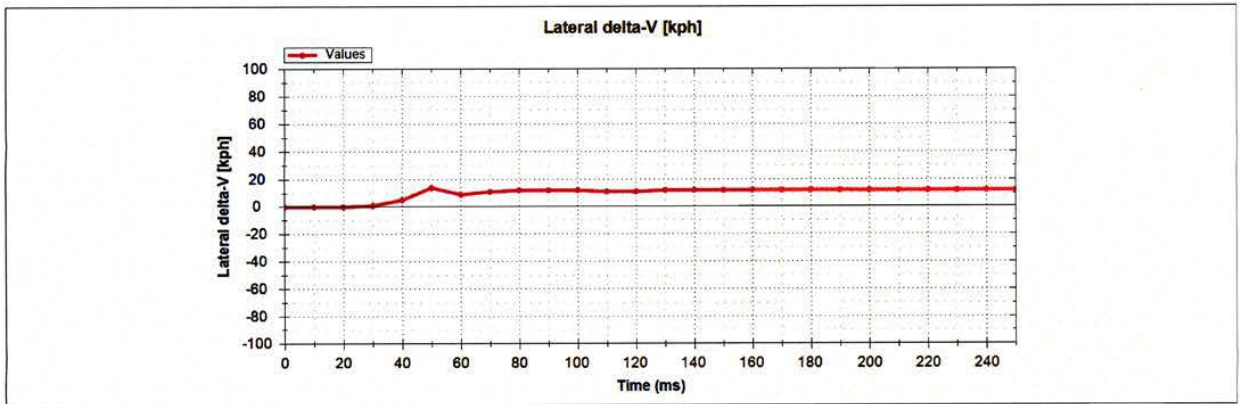
Lateral crash pulse_delta-v (kph, 0 ~ 250msec)

Max. delta-V [kph]	14
Time, Max. delta-V [msec]	47.5

Num	Time (ms)	Lateral delta-V [kph]
1	0.0	0
2	10.0	0
3	20.0	0
4	30.0	1
5	40.0	5
6	50.0	14
7	60.0	9
8	70.0	11
9	80.0	12
10	90.0	12
11	100.0	12
12	110.0	11
13	120.0	11
14	130.0	12
15	140.0	12
16	150.0	12
17	160.0	12
18	170.0	12
19	180.0	12
20	190.0	12
21	200.0	12
22	210.0	12
23	220.0	12
24	230.0	12
25	240.0	12
26	250.0	12
