DOT HS 812 970

# **Special Crash Investigations: On-Site Guardrail End Treatment Crash Investigation; Vehicle: 2012 Ford Escape; Location: Missouri; Crash Date: July 2016**

**Special Crash Investigations**  
**On-Site Guardrail End Treatment Crash Investigation**  
**Case Number: CR16018**  
**Vehicle: 2012 Ford Escape**  
**Location: Missouri**  
**Crash Date: July 2016**

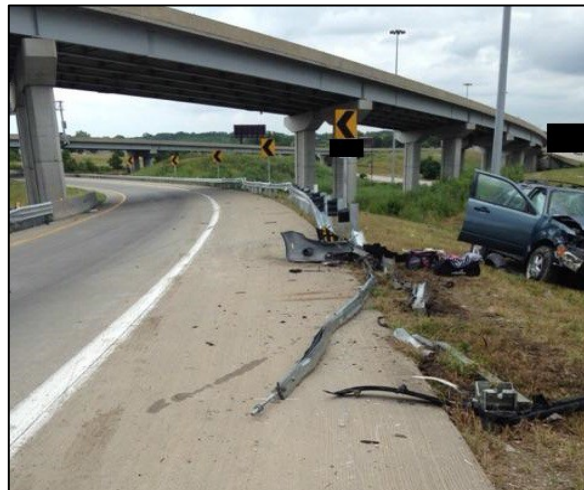
This report documents the on-site investigation of a Soft Stop end terminal during an impact with a 2012 Ford Escape (**Figure 1**). The crash was identified by the Missouri Department of Transportation (MoDOT), which in turn submitted notification to the Federal Highway Administration (FHWA). The FHWA determined that the crash type and end terminal met the criteria for further research and subsequently forwarded the notification to the Crash Investigation Division of the National Highway Traffic Safety Administration in July 2016. The CID assigned an on-site investigation of the crash to the Special Crash Investigations (SCI) team at Crash Research & Analysis, Inc. on the same day. The SCI team initiated contact and cooperation with MoDOT, and the on-site investigation took place in July 2016. The crash occurred when the Ford departed the gore area at a left-exit ramp from an interstate highway. The Ford struck a road sign during the maneuver and continued forward, then struck the end terminal with its front plane. The vehicle separated from that impact with a counterclockwise rotation and subsequently rolled over. The Ford was equipped with certified advanced 208-compliant (CAC) frontal air bags, front-seat-mounted, side-impact air bags, and inflatable curtain (IC) air bags. The frontal, front-row right-side impact, and both IC air bags deployed in the crash. The vehicle's unbelted 29-year-old male driver sustained police-reported A-level (incapacitating) injuries and an unbelted adult female (age unknown) seated in the front-row right position of the Ford sustained B-level (non-incapacitating) injuries. Both occupants were transported to a hospital for treatment.

**Figure 1.** North-looking view of the crash site and the Ford Escape. (Image supplied by MoDOT.)

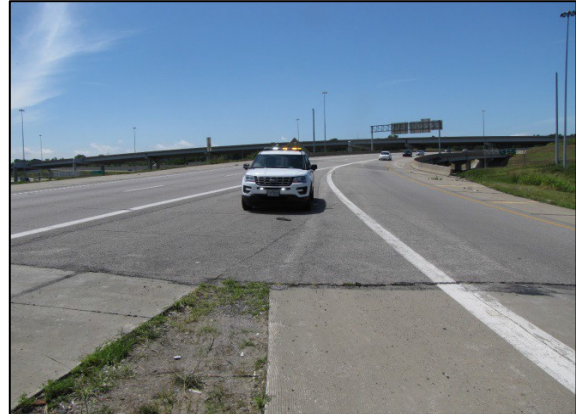
**Figure 2.** South-facing lookback view from the gore area created by the interstate and the left exit ramp.

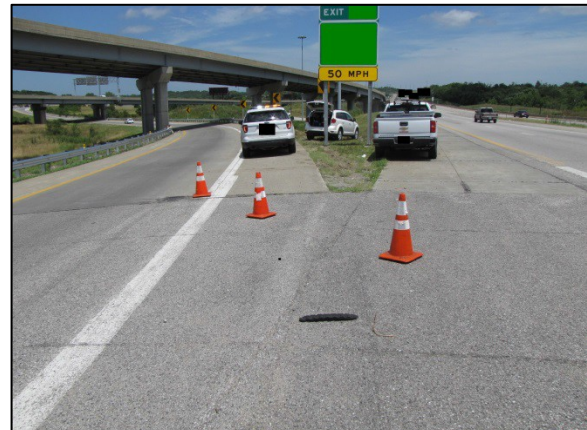
**Figure 4.** North-facing trajectory view of the Ford approximately 1-second prior to the crash.

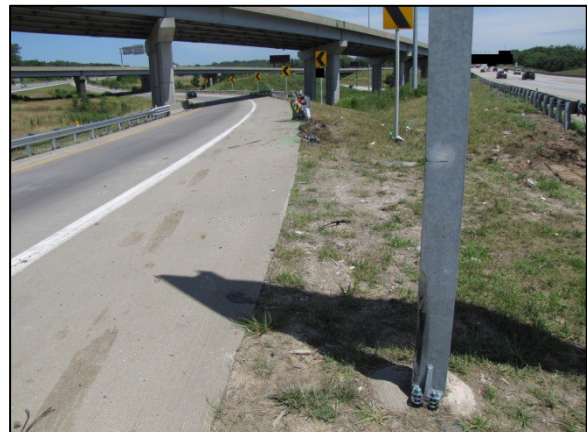
The right plane/forward aspect of the Ford struck the left vertical post of the exit sign (Event 1) at an EDR-reported speed of 108.0 km/h (67.1 mph). The breakaway sign post was constructed with a 3.0 m (10.0 ft) long I-beam fastened to a concrete base that was buried at ground level. Impact forces separate the post's connection to the concrete base and rotated the sign clockwise, out of the vehicle's path. A black transfer to the face of the I-beam evidenced the impact (**Figure 5**). This sign post was under repair at the time of the SCI scene inspection. The Ford's trajectory was not affected by its impact to the sign post. The vehicle's front right tire ran over the post attachment at the concrete base and subsequently aired out.

**Figure 5.** North-looking trajectory view of the Ford at impact with the exit sign post.

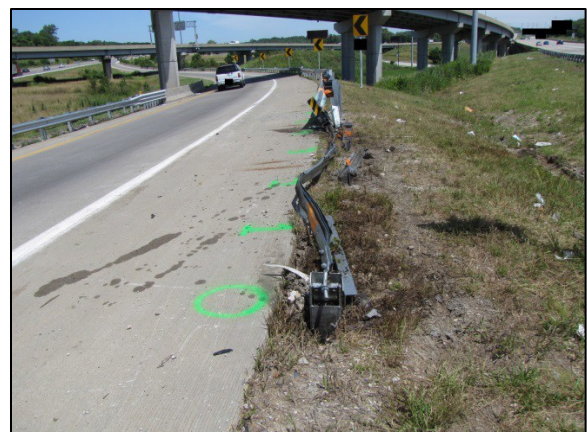
The Ford continued forward 9.1 m (29.9 ft) where its front plane struck the Soft Stop end terminal (**Figure 6**). The force of this impact (Event 2) displaced the end terminal approximately 8.1 m (26.3 ft) northward along the W-beam. During this displacement, the forward undercarriage of the Ford struck the raised structure at post 0 of the guardrail system, resulting in a fracture to the Ford's transmission case (Event 3).

**Figure 6.** North-facing trajectory view of the Ford at impact with the guardrail.

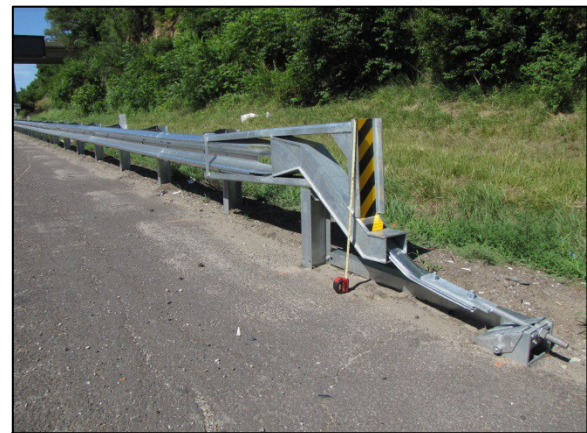
The Soft Stop end terminal was an energy absorbing end treatment used to terminate 79 cm (31 in) high W-beam guardrail (**Figure 8**). The Soft Stop installation consisted of a Soft Stop rail flattening head, Soft Stop anchor W-beam guardrail, anchor post (post 0), two steel yielding terminal posts (SYTP) at post locations 1 and 2, and six standard posts at post locations 3-8 that supported the W-beam with a composite

**Figure 8.** Image depicting an exemplar Soft Stop end terminal and guardrail located approximately 18 km (11 miles) west of the crash site.

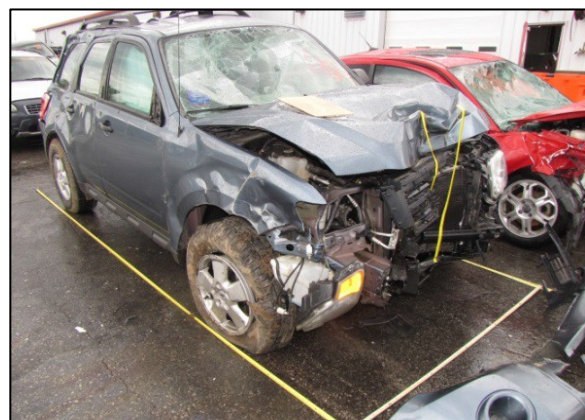
**Figure 12.** Front-right oblique view of the Ford.
