DOT HS 812 986

**Special Crash Investigations:  
Air Bag Non-Deployment Crash  
Investigation;  
Vehicle: 2014 Toyota Avalon;  
Location: Kansas;  
Crash Date: January 2019**

**Special Crash Investigations  
Air Bag Non-Deployment Crash Investigation  
Office of Defects Investigation  
Case Number: DS19011  
Vehicle: 2014 Toyota Avalon  
Location: Kansas  
Crash Date: January 2019**

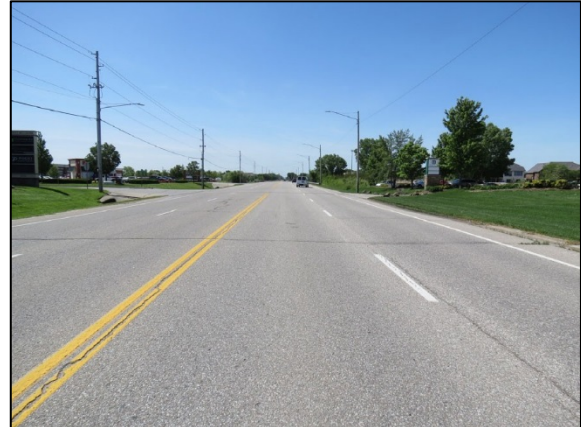
**Figure 2.** Southbound approach.

The Toyota was being driven southbound by a 53-year-old female at a driver-reported speed of 56 to 64 km/h (35 to 40 mph). The vehicle was in the second lane from the right (**Figure 2**) and was traveling behind a 2015 Lexus GX460 sport utility vehicle (SUV) driven by a 56-year-old male. The Lexus had stopped at the intersection in preparation for a left turn. A 2015 Chevrolet Cruze driven by a 62-year-old female was traveling northbound in the second lane from the right.

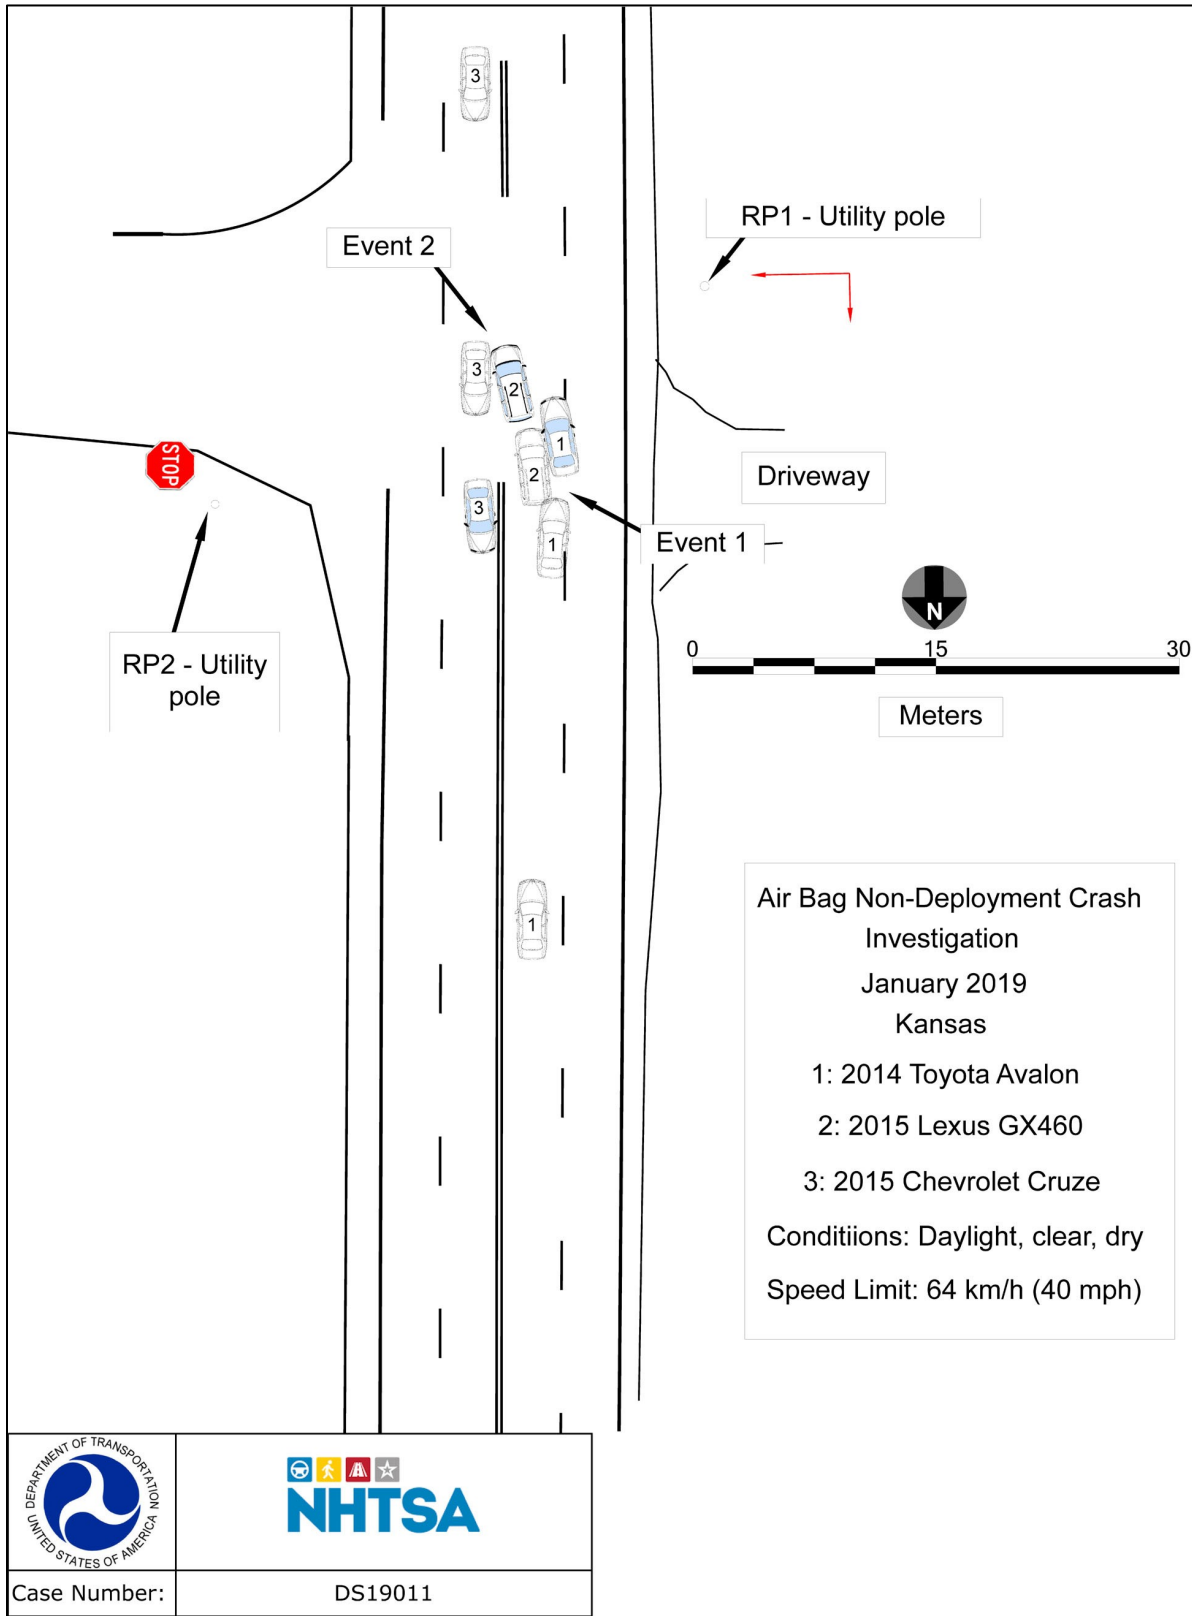
# CRASH DIAGRAM

The front plane of the Toyota struck the rear plane of the Lexus (Event 1). The “missing vehicle” algorithm of the WinSMASH program calculated a total delta V of 25 km/h (16 mph) for the Toyota. The longitudinal and lateral components were -25 km/h (-16 mph) and 0 km/h, respectively. The results fit the model but appear low. The WinSMASH program calculated a total delta V of 17 km/h (11 mph) for the Lexus. The longitudinal and lateral components were 17 km/h (11 mph) and 3 km/h (3 mph), respectively. The Lexus was displaced into the oncoming northbound lane, and the front plane of the Lexus struck the left plane of the Chevrolet (Event 2).
