DOT HS 813 037

**Special Crash Investigations:  
On-Site Frontal Air Bag  
Non-Deployment Crash  
Investigation;  
Vehicle: 2002 Chevrolet  
Trailblazer;  
Location: Pennsylvania;  
Crash Date: January 2016**

**Special Crash Investigations**  
**On-Site Frontal Air Bag Non-Deployment Crash Investigation**  
**Office Of Defects Investigation**  
**Case No.: CR16005**  
**Vehicle: 2002 Chevrolet Trailblazer**  
**Location: Pennsylvania**  
**Crash Date: January 2016**

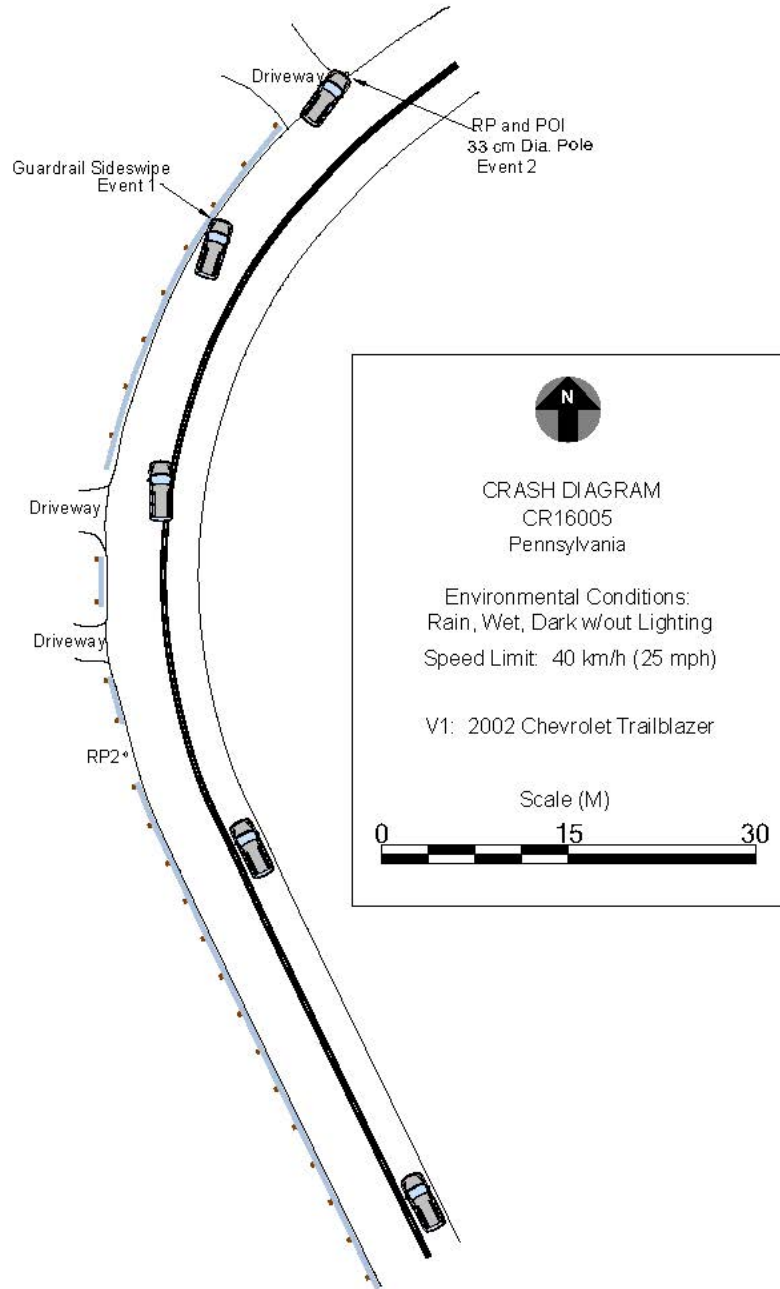
# CRASH DIAGRAM

The combination of the vehicle's speed that was too great for the roadway curvature and the driver's late steering maneuver resulted in the Chevrolet crossing the centerline and sideswiping the guardrail along the north roadside. This guardrail impact (Event 1) did not significantly displace the driver or cause injury. He probably remained in his upright seated position with his hands on the steering wheel rim as he attempted to regain control of the vehicle. The Chevrolet was redirected along the guardrail and struck a wooden utility pole (Event 2) with its front plane. The frontal air bag did not deploy during the crash event.
