DOT HS 813 043

**Special Crash Investigations:  
On-Site Passenger's Frontal Air  
Bag Inflator Rupture Crash and  
Fire Investigation;  
Vehicle: 2006 Nissan Sentra;  
Location: Florida;  
Crash Date: March 2018**

**Special Crash Investigations**  
**On-Site Passenger's Frontal Air Bag Inflator Rupture**  
**Crash and Fire Investigation**  
**Office of Defects Investigations**  
**Case Number: CR18025**  
**Vehicle: 2006 Nissan Sentra**  
**Location: Florida**  
**Crash Date: March 2018**

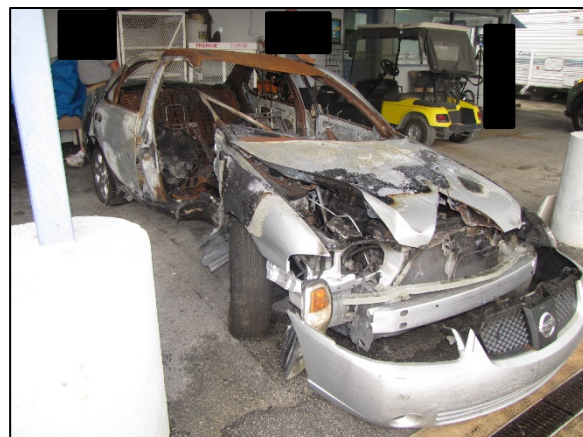
The 2006 Nissan Sentra 4-door sedan (**Figure 6**), identified by the VIN 3N1CB51D96Lxxxxxx, had an unknown date of manufacture. The Nissan was equipped with the special edition trim package. The powertrain consisted of a 1.8-liter, transverse-mounted, 4-cylinder, gasoline engine that was linked to a 4-speed automatic transmission with front-wheel drive. Standard

**Figure 6.** Right front oblique view of the Nissan.
