DOT HS 813 081

**Special Crash Investigations:
Guardrail End Terminal
Investigation;
Vehicle: 2000 Toyota Corolla;
Location: Missouri;
Crash Date: November 2018**

**Special Crash Investigations
Guardrail End Terminal Investigation
Case Number: DS18028
Vehicle: 2000 Toyota Corolla
Location: Missouri
Crash Date: November 2018**

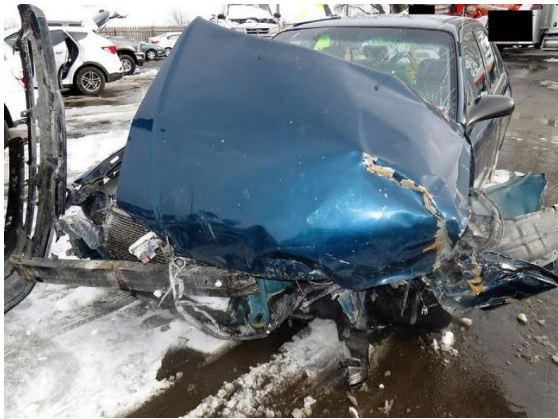
Figure 1. The 2000 Toyota Corolla

This report documents the on-site guardrail end terminal investigation of the SoftStop guardrail end terminal struck by a 2000 Toyota Corolla during a crash and the possible injuries sustained by the driver (Figure 1). The investigation was conducted on behalf of FHWA. The report is meant to document the damage of the guardrail end terminal. This case was initiated by the state transportation agency who notified the Federal Highway Administration (FHWA) of the crash. After reviewing the case and determining the guardrail end terminal qualified and the case was of interest, FHWA forwarded the notification along with on-scene images to the SCI group of the National Highway Traffic Safety Administration with instructions to deploy the SCI team. SCI assigned the case to Dynamic Science, Inc. in November 2018.
