DOT HS 813 085

**Special Crash Investigations:  
On-Site Vehicle Rollaway Crash  
Investigation;  
Vehicle: 2008 Pontiac G6;  
Location: Indiana;  
Crash Date: March 2018**

**Special Crash Investigations  
On-Site Vehicle Rollaway Crash Investigation  
Office of Defects Investigation  
Case Number: IN18007  
Vehicle: 2008 Pontiac G6  
Location: Indiana  
Crash Date: March 2018**

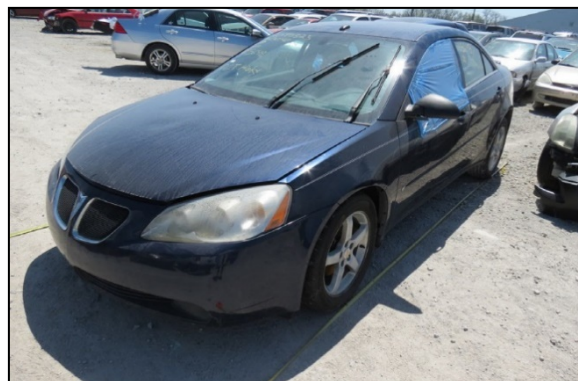
**Figure 1.** The 2008 Pontiac G6.

This report documents an on-scene investigation of a 2008 Pontiac G6 (**Figure 1**) that was involved in a rollaway incident. This incident investigation was initiated by the National Highway Traffic Safety Administration in April 2018 and assigned to the Special Crash Investigations (SCI) team at the Indiana University Transportation Research Center. The Pontiac G6 was the subject of a NHTSA recall involving the malfunction of transmission shift cables. The incident occurred in March 2018 in Indiana and was investigated by a local police department. The Pontiac was inspected in May 2018 in conjunction with the police investigator and an engineer from General Motors. A partial interview with one of the non-motorists was conducted in September 2018.

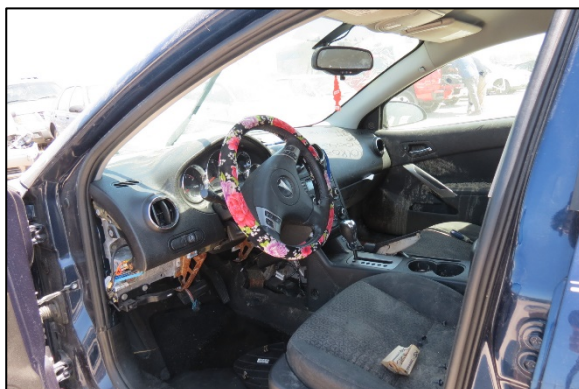
**Figure 4.** Left view of the Pontiac interior.

The interior of the Pontiac (**Figure 4**) was configured with front row bucket seats with a fixed center console and a second row bench seat for seating of three occupants. The transmission

The interior of the Pontiac was water-soaked due to the submergence. There was no deployment of the supplemental restraint systems or any damage.
