DOT HS 813 088

**Special Crash Investigations:
On-Site Air Bag Non-Deployment
Crash Investigation;
Vehicle: 2010 Chevrolet Cobalt;
Location: Arkansas;
Crash Date: May 2013**

Special Crash Investigations
On-Site Air Bag Non-Deployment Investigation
Office of Defects Investigation
Case Number: IN14015
Location: Arkansas
Vehicle: 2010 Chevrolet Cobalt
Crash Date: May 2013

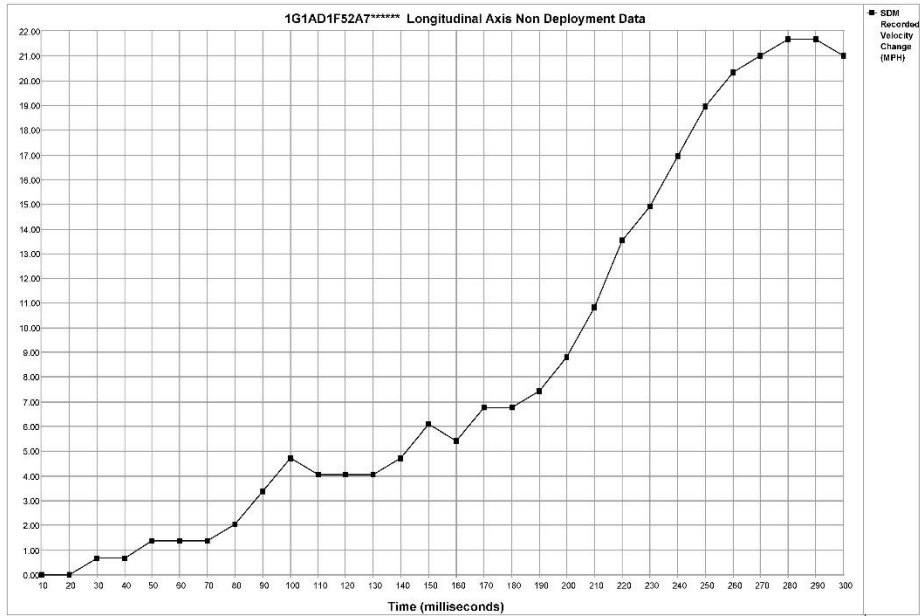
Time (milliseconds)	10	20	30	40	50	60	70	80	90	100	110	120	130	140	150
SDM Longitudinal Axis Recorded Velocity Change (MPH)	0.00	0.00	0.68	0.68	1.36	1.36	1.36	2.03	3.39	4.74	4.07	4.07	4.07	4.74	6.10
Time (milliseconds)	160	170	180	190	200	210	220	230	240	250	260	270	280	290	300
SDM Longitudinal Axis Recorded Velocity Change (MPH)	5.42	6.78	6.78	7.45	8.81	10.84	13.55	14.91	16.94	18.98	20.33	21.01	21.69	21.69	21.01

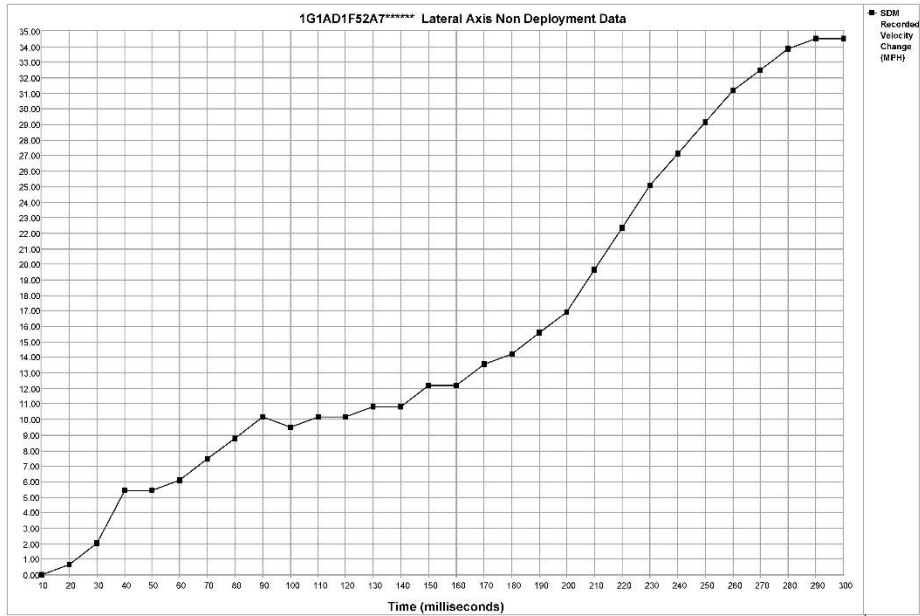
Time (milliseconds)	10	20	30	40	50	60	70	80	90	100	110	120	130	140	150
SDM Lateral Axis Recorded Velocity Change (MPH)	0.00	0.68	2.03	5.42	5.42	6.10	7.45	8.81	10.17	9.49	10.17	10.17	10.84	10.84	12.20
Time (milliseconds)	160	170	180	190	200	210	220	230	240	250	260	270	280	290	300
SDM Lateral Axis Recorded Velocity Change (MPH)	12.20	13.55	14.23	15.59	16.94	19.65	22.36	25.07	27.11	29.14	31.17	32.53	33.88	34.56	34.56
