DOT HS 813 090

**Special Crash Investigations:  
On-Site Non-Crash Vehicle  
Fire Investigation;  
Vehicle: 2017 Chevrolet Volt;  
Location: California;  
Incident Date: November 2018**

**Special Crash Investigations  
On-Site Non-Crash Vehicle Fire Investigation  
Office of Defects Investigation  
Case Number: DS18031  
Vehicle: 2017 Chevrolet Volt  
Location: California  
Incident Date: November 2018**

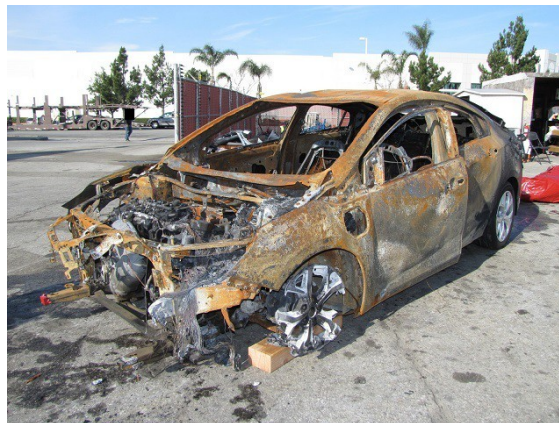
This report documents the investigation of a non-crash-related vehicle fire involving a 2017 Chevrolet Volt (Figure 1) that caught fire while traveling in extended range (combination battery and gas-engine power) mode. The investigation was intended to determine the cause of the fire, its area of origin, and to identify affected components. The investigation was initiated by the Office of Defects Investigation (ODI) group of the National Highway Traffic Safety Administration in response to a notification. The Special Crash Investigations (SCI) group assigned the case to Dynamic Science, Inc., in December 2018. The SCI team obtained the fire incident report and permission to inspect the vehicle. The inspection was completed in February 2019 with representatives from General Motors (GM) present. Based on the vehicle inspection by SCI and GM, and information provided by GM, the root cause of the fire was unknown.

*Figure 1. 2017 Chevrolet Volt*

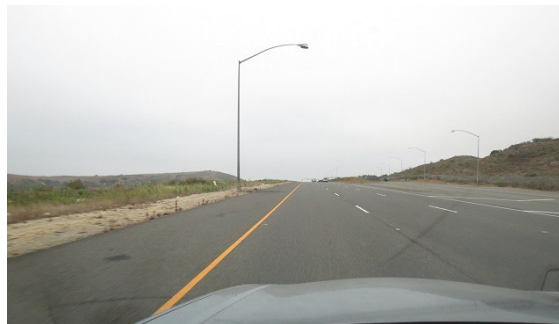
The incident site was a three-lane, southbound, divided State highway (Figure 2). The surface was asphalt, the lanes were separated by dashed white painted stripes, and the roadway was bordered by a solid yellow painted fog line on the left edge and a solid white painted fog line on the right. The roadway was configured with paved shoulders on the left and right edge, and a median divider on the left edge. The lanes measured 3.7 m (12.0 ft) in width. The section of roadway where the incident occurred was straight and level. Conditions at the time of the incident were daylight, clear, and dry. A weather history recorded at the nearest reporting station reported winds at 8-10 km/h (5-6 mph). The fire report estimated winds at the incident site were 16-24 km/h (10-15 mph) and gusting. The posted speed limit was 104 km/h (65 mph). An incident diagram is included at the end of this report.

*Figure 2. Incident site, looking south*
