DOT HS 813 126

**Special Crash Investigations:
On-Site Guardrail End Terminal
Crash Investigation;
Vehicle: 2006 Kia Sedona;
Location: Pennsylvania;
Crash Date: November 2018**

Special Crash Investigations
On-Site Guardrail End Terminal Crash Investigation
Case Number: CR18033
Vehicle: 2006 Kia Sedona
Location: Pennsylvania
Crash Date: November 2018

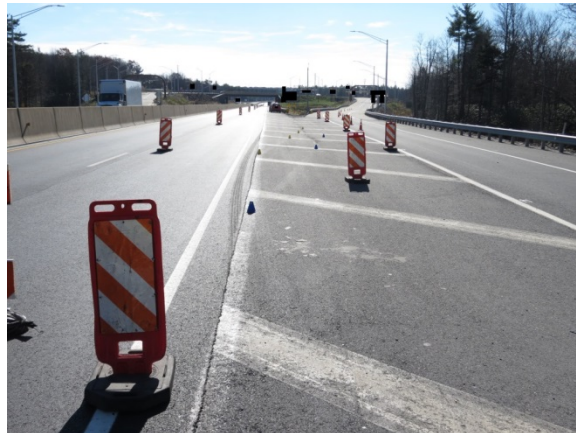
This guardrail crash occurred at night on a divided interstate highway. At the time of the crash, conditions reported by the National Weather Service included an ambient temperature of 7.7 °C (46 °F) with cloudy skies and 100-percent humidity. The winds were out of the north-northeast at 8 km/h (5 mph). Official records documenting the crash indicated that the road surface and environmental conditions were wet. The divided highway was oriented north/south (Figure 2) and consisted of two travel lanes in each direction, physically divided by a concrete jersey-style barrier. The southbound travel lanes each measured 3.5 m (11.5 ft) wide and were straight and level with a recently resurfaced bituminous asphalt surface. Lane delineation consisted of a broken white centerline with a solid yellow east edge line and a solid white west edge line. A narrow 0.7 m (2.3 ft) wide paved shoulder was present between the east edge line and the center barrier. In the vicinity of the crash, the 3.6 m (11.8 ft) wide west shoulder transitioned to an asphalt-surfaced triangular gore area that separated the southbound lanes from an exit ramp. The ramp curved to the right with respect to southbound traffic flow, resulting in an increasing width of the gore area. The surface of the ramp transitioned from new asphalt to a new concrete surface at the south end of the gore area. Loose stone extended beyond the gore and between the shoulders of the southbound lanes and the off-ramp.

Figure 2. Southbound trajectory view of the crash site

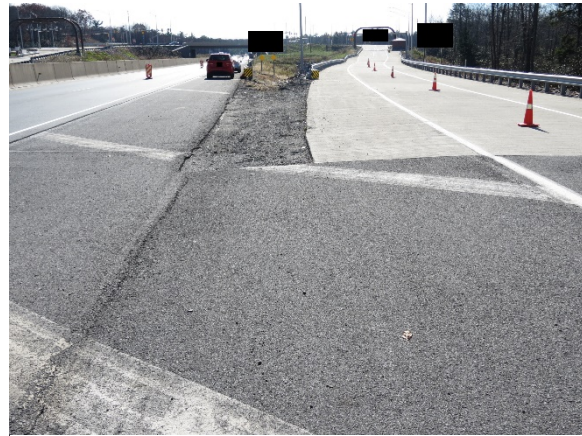
The tire marks faded as the driver probably released brake pedal pressure. The Kia continued south through the gore area for a distance of 39.0 m (128.0 ft) before it transitioned onto the loose stone and new concrete surfaces (Figure 4). The left-side tires entered the stone surface between the paved shoulders of the highway and the exit ramp, while the right-side tires traveled on the new concrete surface of the ramp. The Kia continued for an additional 31.0 m (101.7 ft) between the highway and exit ramp as it approached the SKT end terminal.

Figure 4. Southbound view of the Kia's approach to the guardrail impact

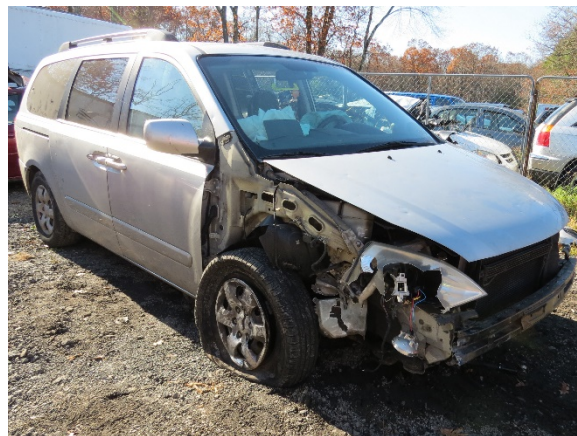
The 2006 Kia Sedona minivan (Figure 15), manufactured in May 2006, was identified by the VIN KNDMB233666xxxxxx. It was equipped with the LX trim package. At the time of the crash, the vehicle's odometer reading was 387,489 km (240,781 mi). The front-wheel-drive Kia was powered by a transverse-mounted, 3.8 liter, gasoline engine linked to a 5-speed automatic transmission with a forward-console-mounted shift lever. Additional features included power-assisted 4-wheel disc brakes with ABS and electronic brakeforce distribution, hydraulic speed-proportional power-assisted steering, a tire pressure monitoring system, electronic stability control, and traction control. The fuel system consisted of a high-density polyethylene tank mounted to the undercarriage forward of the rear axle with a left-plane-mounted fuel filler port, also located forward of the axle. There was no fuel leakage associated with this crash. The Kia's gross vehicle weight rating was 2,675 kg (5,898 lb), with gross axle weight ratings of 1,360 kg (2,998 lb) front and 1,390 kg (3,064 lb) rear. It was equipped with OEM steel wheels and polymer hubcaps. The Kia was configured with four different tires at the time of the crash; however, they were of the vehicle manufacturer recommended size of P225/70R16. The vehicle manufacturer recommended tire pressure was 240 kPa (35 PSI) at all four axle positions. Specific tire data were as follows:

Figure 15. Right front oblique view of the 2006 Kia Sedona at the time of the SCI inspection
