DOT HS 813 134

**Special Crash Investigations:
On-Site Alleged Air Bag Non-
Deployment Crash Investigation;
Vehicle: 2017 Kia Forte;
Location: Illinois;
Crash Date: July 2017**

Special Crash Investigations
On-Site Alleged Air Bag Non-Deployment Crash Investigation
Office of Defects Investigation
Case Number: CR18028
Vehicle: 2017 Kia Forte
Location: Illinois
Crash Date: July 2017

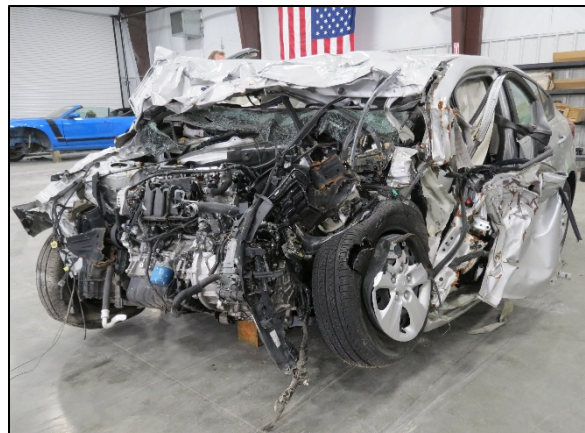
This report documents the on-site investigation of a head-on crash involving a 2017 Kia Forte (**Figure 1**) and a 2009 GMC Sierra 1500. A belted 37-year-old male driver and a belted 36-year-old male front row right passenger in the Kia sustained fatal injuries in the crash. A person reported the crash to the National Highway Traffic Safety Administration and alleged that the seat belt systems did not lock and that no air bags deployed. The Kia was equipped with a Certified Advanced 208-Compliant (CAC) frontal air bag system for the driver and front passenger positions, front seat-mounted and inflatable curtain (IC) side impact air bags, and front lower anchor and retractor pretensioners. Through the course of this SCI investigation, it was concluded that at the time of the crash, both Kia occupants were belted, all of the front lower anchor and retractor pretensioner systems actuated, and inflatable supplemental restraints deployed. This included the driver's and passenger's frontal air bags, the left IC air bag, and the left front-seat-mounted air bag. The allegations made by the person who reported the crash were inconsistent with the findings of this SCI investigation.

Figure 1. Front left oblique view of the 2017 Kia Forte.

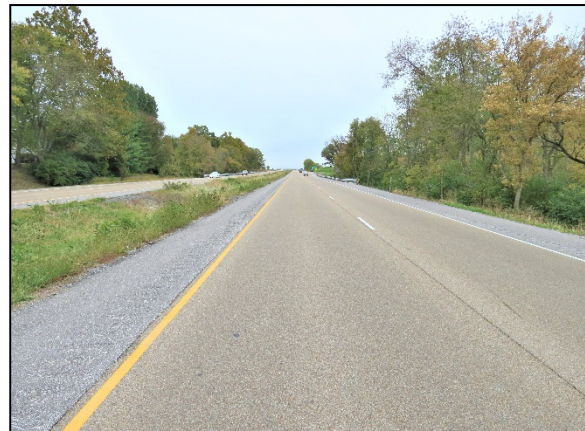
The limited-access roadway consisted of a westbound and eastbound portion, divided by a depressed grass median. The eastbound portion consisted of two travel lanes, delineated by a broken white center lane line; a single, solid yellow median line; and a single, solid white fog line. A 1.9 m (6.2 ft) shoulder supported the left lane along the median, while a 2.2 m (7.2 ft) wide shoulder supported the right lane. The left lane measured 3.7 m (12.1 ft) wide, and the right lane was 3.6 m (11.8 ft) wide. There were tactile rumble strips cut into each shoulder parallel to the solid lane markings. A W-beam guardrail system paralleled the right road edge along a ravine in the vicinity of the crash. Speed of traffic was regulated by a posted limit of 89 km/h (55 mph). **Figure 2** depicts an eastbound view of the roadway for the Kia's pre-crash approach trajectory. A crash diagram is included at the end of this technical report.

Figure 2. Eastbound view of the roadway for the Kia's pre-crash travel trajectory.

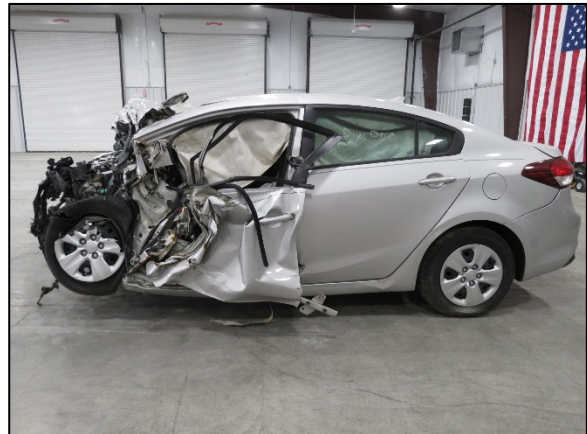
The Kia (**Figure 4**), manufactured in February 2017, was identified by the vehicle identification number (VIN) 3KPFK4A76HExxxxxx. It was a 4-door sedan built on a 270 cm (106.3 in) wheelbase with a 2.0 liter, inline, 4-cylinder gasoline engine. The Kia's electronic odometer reading could not be obtained during the SCI inspection due to electrical system inoperability and complete destruction of the instrument cluster. The Kia had a gross vehicle weight rating of 1,760 kg (3,880 lb). Front and rear axle ratings were 980 kg (2,161 lb) and 910 kg (2,006 lb), respectively. The curb weight was 1,272 kg (2,804 lb). Placarding on the frame of the left

Figure 4. Left plane view of the 2017 Kia Forte at the time of the SCI vehicle inspection.
