DOT HS 813 139

**Special Crash Investigations:
On-Site Driver Air Bag Inflator
Rupture Crash Investigation;
Vehicle: 2004 Honda Civic;
Location: Alabama;
Crash Date: March 2018**

Special Crash Investigations
On-Site Driver Air Bag Inflator Rupture Crash Investigation
Office of Defects Investigation
Case Number: CR18024
Vehicle: 2004 Honda Civic
Location: Alabama
Crash Date: March 2018

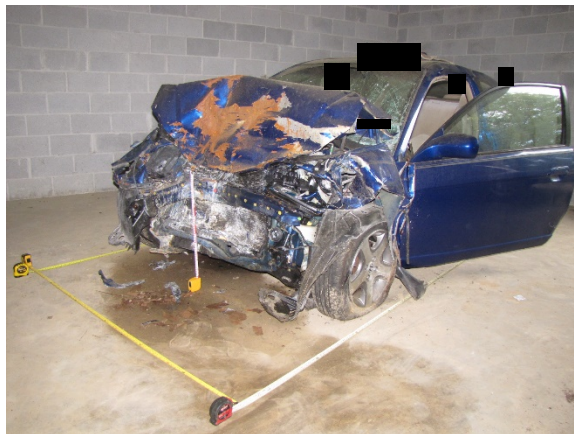
This report documents the investigation of the rupture of the driver's frontal air bag inflator in a 2004 Honda Civic (Figure 1) involved in a head-on crash with a 2017 Toyota Corolla in March 2018. The Honda had dual-stage driver and passenger frontal air bags. Impact forces deployed the Honda's driver's frontal air bag, which had an explosive rupture of its inflator that projected metallic fragments rearward into the occupant compartment, striking the belted 48-year-old male driver in the face. He sustained undetermined fatal injuries as a result of the crash. No autopsy was performed.

Figure 1. Left front oblique view of the Honda.

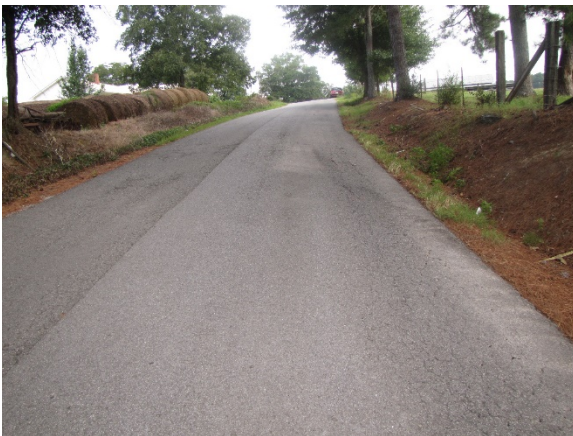
In the Honda's pre-crash northbound direction (Figure 2), there was a right curve, and the roadway had a positive grade of 5.9 percent. The radius of the curve measured 297 m (974.4 ft). The Toyota's pre-crash southbound direction (Figure 3) had a positive 4.2 percent grade and a shallow right curve that extended beyond the hillcrest. The radius of this curve measured 277 m (908.8 ft). At the hillcrest, the grade of the roadway rapidly changed. The point of impact was 58.4 m (191.6 ft) south of the hillcrest in the northbound lane.

Figure 2. Northbound pre-crash trajectory view for the Honda

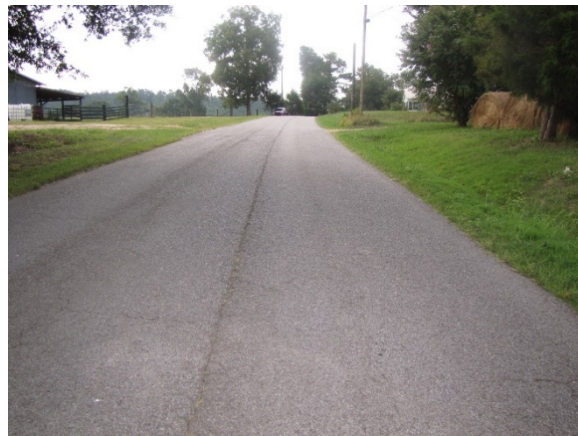
Figure 3. Southbound pre-crash trajectory view for the Toyota

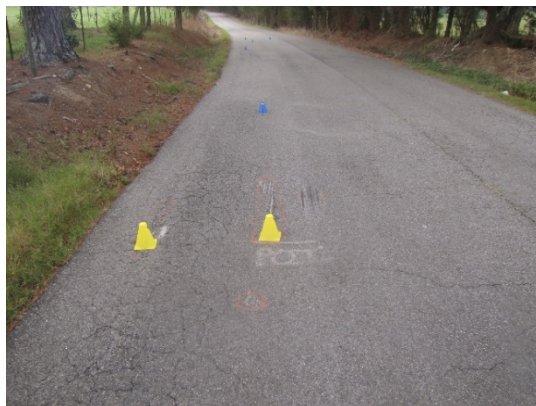
The front of the Toyota struck the front of the Honda (Event 1). The damage pattern of the Honda indicated that there was 100-percent overlap and an alignment of the vehicles' centers of mass. The EDR-recorded impact speed of the Toyota was 121.0 km/h (75.2 mph). Gouge marks in the northbound lane, highlighted by the yellow cones in Figure 4, evidenced the point of impact. The impact deployed the frontal air bag systems of both vehicles. The Honda's driver's air bag inflator ruptured during deployment. The seat belt pretensioners actuated; the front, side impact, and inflatable curtain air bags in the Toyota deployed.

Figure 4. South-facing image of the point of impact (the Toyota's perspective) in the northbound lane of the roadway

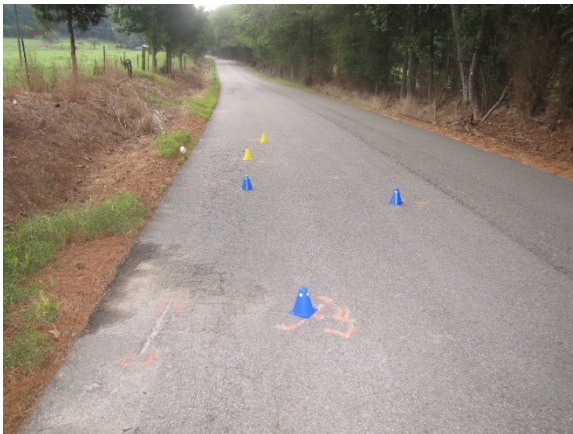
Figures 5 and 6 are the south-facing and north-facing views of the crash site showing the final rest locations of the vehicles. The three blue cones in the images denote the final rest locations of the Toyota's left front and rear tires. The yellow cones depict the final rest positions of the Honda's rear tires. An analysis of the severity of the crash (delta V) using the missing vehicle algorithm of the WinSMASH program calculated that the delta V of the Honda was 86 km/h (53 mph), and that the delta V of the Toyota was 80 km/h (50 mph). The calculated results were considered reasonable based on SCI experience.

Figure 5. South-facing view of the crash site (the Toyota's perspective) depicting the final rest locations of the vehicles

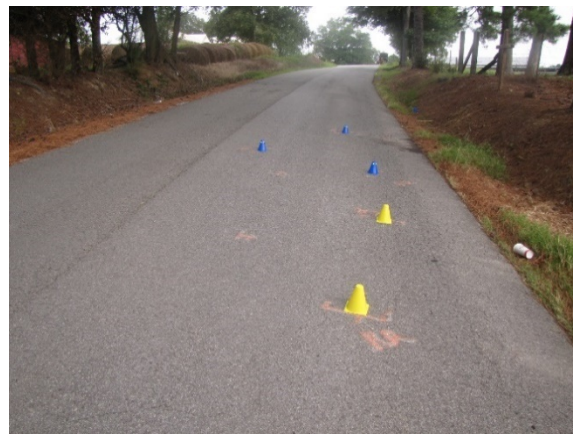
Figure 6. North-facing view of the crash site (the Honda's perspective) depicting the final rest locations of the vehicles

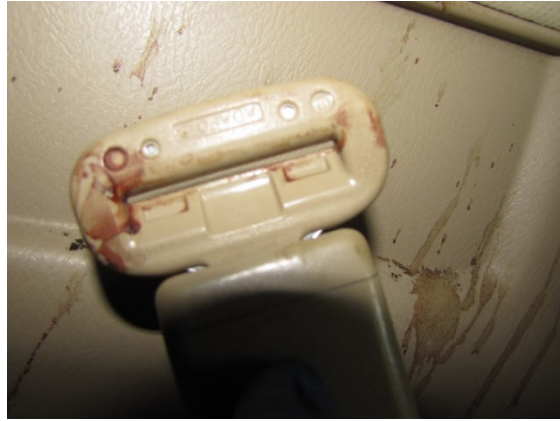
Figure 16. Image depicting the latch plate of the Honda driver's seat belt in the buckle receiver

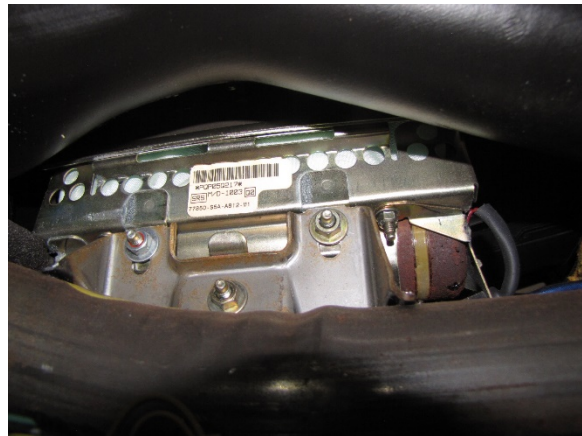
The passenger's frontal air bag module was a top-mount design located in the right instrument panel. This air bag deployed as designed (Figure 25). It was not tethered and was vented by two ports located on its side panels. The inspection of the air bag fabric was unremarkable. A label fixed to the module assembly (Figure 26) identified the module with the number PQP05Q217.

Figure 26. View of the Honda's passenger air bag module and its identification label

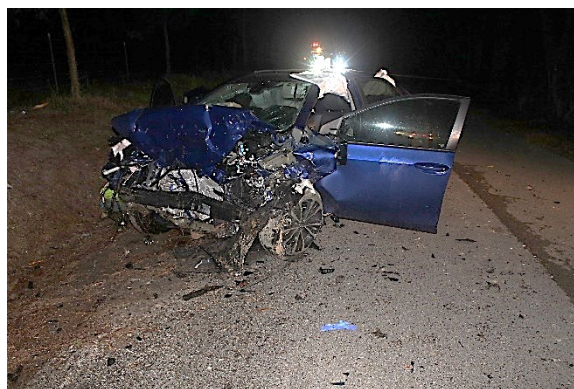
Figure 27. On-scene police image of the Toyota at its final rest position. Image provided by the police investigator

The Toyota was not available for inspection by SCI. A review of the on-scene images determined that the Toyota sustained moderate-to-severe frontal damage which extended across the entire width of the vehicle. The extent and width of damage were consistent with the dynamics of the impact. The CDC assigned to the damage pattern was 12FDEW3. The delta V calculated by the WinSMASH missing vehicle algorithm was 80 km/h (50 mph). The result was considered reasonable.
