DOT HS 813 155

December 2021

# **Special Crash Investigations: On-Site Driver Frontal Air Bag Non-Deployment Investigation; Vehicle: 2013 Chevrolet Impala; Location: Pennsylvania; Crash Date: January 2017**

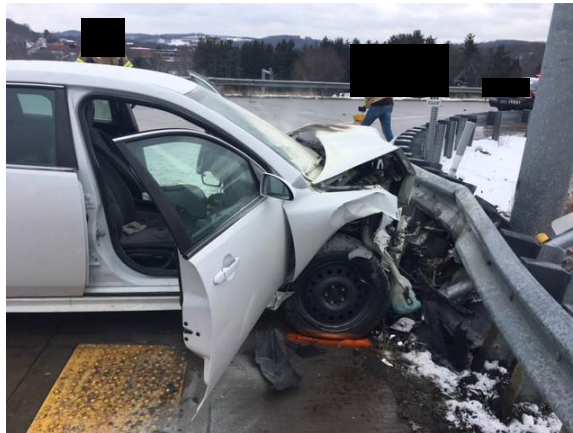
*Figure 1. On-scene police image of the Chevrolet at its final rest position*

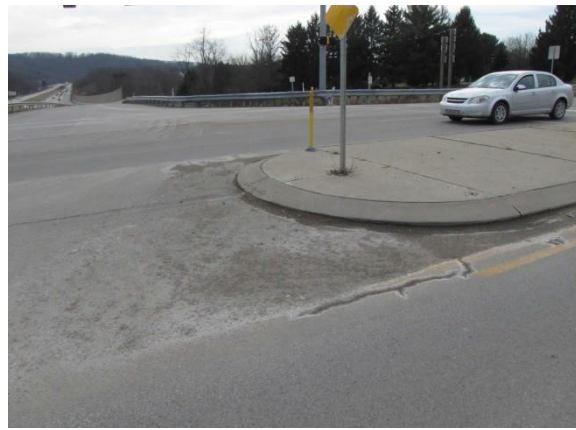
*Figure 5. Southwest-looking trajectory view of the Chevrolet at the median (Events 1 and 2). The location of the guardrail impact (Event 3) is in the background*

The Chevrolet overran the end of the median that divided the traffic lanes of the intersecting road (Figure 5) at a reconstructed speed of approximately 85 km/h (53 mph). The front plane struck and fractured the sign post located at the center of the median (Event 1). As the vehicle continued forward, the left-exterior mirror struck and was abraded by the polymer delineator (Event 2). Yellow/orange paint transfer to the exterior surface of the mirror's body evidenced the contact. The crash reconstruction timeline determined that these impact events occurred less than one second prior to AE.
