DOT HS 813 171

**Special Crash Investigations:
On-Site ET-Plus Guardrail End
Treatment Crash Investigation;
Vehicle: 2003 Nissan Maxima;
Location: Missouri;
Crash Date: April 2016**

Special Crash Investigations
On-Site ET-Plus Guardrail End Treatment Crash Investigation
Case Number: CR16013
Vehicle: 2003 Nissan Maxima
Location: Missouri
Crash Date: April 2016

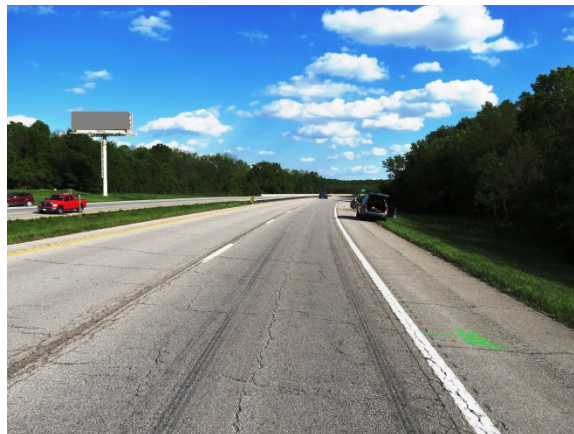
Both shoulders contained rumble strips adjacent to the shows travel lanes. Surfaces consisted of concrete shoulders and asphalt travel lanes. The roadway curved slightly to the right (Figure 2) with a radius of curvature of 860 m (2,822 ft). Along the curve, a guardrail adjacent to the south shoulder of the roadway provided protection for an upcoming overpass over a waterway. The guardrail began 110 m (360 ft) west of the overpass. It consisted of W-beam guardrail with steel I-beam posts and was installed with an ET-Plus end treatment system (see ET-Plus End Treatment and Guardrail section of this report). Speed was regulated by a posted limit of 105 km/h (65 mph). A crash diagram is included at the end of this technical report.

Figure 2. East-facing view of the Nissan's eastbound pre-crash travel trajectory on the divided roadway

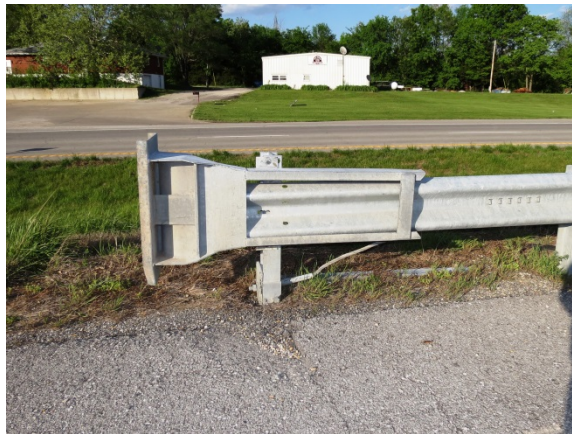
Figure 4. Image depicting an exemplar ET-Plus installation located on the opposite side of the roadway from the struck system

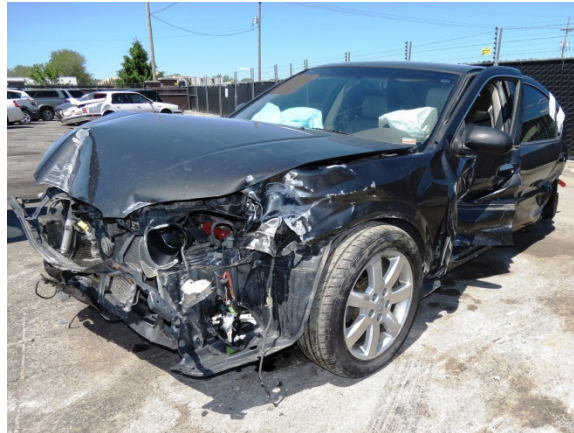
Figure 9. Front-left oblique view of the Nissan
