DOT HS 813 201

**Special Crash Investigations:
On-Site Alleged Brake Failure
Crash Investigation;
Vehicle: 2015 Nissan Rogue;
Location: Arizona;
Crash Date: October 2020**

Special Crash Investigations
On-Site Alleged Brake Failure Crash Investigation
Office of Defects Investigation
Case Number: DS20016
Vehicle: 2015 Nissan Rogue
Location: Arizona
Crash Date: October 2020

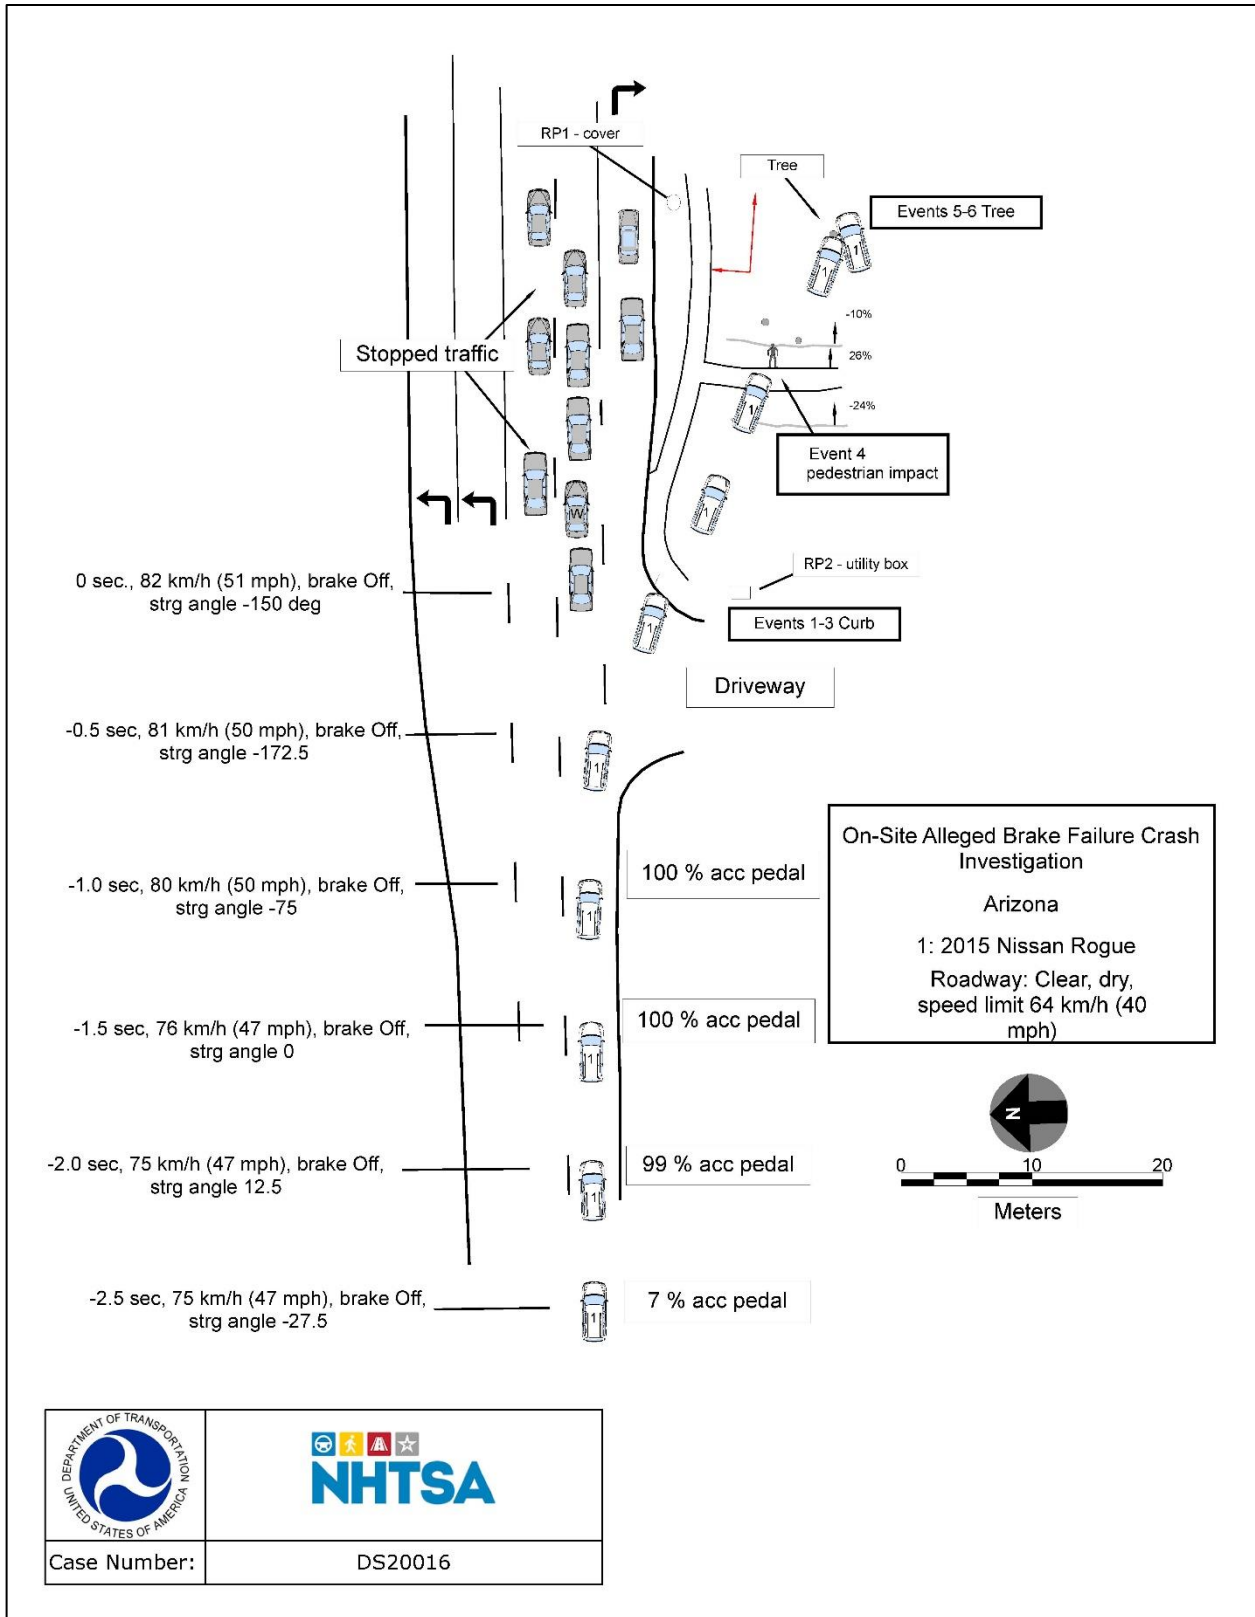
Crash Diagram

The 29-year-old male pedestrian was standing in the landscaped area between the main road and a parking lot. He was part of a three- or four-person landscaping crew and was actively trimming or cutting a tree. He was positioned east of the north/south sidewalk. The Nissan departed the roadway, traveled over the undulated terrain, crossed the sidewalk, and struck the pedestrian. The witness reported that he was struck directly in the abdominal area. He was displaced to the east and came to rest under the branches near the struck tree. He was initially cared for by a surgical nurse who was also a witness to the crash. He was then treated by the police and EMS before being transported to a local trauma center, where he was hospitalized for 16 days.

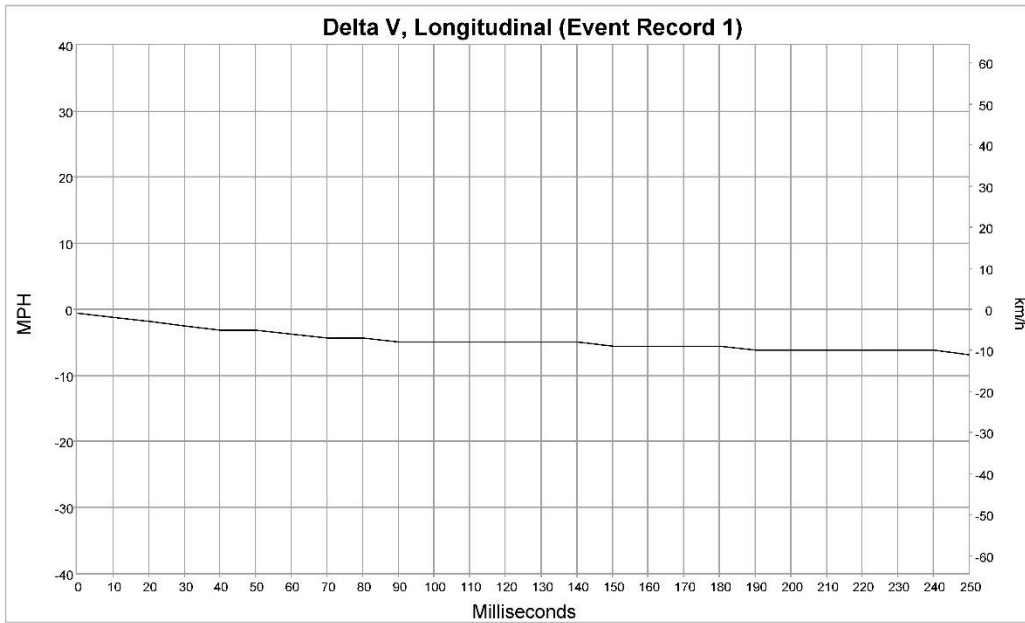
Longitudinal Delta V (Event Record 1)

Time (msec)	MPH [km/h]
0	-1 [-1]
10	-1 [-2]
20	-2 [-3]
30	-2 [-4]
40	-3 [-5]
50	-3 [-5]
60	-4 [-6]
70	-4 [-7]
80	-4 [-7]
90	-5 [-8]
100	-5 [-8]
110	-5 [-8]
120	-5 [-8]
130	-5 [-8]
140	-5 [-8]
150	-6 [-9]
160	-6 [-9]
170	-6 [-9]
180	-6 [-9]
190	-6 [-10]
200	-6 [-10]
210	-6 [-10]
220	-6 [-10]
230	-6 [-10]
240	-6 [-10]
250	-7 [-11]

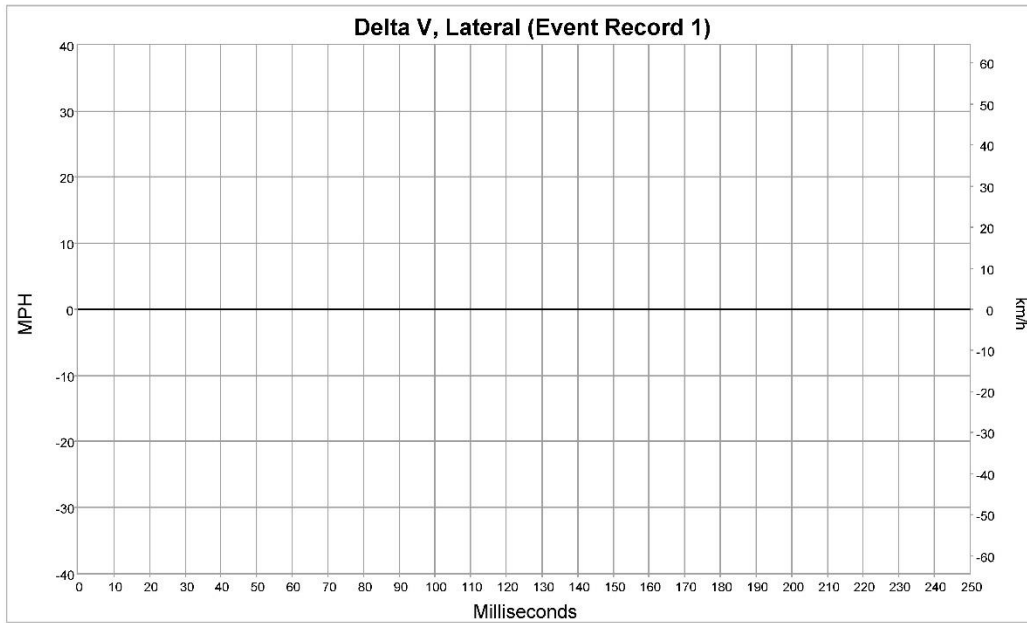
Lateral Delta V (Event Record 1)

Time (msec)	MPH [km/h]
0	0 [0]
10	0 [0]
20	0 [0]
30	0 [0]
40	0 [0]
50	0 [0]
60	0 [0]
70	0 [0]
80	0 [0]
90	0 [0]
100	0 [0]
110	0 [0]
120	0 [0]
130	0 [0]
140	0 [0]
150	0 [0]
160	0 [0]
170	0 [0]
180	0 [0]
190	0 [0]
200	0 [0]
210	0 [0]
220	0 [0]
230	0 [0]
240	0 [0]
250	0 [0]

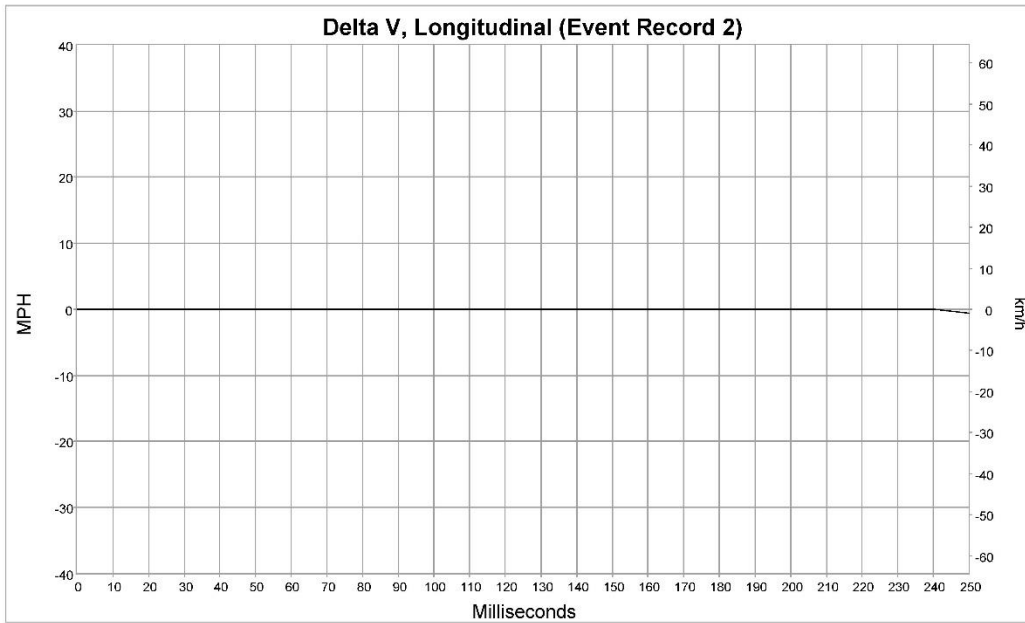
Longitudinal Delta V (Event Record 2)

Time (msec)	MPH [km/h]
0	0 [0]
10	0 [0]
20	0 [0]
30	0 [0]
40	0 [0]
50	0 [0]
60	0 [0]
70	0 [0]
80	0 [0]
90	0 [0]
100	0 [0]
110	0 [0]
120	0 [0]
130	0 [0]
140	0 [0]
150	0 [0]
160	0 [0]
170	0 [0]
180	0 [0]
190	0 [0]
200	0 [0]
210	0 [0]
220	0 [0]
230	0 [0]
240	0 [0]
250	-1 [-1]

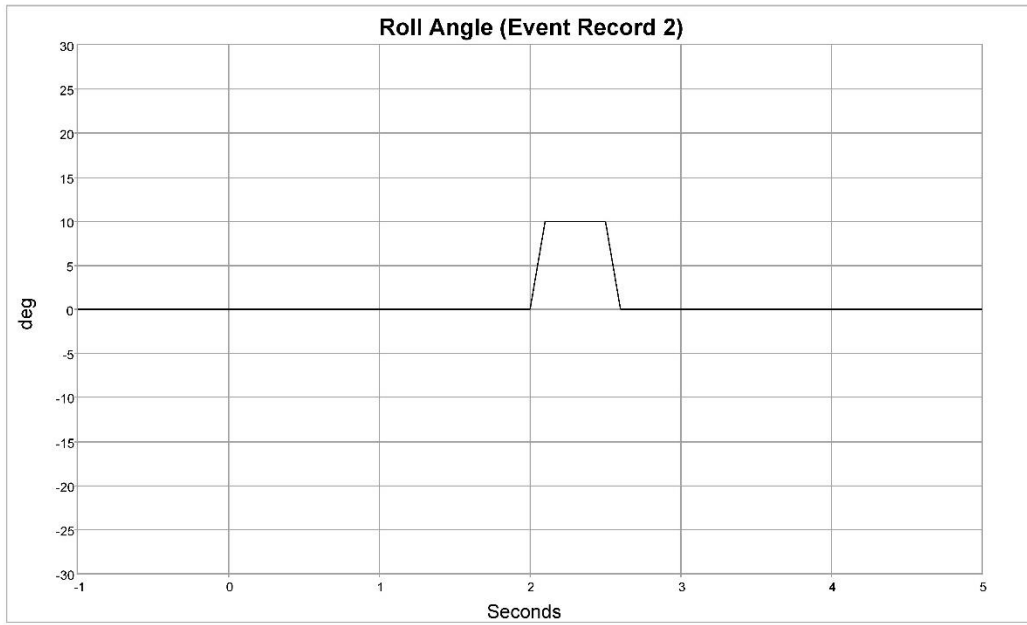
Roll Angle (Event Record 2)

Time (sec)	deg
-1.0	0
-0.9	0
-0.8	0
-0.7	0
-0.6	0
-0.5	0
-0.4	0
-0.3	0
-0.2	0
-0.1	0
0.0	0
0.1	0
0.2	0
0.3	0
0.4	0
0.5	0
0.6	0
0.7	0
0.8	0
0.9	0
1.0	0
1.1	0
1.2	0
1.3	0
1.4	0
1.5	0
1.6	0
1.7	0
1.8	0
1.9	0
