DOT HS 813 215

**Special Crash Investigations:
On-Site Air Bag Non-Deployment
Crash Investigation;
Vehicle: 2014 Chevrolet Traverse;
Location: New York;
Crash Date: November 2017**

Special Crash Investigations
On-Site Air Bag Non-Deployment Crash Investigation
Office of Defects Investigation
Case Number: CR17032
Vehicle: 2014 Chevrolet Traverse
Location: New York
Crash Date: November 2017

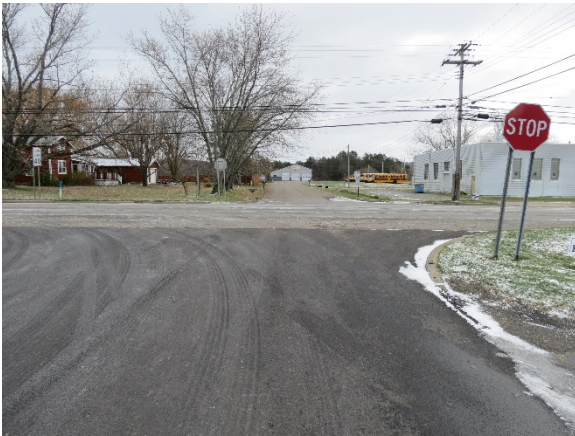
At the crash site, an east/west local road intersected a two-lane north/south State-maintained roadway. The local roadway measured 6.6 m (21.7 ft) in total width and had no painted lane markings. Stop signs controlled the traffic approaching the intersection (Figure 2) on the local roadway. A posted speed limit of 48 km/h (30 mph) regulated speed on the local roadway for the Chevrolet's approach to the intersection.

Figure 2. Eastbound trajectory view of the Chevrolet for the local roadway on approach to the intersection

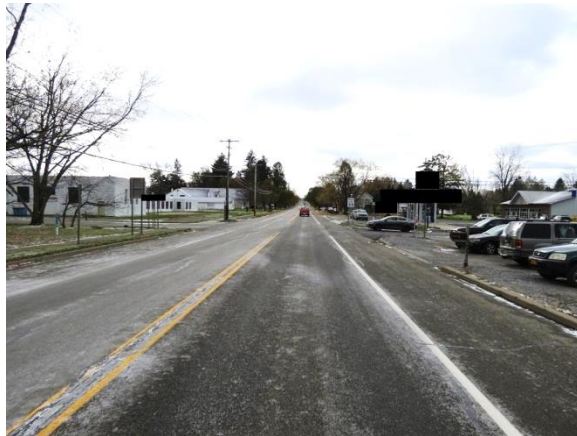
Figure 3. Southbound trajectory view of the Mack on the approach to the intersection

The State-maintained north/south roadway consisted of two travel lanes that measured 3.7 m (12.1 ft) in width and were separated by a double solid yellow centerline (Figure 3). Both lane edges were defined by solid white fog lines and supported by 3.0 m (9.8 ft) wide shoulders. Speed for southbound traffic on the State roadway (the Mack's pre-crash travel trajectory) changed from 64 km/h (40 mph) to 56 km/h (35 mph) at the intersection.

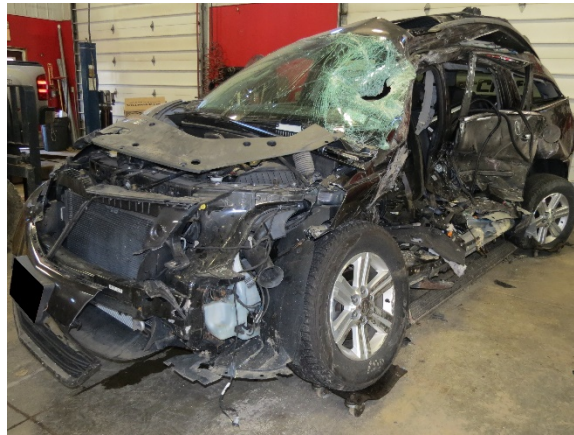
Figure 6. Left front oblique view of the 2014 Chevrolet Traverse at the time of the SCI vehicle inspection

The SUV (Figure 6) was configured on a 302 cm (118.9 in) wheelbase and had a curb weight of 2,197 kg (4,844 lb). The gross vehicle weight rating (GVWR) was 2,930 kg (6,459 lb), with gross axle weight ratings (GAWR) of 1,450 kg (3,196 lb) front and 1,600 kg (3,527 lb) rear. Standard features included electronic traction control, electronic stability control, electronic brakeforce distribution, a direct tire pressure monitoring system, and 4-wheel, power-assisted disc brakes with ABS. Additional exterior features included a full panoramic sun roof that consisted of two panels, one between the A- and B-pillar location and the other between the B- and C-pillar. Aftermarket step bars were mounted to the frame at the sill level. The vehicle manufacturer's recommended tire size was P255/65R18, with recommended cold tire pressures of 240 kPa (35 PSI). At the time of the crash, the Chevrolet was equipped with Goodyear Fortera all-season radial tires of the recommended size, mounted on OEM, 6-spoke, alloy wheels. Specific tire data at the time of the SCI inspection were as follows:

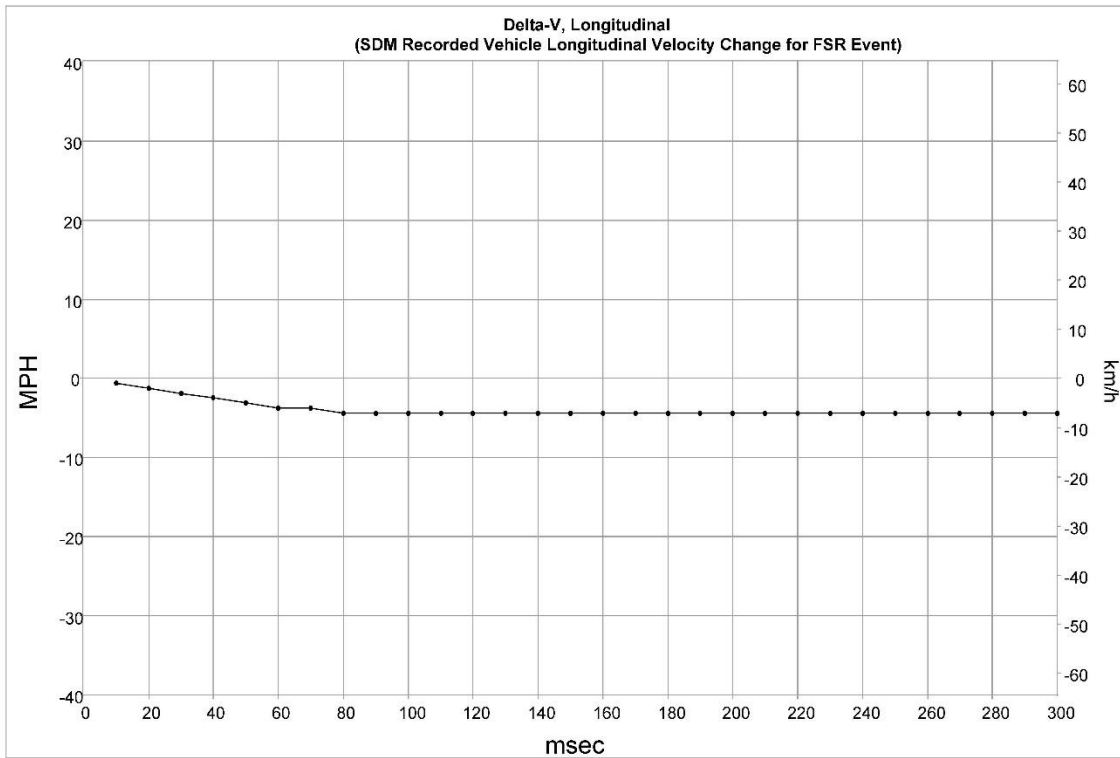
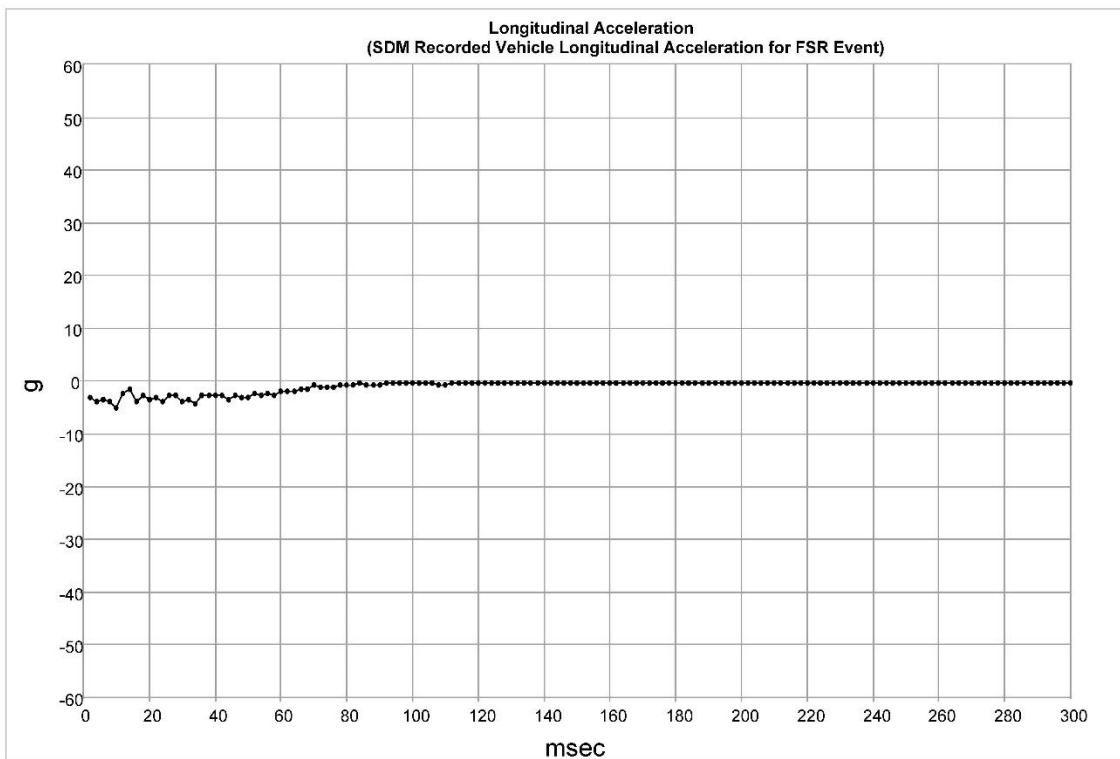
Longitudinal Crash Pulse (Event Record 1)

Time (msec)	Delta-V, Longitudinal (SDM Recorded Vehicle Longitudinal Velocity Change for FSR Event) (MPH)	Delta-V, Longitudinal (SDM Recorded Vehicle Longitudinal Velocity Change for FSR Event) (km/h)
10	-0.6	-1.0
20	-1.2	-2.0
30	-1.9	-3.0
40	-2.5	-4.0
50	-3.1	-5.0
60	-3.7	-6.0
70	-3.7	-6.0
80	-4.3	-7.0
90	-4.3	-7.0
100	-4.3	-7.0
110	-4.3	-7.0
120	-4.3	-7.0
130	-4.3	-7.0
140	-4.3	-7.0
150	-4.3	-7.0
160	-4.3	-7.0
170	-4.3	-7.0
180	-4.3	-7.0
190	-4.3	-7.0
200	-4.3	-7.0
210	-4.3	-7.0
220	-4.3	-7.0
230	-4.3	-7.0
240	-4.3	-7.0
250	-4.3	-7.0
260	-4.3	-7.0
270	-4.3	-7.0
280	-4.3	-7.0
290	-4.3	-7.0
300	-4.3	-7.0

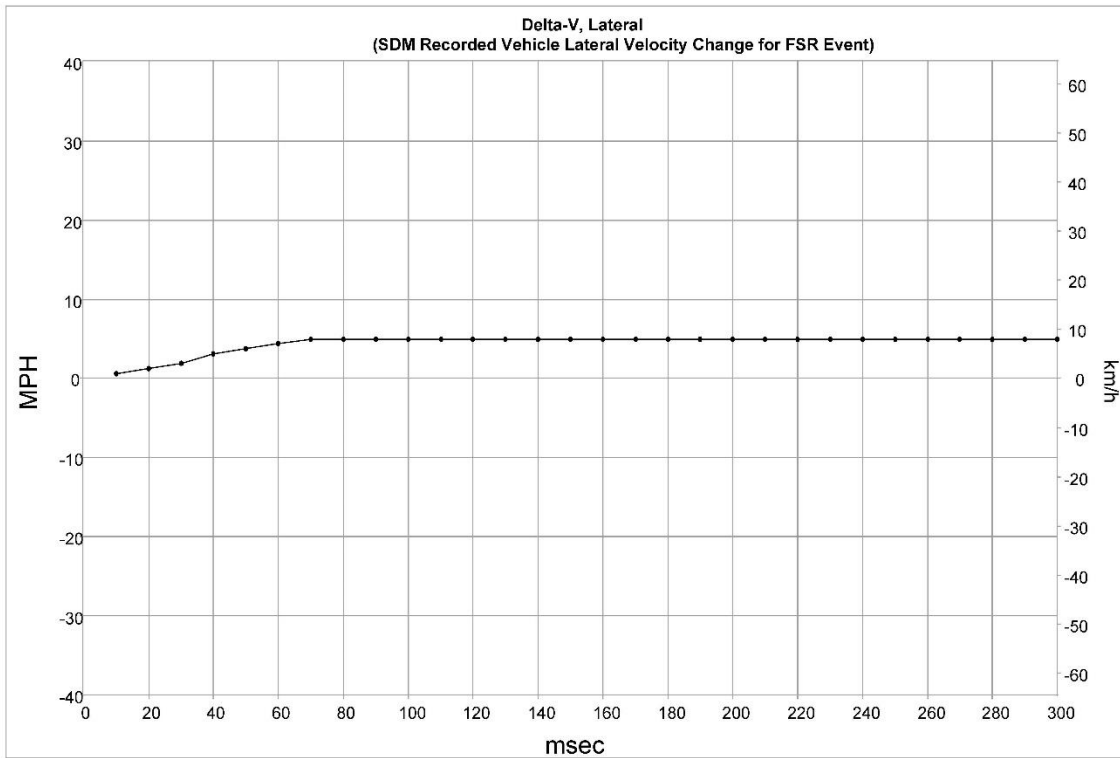
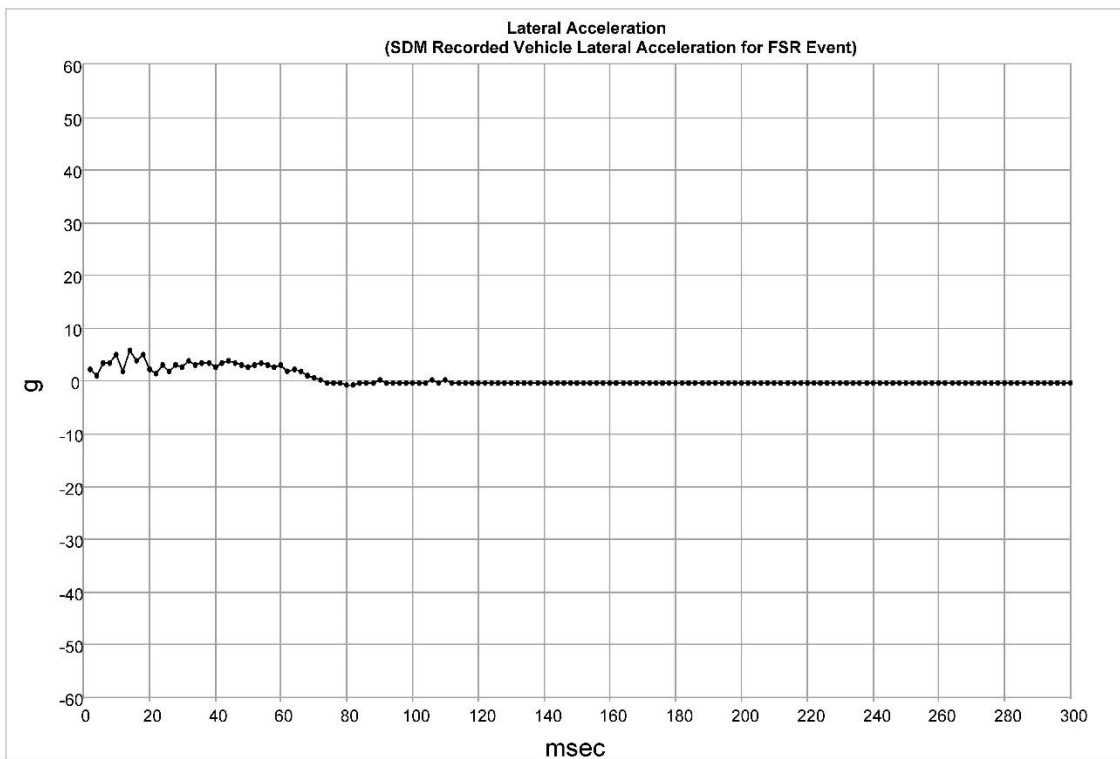
Lateral Crash Pulse (Event Record 1)

Time (msec)	Delta-V, Lateral (SDM Recorded Vehicle Lateral Velocity Change for FSR Event) (MPH)	Delta-V, Lateral (SDM Recorded Vehicle Lateral Velocity Change for FSR Event) (km/h)
10	0.6	1.0
20	1.2	2.0
30	1.9	3.0
40	3.1	5.0
50	3.7	6.0
60	4.3	7.0
70	5.0	8.0
80	5.0	8.0
90	5.0	8.0
100	5.0	8.0
110	5.0	8.0
120	5.0	8.0
130	5.0	8.0
140	5.0	8.0
150	5.0	8.0
160	5.0	8.0
170	5.0	8.0
180	5.0	8.0
190	5.0	8.0
200	5.0	8.0
210	5.0	8.0
220	5.0	8.0
230	5.0	8.0
240	5.0	8.0
250	5.0	8.0
260	5.0	8.0
270	5.0	8.0
280	5.0	8.0
290	5.0	8.0
300	5.0	8.0
