**National Highway
Traffic Safety
Administration**

DOT HS 813 222

**Special Crash Investigations:
On-Site Guardrail End Terminal
Crash Investigation;
Vehicle: 2007 Pontiac G5;
Location: Missouri;
Crash Date: January 2017**

Special Crash Investigations
On-Site Guardrail End Terminal Crash Investigation
Case Number: IN17010
Vehicle: 2007 Pontiac G5
Location: Missouri
Crash Date: January 2017

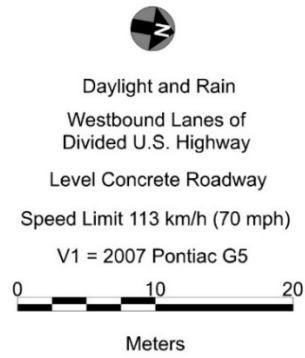
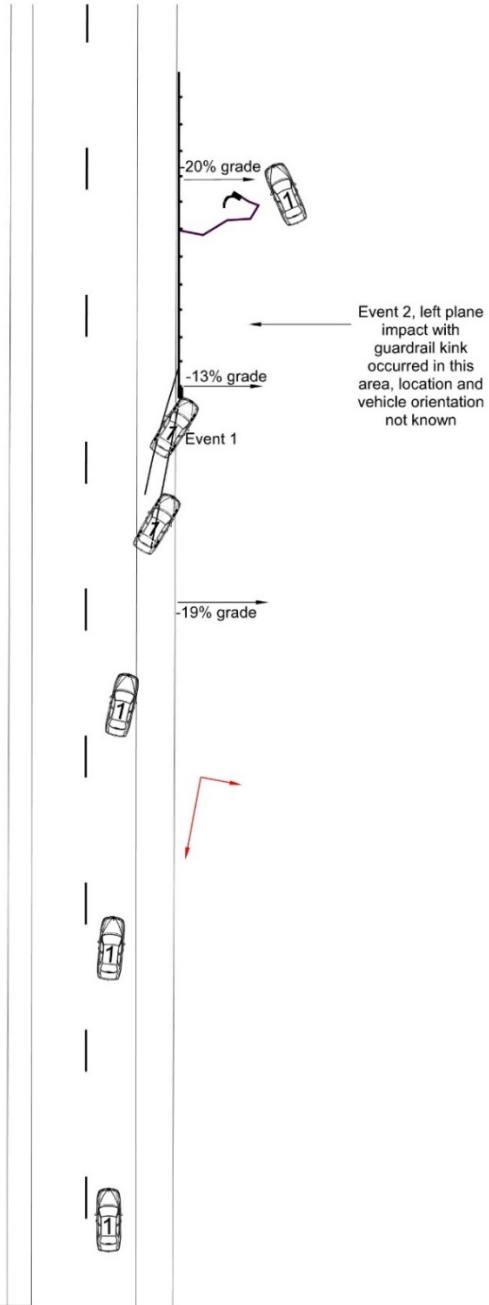
Crash Diagram

The driver was not restrained by the lap and shoulder safety belt. The seat track adjustment could not be determined since the seat was damaged and displaced during the crash. The crash scene evidence documented during the SCI inspection showed that the vehicle was in a clockwise rotation as it approached impact with the guardrail head. The driver was probably displaced to the left to some degree during this rotation. The front plane impact to the guardrail head resulted in deployment of the driver's frontal air bag. The driver was displaced forward and to the left and her face and chest probably loaded the frontal air bag. It is also likely that the left side of her body contacted the driver's door and her knees contacted the lower left instrument panel. The driver probably rebounded rearward and to the right and was then redirected to the left as the left plane of the vehicle struck a kink in guardrail. The left side of the driver's body probably contacted the left front door again. She was then redirected to the right by the intruded left front door, which contacted and damaged the driver's seat. The driver then probably contacted the right front door. The crash jammed the left front door shut and emergency responders used a hydraulic rescue tool to cut and remove the roof and both doors to extricate the driver from the vehicle. She sustained police reported "B" (non-incapacitating) injuries and was transported by ambulance to a hospital where her treatment status is unknown.

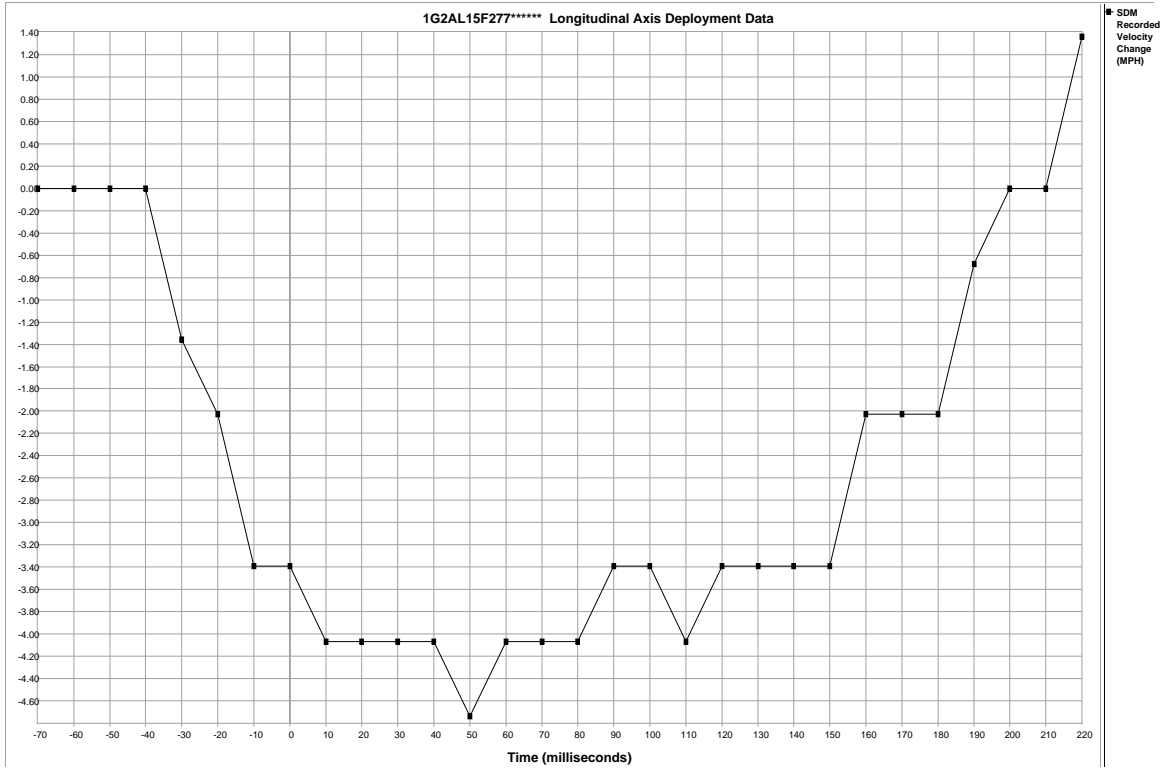
Time (milliseconds)	-70	-60	-50	-40	-30	-20	-10	0	10	20	30	40	50	60	70
SDM Longitudinal Axis Recorded Velocity Change (MPH)	0.00	0.00	0.00	0.00	-1.36	-2.03	-3.39	-3.39	-4.07	-4.07	-4.07	-4.07	-4.74	-4.07	-4.07
Time (milliseconds)	80	90	100	110	120	130	140	150	160	170	180	190	200	210	220
SDM Longitudinal Axis Recorded Velocity Change (MPH)	-4.07	-3.39	-3.39	-4.07	-3.39	-3.39	-3.39	-3.39	-2.03	-2.03	-2.03	-0.68	0.00	0.00	1.36

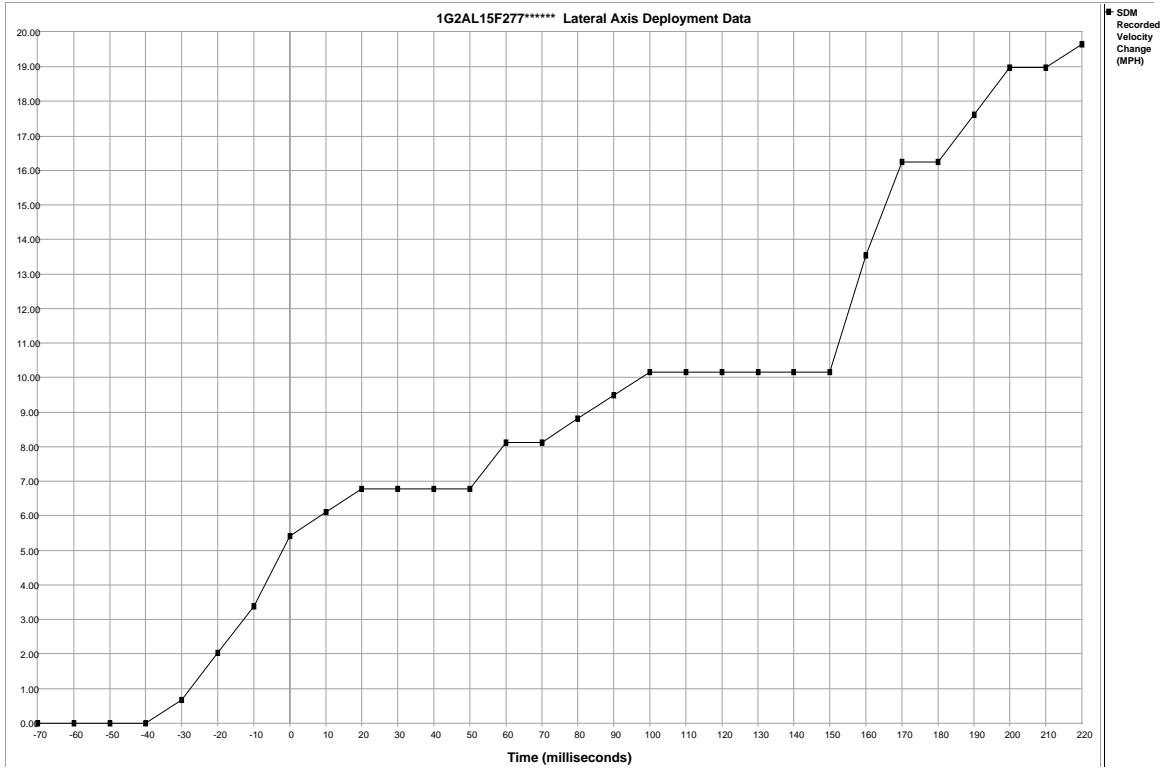
Time (milliseconds)	-70	-60	-50	-40	-30	-20	-10	0	10	20	30	40	50	60	70
SDM Lateral Axis Recorded Velocity Change (MPH)	0.00	0.00	0.00	0.00	0.68	2.03	3.39	5.42	6.10	6.78	6.78	6.78	6.78	8.13	8.13
Time (milliseconds)	80	90	100	110	120	130	140	150	160	170	180	190	200	210	220
SDM Lateral Axis Recorded Velocity Change (MPH)	8.81	9.49	10.17	10.17	10.17	10.17	10.17	10.17	13.55	16.26	16.26	17.62	18.98	18.98	19.65

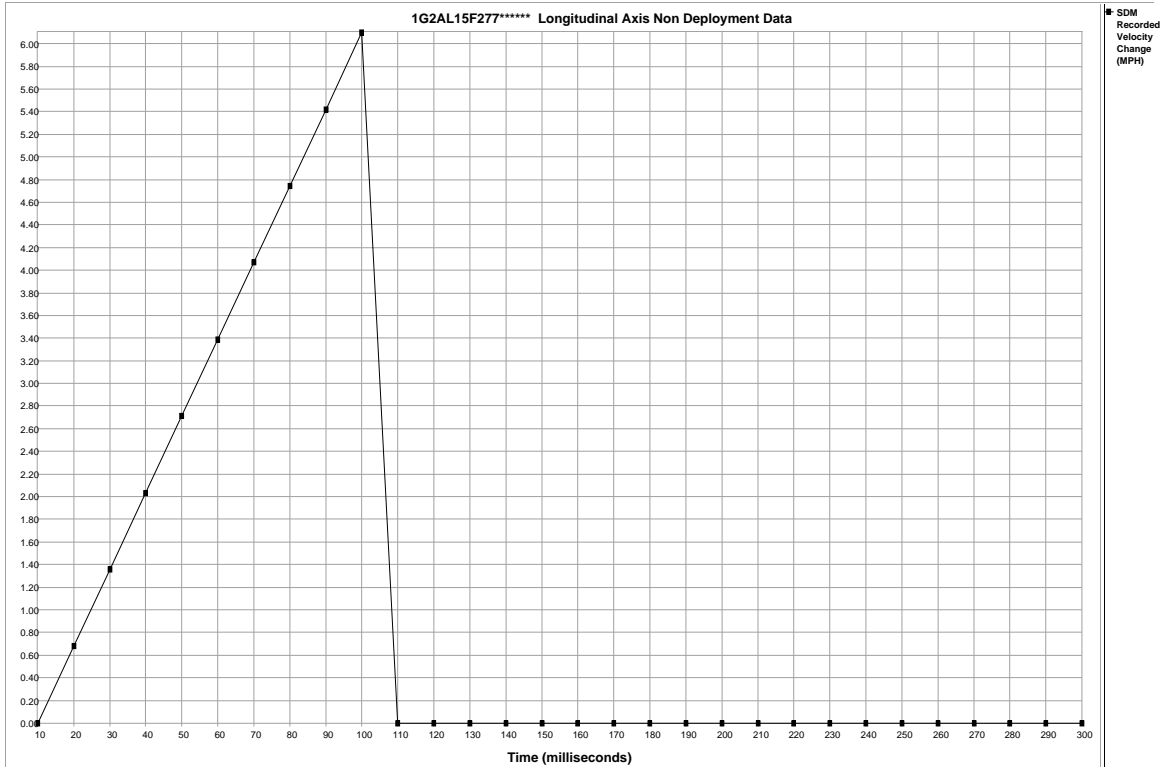
Time (milliseconds)	10	20	30	40	50	60	70	80	90	100	110	120	130	140	150
SDM Longitudinal Axis Recorded Velocity Change (MPH)	0.00	0.68	1.36	2.03	2.71	3.39	4.07	4.74	5.42	6.10	0.00	0.00	0.00	0.00	0.00
Time (milliseconds)	160	170	180	190	200	210	220	230	240	250	260	270	280	290	300
SDM Longitudinal Axis Recorded Velocity Change (MPH)	0.00	0.00	0.00	0.00	0.00	0.00	0.00	0.00	0.00	0.00	0.00	0.00	0.00	0.00	0.00

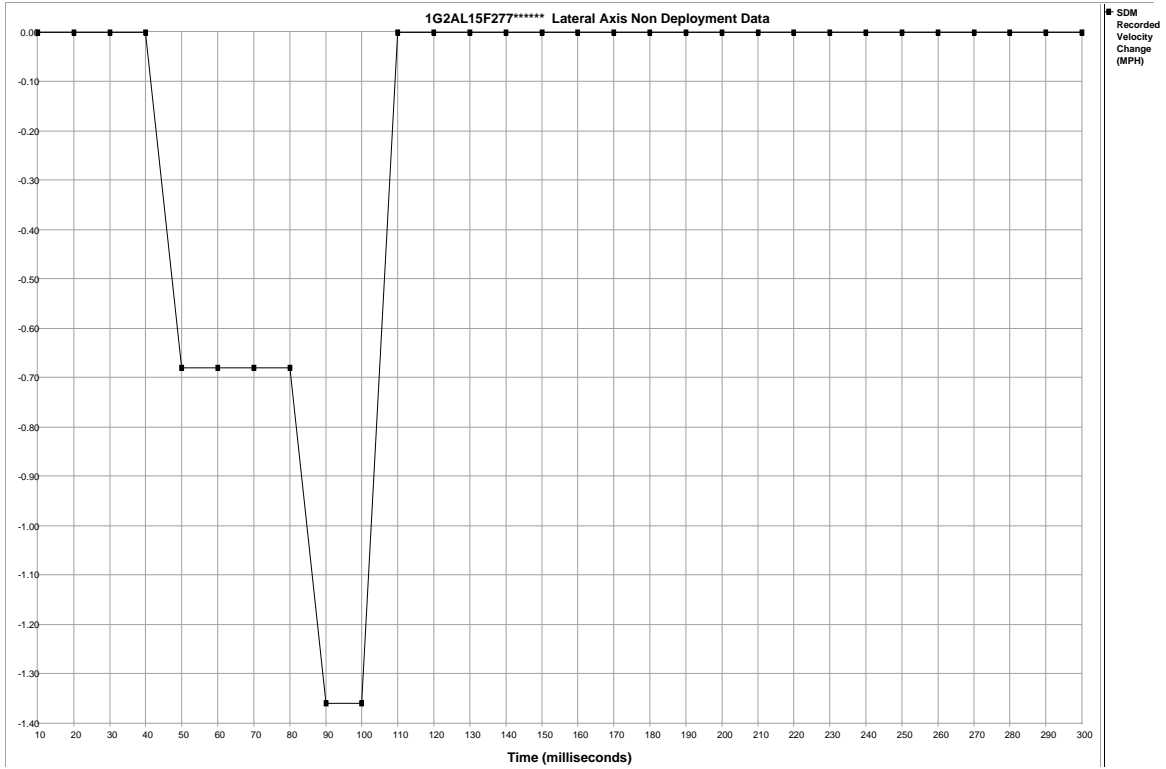
Time (milliseconds)	10	20	30	40	50	60	70	80	90	100	110	120	130	140	150
SDM Lateral Axis Recorded Velocity Change (MPH)	0.00	0.00	0.00	0.00	-0.68	-0.68	-0.68	-0.68	-1.36	-1.36	0.00	0.00	0.00	0.00	0.00
Time (milliseconds)	160	170	180	190	200	210	220	230	240	250	260	270	280	290	300
SDM Lateral Axis Recorded Velocity Change (MPH)	0.00	0.00	0.00	0.00	0.00	0.00	0.00	0.00	0.00	0.00	0.00	0.00	0.00	0.00	0.00
