DOT HS 813 235

**Special Crash Investigations:
On-Site Steering Malfunction
Crash Investigation;
Vehicle: 2010 Nissan Versa;
Location: Colorado;
Crash Date: February 2020**

**Special Crash Investigations
On-Site Steering Malfunction Crash Investigation
Office of Defects Investigation
Case Number: DS20006
Vehicle: 2010 Nissan Versa
Location: Colorado
Crash Date: February 2020**

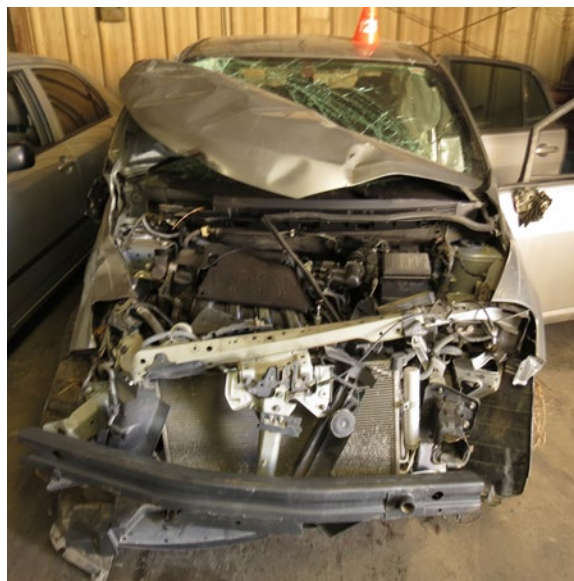
Figure 1. The 2010 Nissan Versa

This report documents the on-site investigation of a single-vehicle rollover crash of a 2010 Nissan Versa with a steering malfunction (Figure 1). The vehicle inspection documented the vehicle damage, the restraint systems, and the steering wheel/column assembly. This investigation was initiated by the Office of Defects Investigation (ODI) group of the National Highway Traffic Safety Administration in response to a police-reported possible steering malfunction. The Special Crash Investigations (SCI) group assigned the case to Dynamic Science, Inc., in March 2020. The inspection was originally scheduled for April 2020 but was rescheduled due to COVID-19 travel restrictions. The vehicle inspection was conducted in November 2020 at a secure storage location. The steering wheel had been removed and placed into evidence by the investigating police agency. The steering wheel was inspected at the police agency and taken into SCI's possession. It has since been shipped to the ODI group for further analysis. A representative from Nissan was present during the inspections. The vehicle was not supported by the Bosch Crash Data Retrieval system. The Nissan representative was able to extract diagnostic data from the vehicle during the inspection. He was not able to extract any crash/pre-crash data during the inspection from the vehicle's Event Data Recorder (EDR) but was able to extract the data from the vehicle during a follow-up visit. The EDR data, provided to SCI, are included as Appendix A at the end of this report.

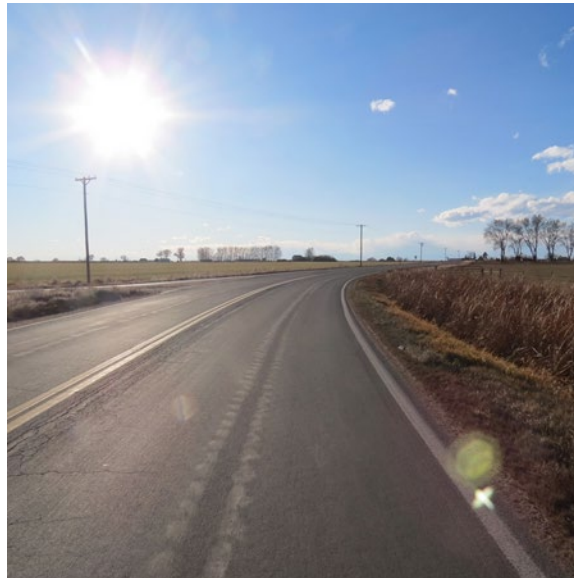
Figure 2. Westbound approach

The crash site was a curved two-lane county highway that transitions from a north/south roadway to an east/west roadway. The curve radius was approximately 277 m (910 ft) near the exit to the east/west roadway (Figure 2). The asphalt roadway was clear and dry. The critical speed of the curve in this area was calculated to be 170 km/h (106 mph). The roadway was level near the area of departure with a superelevation of 1.5 percent. The travel lanes were marked with a solid double yellow centerline and solid white fog lines. The roadway was bordered on the south by a drainage ditch. The ditch was located approximately 3 m (10 ft) south of the roadway and had a grade that varied between 10 and 15 degrees. The posted speed limit was 89 km/h (55 mph). The weather at the nearest reporting station was -5.5 °C (22 °F), 92 percent humidity, light winds, and cloudy. A crash diagram is included at the end of this report.

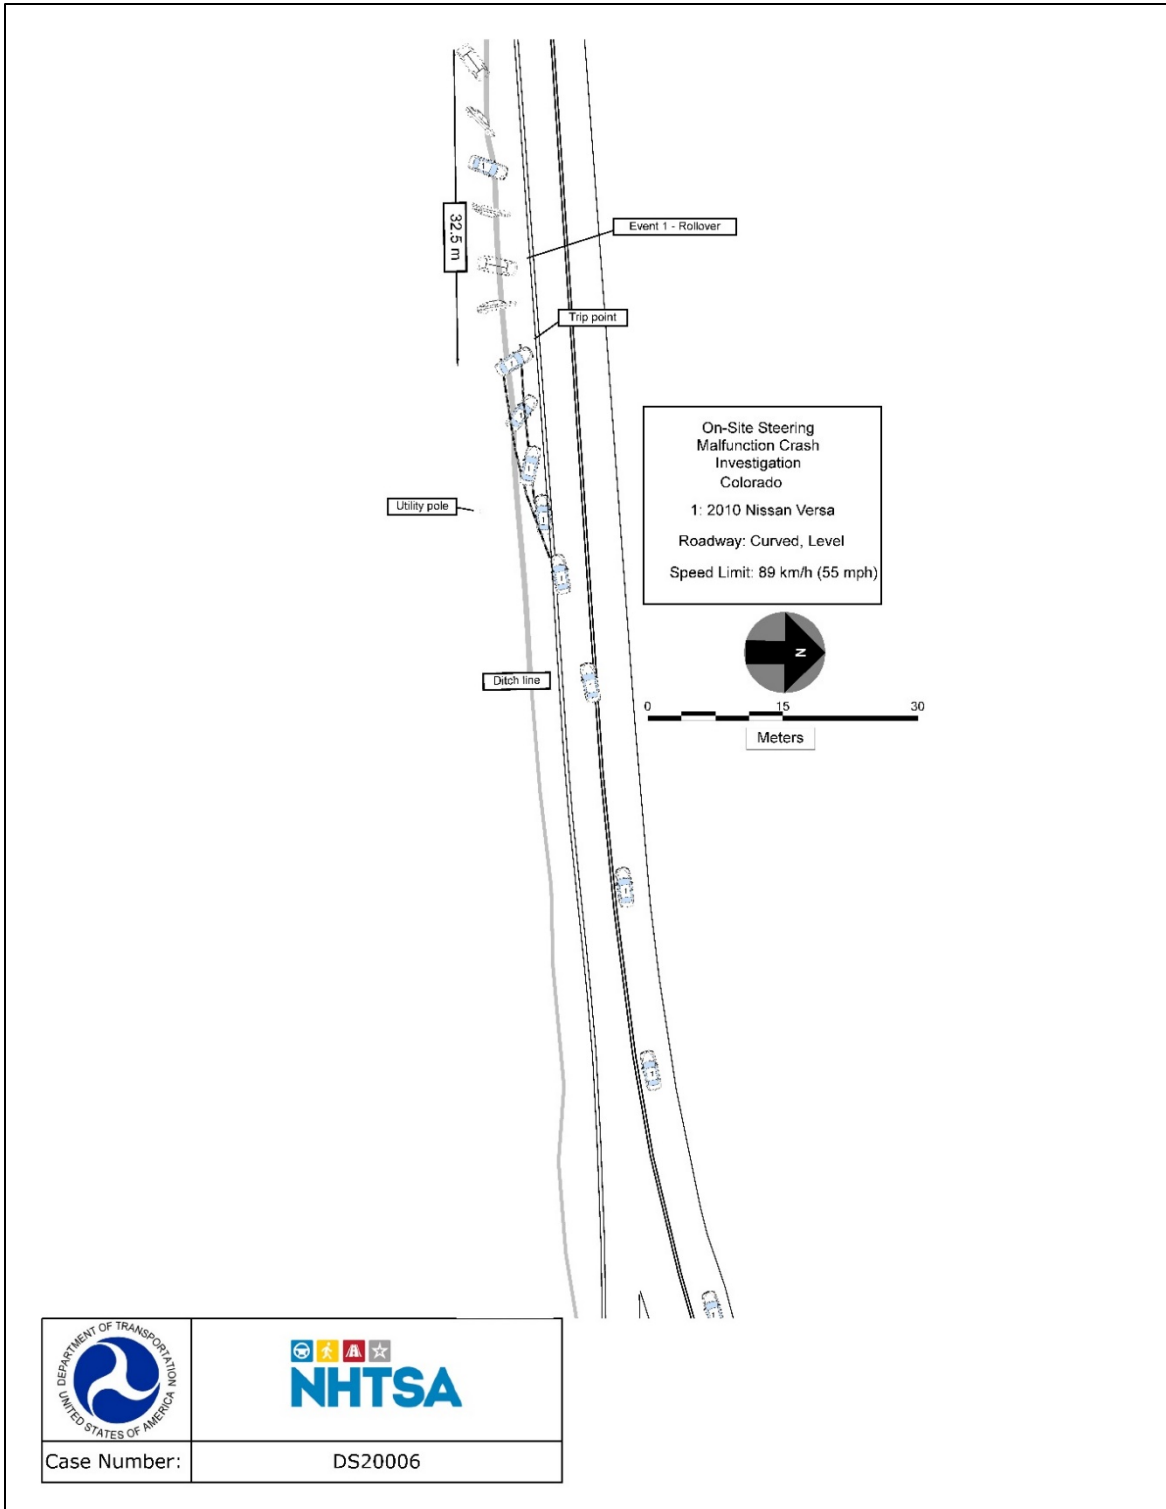
Crash Diagram

The police noted two marks on the eastbound fog line and, based on their appearance and distance between them, surmised that the vehicle was rotating clockwise prior to departing the roadway. The vehicle traveled off the south side of the roadway in a continuing clockwise rotation for approximately 20.2 m (66.3 ft). The vehicle rotated 90 degrees with a speed loss of approximately 49 km/h (31 mph) before tripping (Figure 3). The vehicle then began a left-plane-leading rollover. The vehicle appeared to have rolled six quarter-turns over a distance of 32.5 m (106.7 ft) with a speed loss of approximately 64 km/h (40 mph)² and came to rest on its roof (Figure 4). The combined speed loss for the road departure and overturn sequence was approximately 82 km/h (51 mph).
