DOT HS 813 256

**Special Crash Investigations:  
On-Site Hazardous Materials Fatality;  
Vehicle: 2006 Porsche Cayenne;  
Location: Florida;  
Incident Date: June 2016**

**Special Crash Investigations**  
**On-Site Hazardous Materials Fatality Investigation**  
**Office of Defects Investigation**  
**Case Number: CR16026**  
**Vehicle: 2006 Porsche Cayenne**  
**Location: Florida**  
**Incident Date: June 2016**

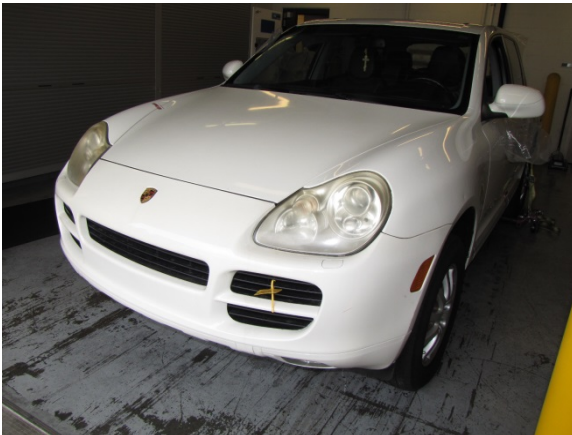
The 2006 Porsche Cayenne (Figure 2), manufactured in June 2005, was identified by the Vehicle Identification Number WP1AA29P86Lxxxxxx. Its digital odometer reading was 228,691 km (142,106 miles). The all-wheel drive platform was configured on a 286 cm (112.6 in) wheelbase and was powered by a 3.2-liter V6 gasoline engine that was linked to a 6-speed automatic transmission. The service brakes were a power-assisted front/rear disc system with ABS. The gross vehicle weight rating was placarded at 2,945 kg (6,493 lb). Front and rear gross axle weight ratings were 1,385 kb (3,053 lb) and 1,650 kg (3,638 lb rear), respectively. The curb weight was 2,160 kg (4,763 lb). The manufacturer's recommended tire size was P235/65R17 at all four axle positions. At the time of the SCI inspection, the Porsche was equipped with four Continental Cross Contact tires of the recommended size.

Figure 2. Front left image of the Porsche Cayenne

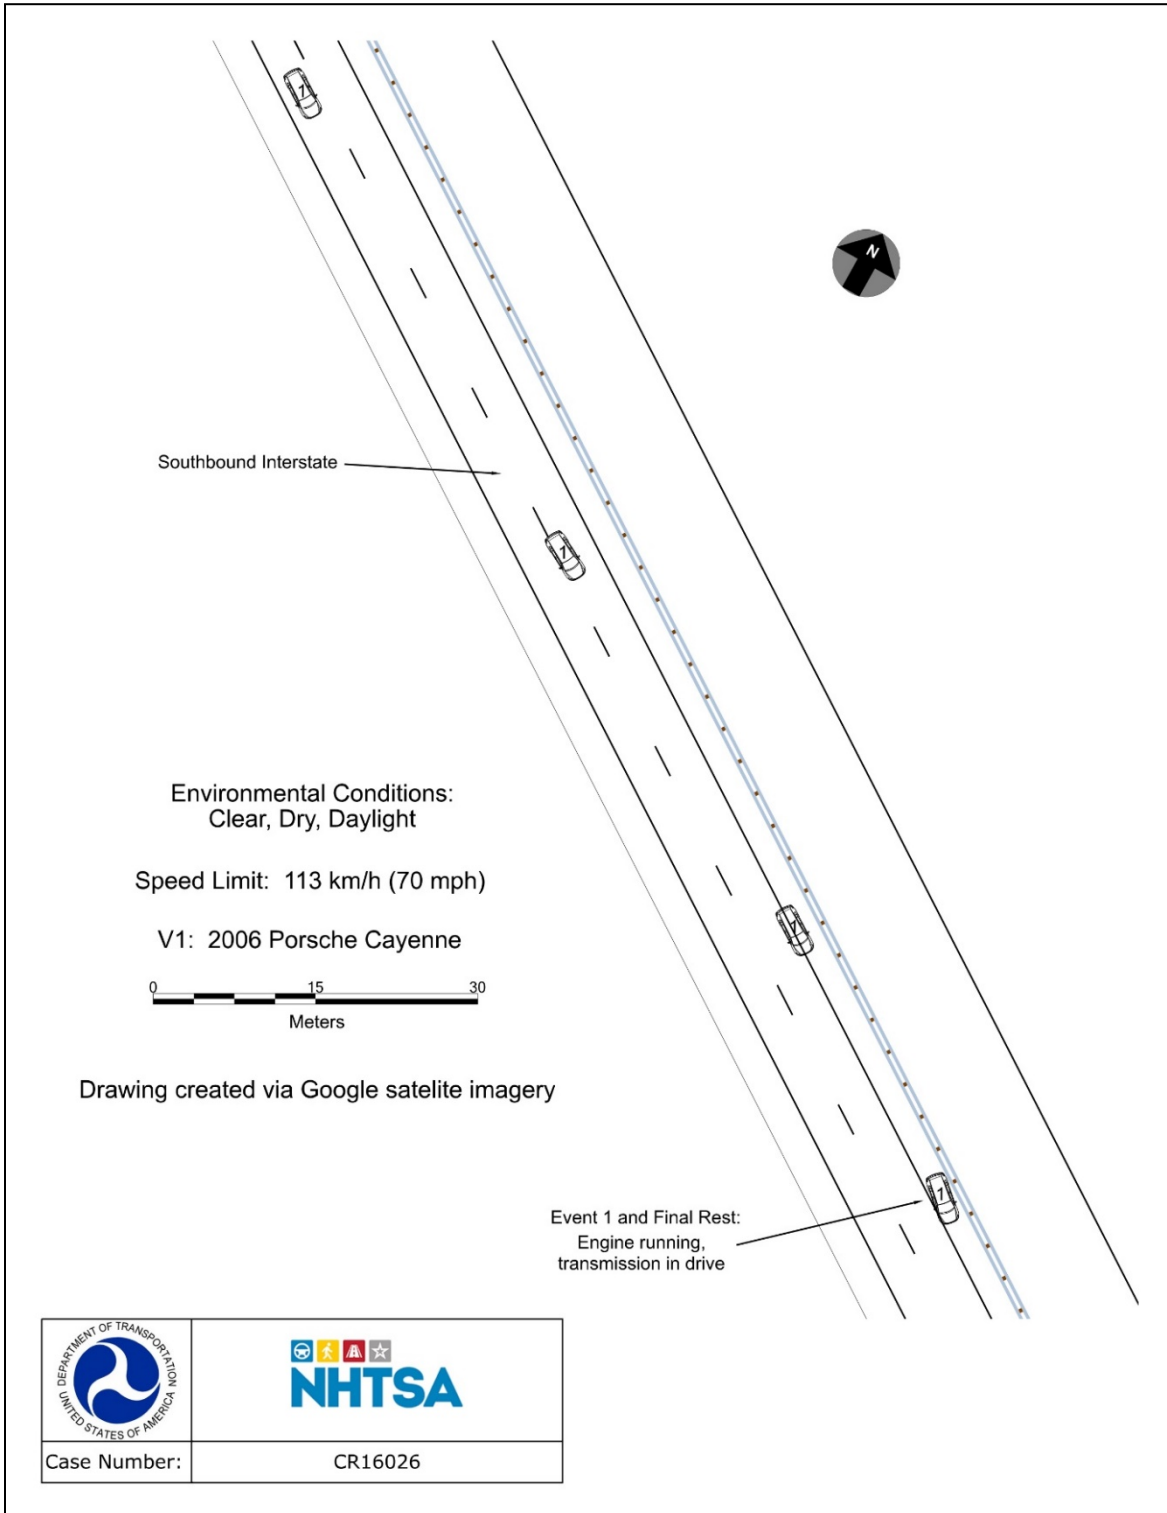
# Incident Diagram

- Rendered unconscious, the driver and the second row occupant succumbed to the toxic hydrogen sulfide fumes while the Porsche idled on the roadside.
