DOT HS 813 277

**Special Crash Investigations:  
On-Site School Bus Crash  
Investigation;  
Vehicle: 2012 IC Corporation  
CE-300 School Bus;  
Location: New Jersey;  
Crash Date: May 2018**

**Special Crash Investigations**  
**On-Site School Bus Crash Investigation**  
**Case Number: CR18014**  
**Vehicle: 2012 IC Corporation CE-300 School Bus**  
**Location: New Jersey**  
**Crash Date: May 2018**

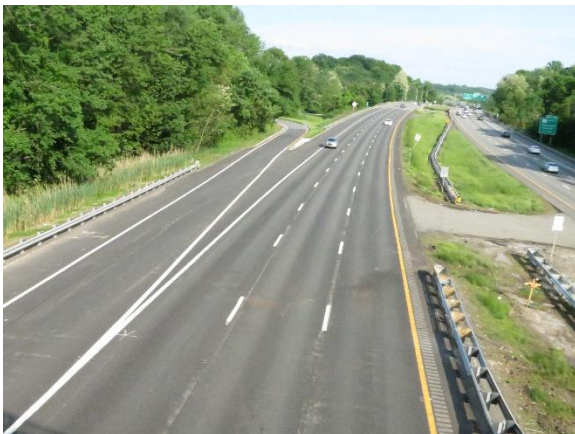
The crash occurred in the westbound lanes of a divided, limited-access roadway during the morning hours (Figure 2). In the vicinity of the crash was an interchange where an entrance ramp merged into the westbound lanes from the north. A median crossover was located immediately south of the end of the gore of the entrance ramp. Weather conditions in the suburban locale as reported by the National Weather Service included clear skies with a temperature of 28°C (82°F), a 66-percent relative humidity, and a 32 km/h (20 mph) easterly wind. The police crash report listed the environmental conditions as daylight, cloudy, and wet.

*Figure 2. East-facing view of the crash site on the westbound lanes of the interstate (image taken from an overpass located immediately west of the area of impact)*

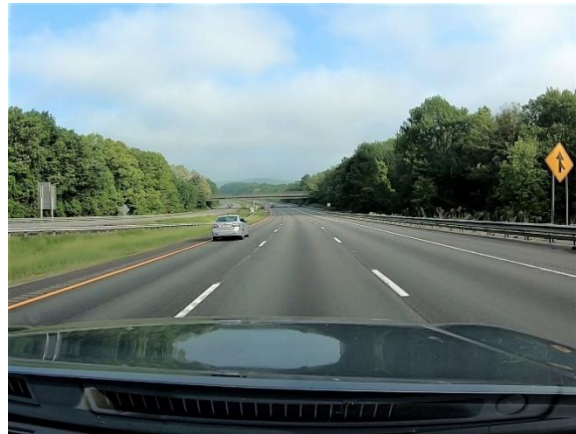
*Figure 3. Westbound pre-crash trajectory view of the Kenworth (image obtained as a screen capture from an SCI GoPro video)*

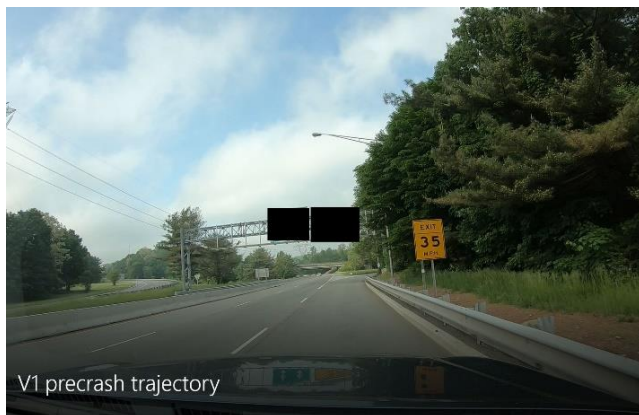
As the bus traveled forward on the three-lane State roadway, the roadway diverged in a Y-configuration (Figure 4). The school bus took the right lane that served as an entrance ramp onto the interstate. Two overhead signs along the school bus's path declared that the right lane led onto the westbound interstate highway. The ramp was approximately 285 m (935 ft) long, curved right with a heading change of 80 degrees, and had a positive grade to meet the interstate. As the school bus continued along the ramp toward its merge point with the westbound lanes (Figure 5), a raised, triangular concrete gore extended from the roadside grass. A road sign declaring "No Turns" was located at the gore. For undetermined reasons, the driver of the school bus turned left at the end of the concrete gore and headed toward the median crossover. During post-crash inspection, it was observed that the speedometer was stuck at 27 km/h (17 mph). This value was consistent with the speed of a school bus executing a 90-degree turn, based on SCI experience.

*Figure 4. Pre-crash trajectory of the school bus at the entry point for the westbound interstate entrance ramp (image obtained as a screen capture from an SCI GoPro video)*

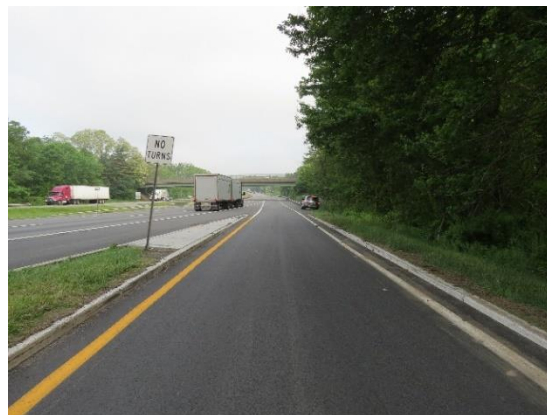
*Figure 5. West-facing view of the entrance ramp to the limited access roadway for the pre-crash travel trajectory of the school bus*

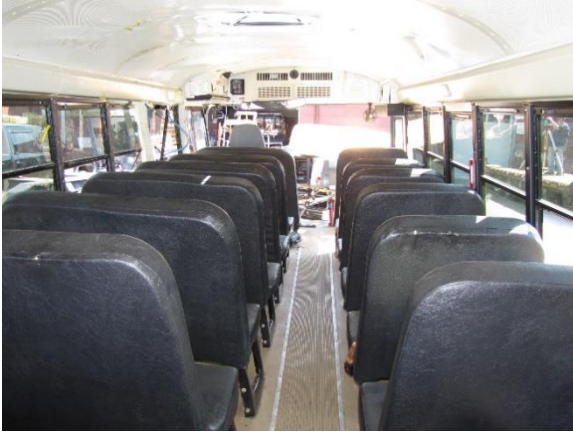
*Figure 14. Forward-looking view of the bus interior from row 6*

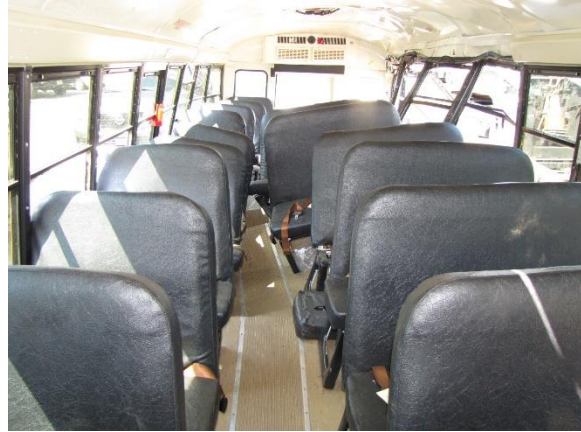
*Figure 15. Rear-looking view of the bus interior from row 3*

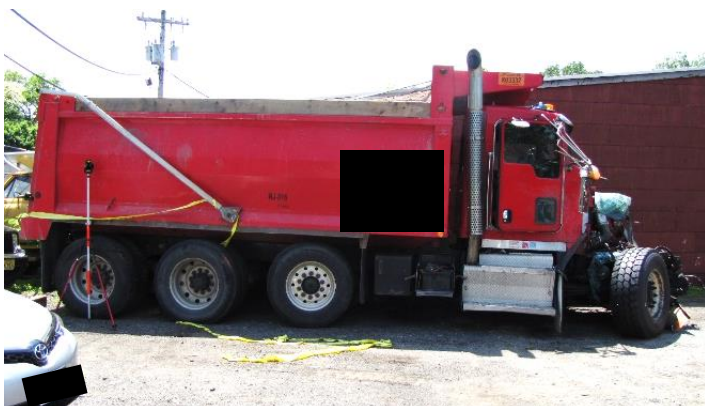
Figure 22. Right side view of the Kenworth
