DOT HS 813 284

**Special Crash Investigations:  
On-Site School Bus Crash  
Investigation;  
Vehicle: 2013 Thomas Type D  
School Bus;  
Location: Tennessee;  
Crash Date: October 2020**

**Special Crash Investigations**  
**On-Site School Bus Crash Investigation**  
**Case Number: CR20032**  
**Vehicle: 2013 Thomas Type D School Bus**  
**Location: Tennessee**  
**Crash Date: October 2020**

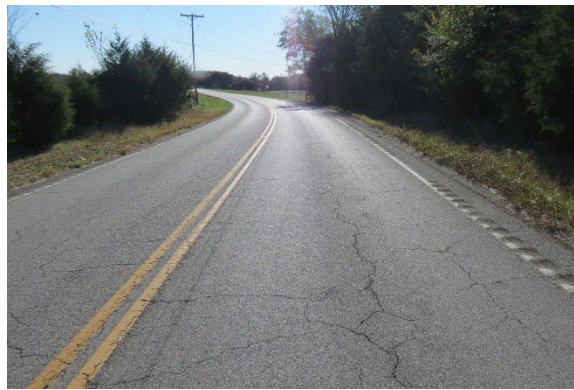
This crash occurred during the afternoon hours in a rural area. The weather conditions included partly cloudy skies with no wind and a temperature of 23 °C (73 °F), according to the local weather reports. The roadway (Figure 2) was dry, level, bituminous, and oriented in a general north/south direction with one lane in each direction, both 3.4 m (11.2 ft) wide. The road was curved left for southbound traffic. South of the crash site, the east shoulder was 30 cm (11.8 in) wide, and the west shoulder was 1.0 m (3.3 ft) wide. North of the crash site, the shoulders were approximately 50 cm (20 in) wide. Roadway markings consisted of solid white edge lines and a double yellow centerline, and there were rumble strips on both edges of the roadway. A driveway and mailbox were located on the west side of the road at the apex of the curve. The speed limit was 89 km/h (55 mph). The bus's pre-crash roadway had a superelevation of +4.4% to the west. A crash diagram is included at the end of this report.

*Figure 2. South view of the bus's approach to the point of impact*

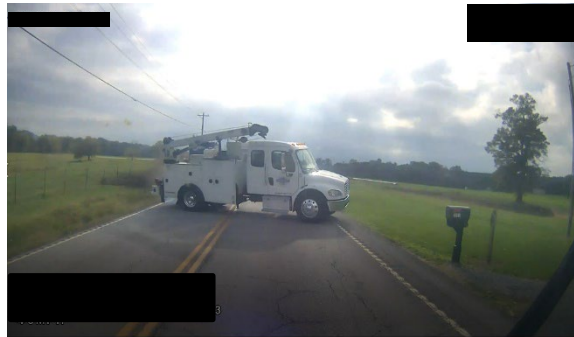
The bus was traveling south (Figure 2), and the driver was intending to negotiate the left curve. The forward-looking video indicated a speed range of 77 to 74 km/h (48 to 46 mph) at 10-second to 1-second pre-crash intervals (Figure 3). The Freightliner was traveling north, and the driver was intending to continue straight ahead, approaching the same curve. Approaching the curve, the Freightliner drifted to the right, and its right wheels traveled off the east road edge, along the downslope of the ditch, at a negative grade of 1.6 percent (Figure 4). After approximately 26 m (85 ft) of off-road travel, the driver steered left, and the right front tire returned to the roadway. This resulted in an oversteer condition, and the Freightliner began to yaw counterclockwise and

*Figure 3. Bus video of the truck just prior to impact (bus speed = 74 km/h [46 mph])*

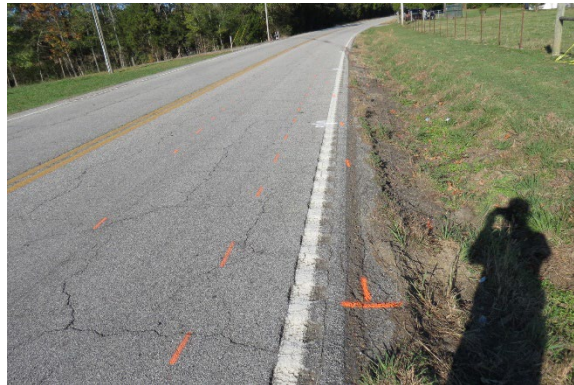
*Figure 4. North view of the Freightliner's pre-crash travel path*

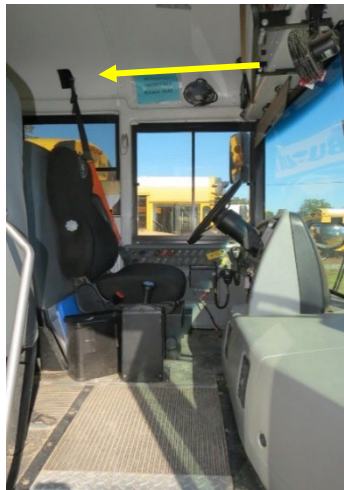
Figure 12. Exemplar bus driver's area

The front of the bus sustained severe intrusion damage (Figure 11) from the impact with the Freightliner. Figure 12 is a right-looking image of the driver's area in an exemplar bus for comparison. Table 1 presents the intruded component, location, magnitude of intrusion, and direction of intrusion.
